# ➤ Integrity Management of off-axis SCC Through an ILI System and Engineering Assessment

## Pipeline Pigging and Integrity Management Conference

February 12-16, 2024

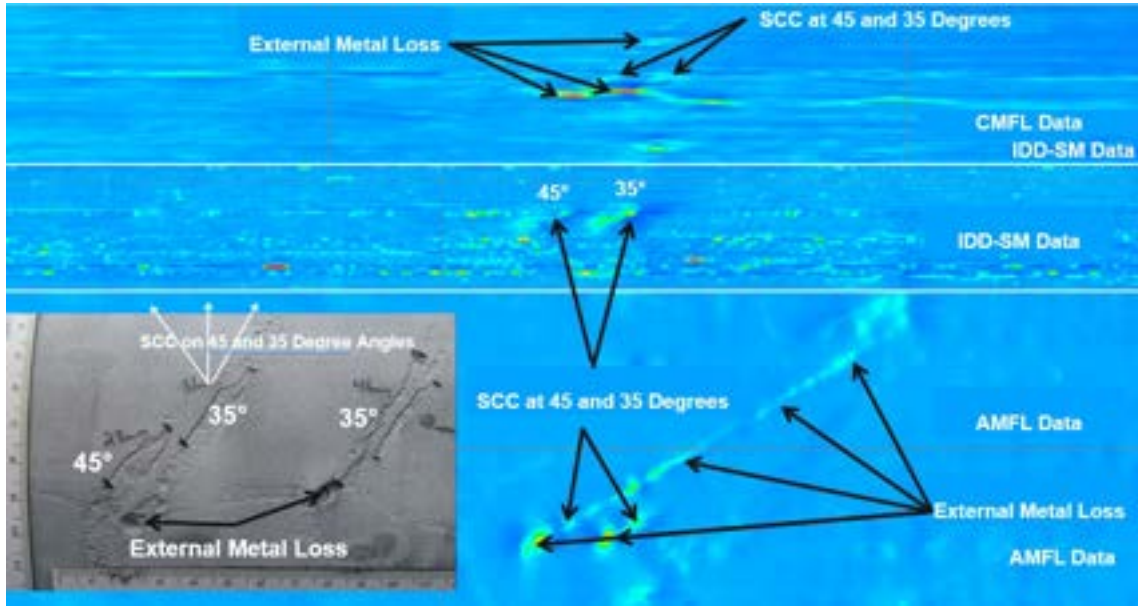
Figure 1 demonstrates the detection and discrimination of CSCC cracks that are at 35° and 45° off angle to the circumferential axis of the pipe. The AMFL and IDD-SM<sup>SM</sup> magnetic field and signal response vs. background level is clearly visible and was precisely quantified as well as AMFL data that clearly depicted the areas that were external corrosion.

**Figure 1.** Detection of an Off Angle CSCC features.

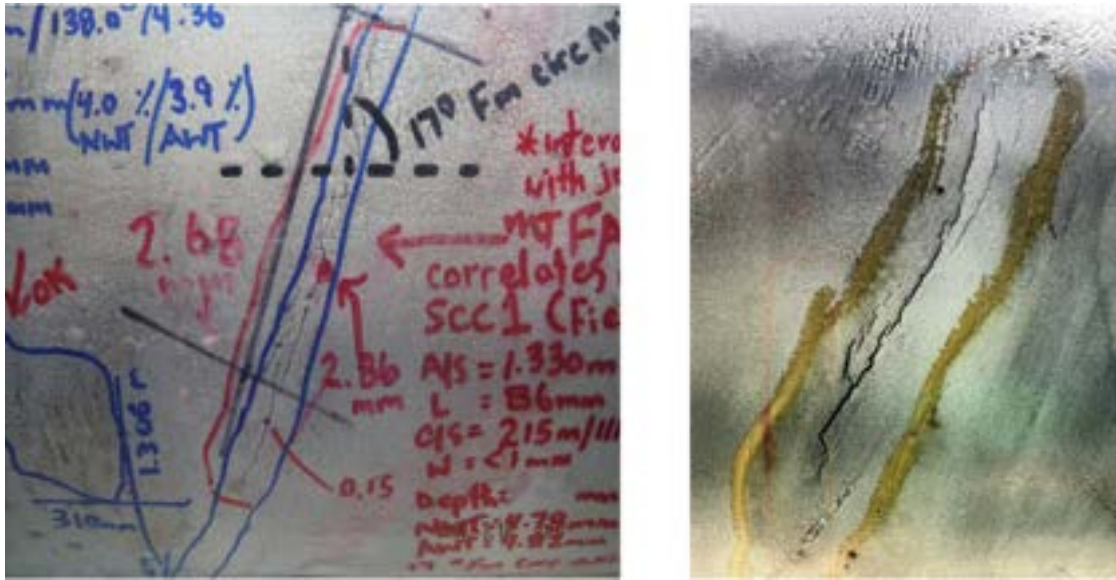
This translated into real world performance whereby crack occurrences that are off angled to the circumference or cracks with multiple or radially skewed branches are detected as reliably as a single branch through wall radial crack. The magnetic based inspection technology sizing capability does not rely in the detection of signals from the crack tips as the ultrasonic technique used in the Phased Array Ultrasonic (PAUT) field verification did. Figure 2 below shows another example of an off-axis crack detected by the ILI system.

Figure 2. Example of CSCC Features Located at 17° and 27° off the Pipe Circumference.

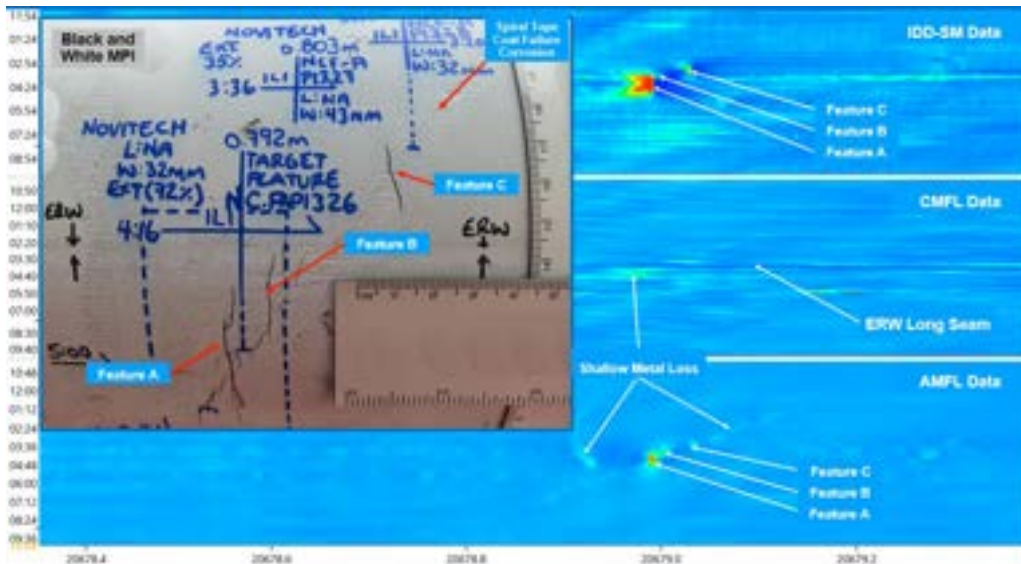
An example of a feature located in such an area is shown in Figure 3 below.

Figure 3. CSCC Feature in an Area with no Obvious Bending Strain Indication.

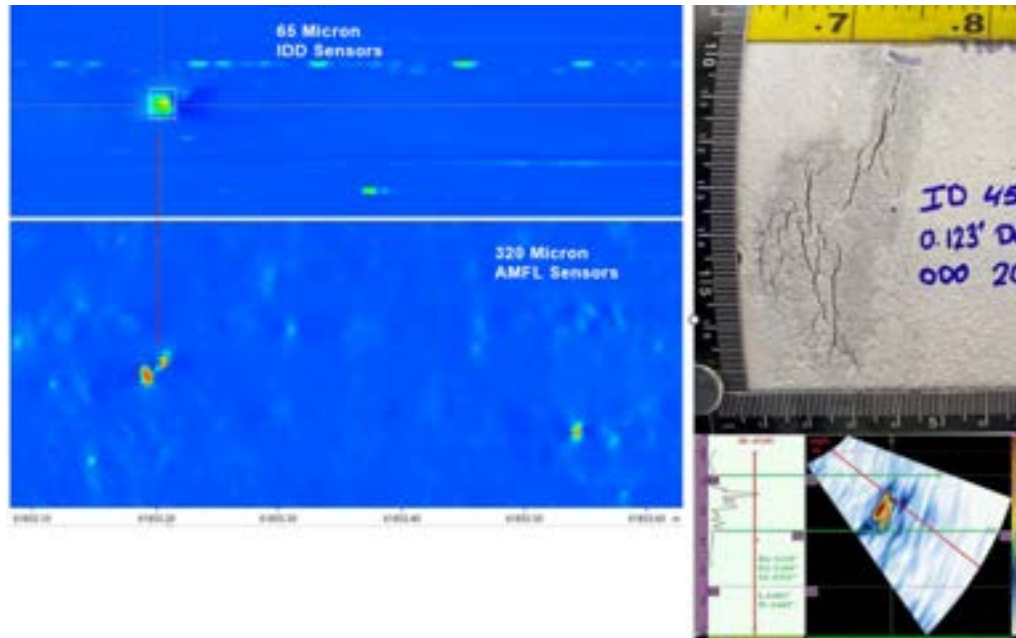
SCC features are very often found in colonies or groups of cracks in close proximity to one another. The CSCC features exhibit similar behaviour where the cracks are not only found as an individual indication, but also as colonies with several cracks in close to one another. An example of such a group of cracks is shown in Figure 4 below, where the dominant cracks are well visible in the data.

**Figure 4.** CSCC Feature Colony/Cluster.

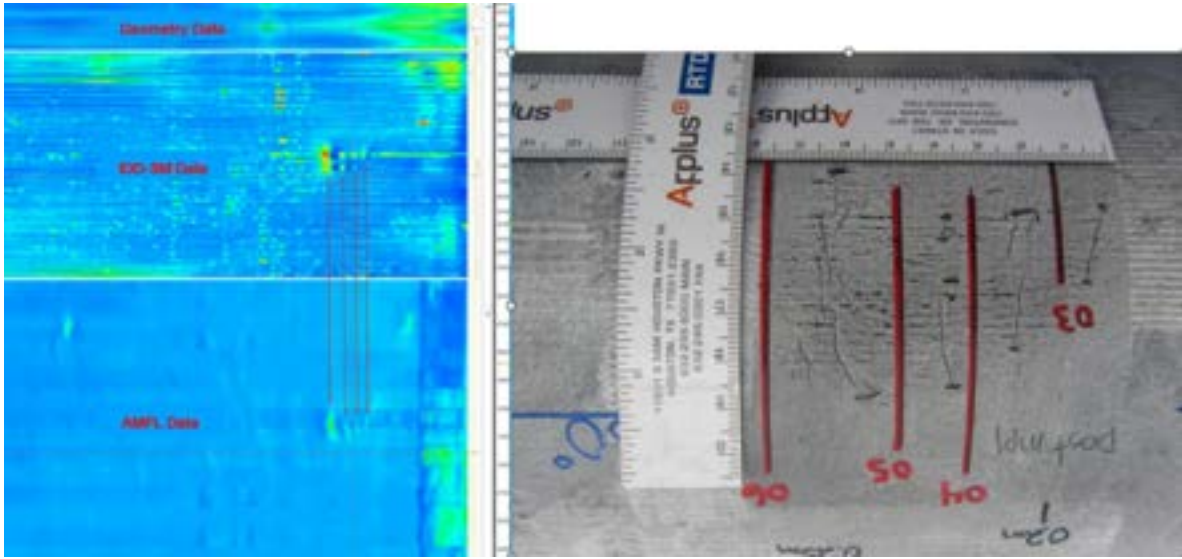
The resolution of the MFL system, combined with the use of up to five data sets, AMFL, CMFL, IDD-SM<sup>SM</sup>, Geometry and IMU, can allow for de-clustering a crack colony when spacing between features exceeds 20 mm, while sizing each of them accurately. This characteristic of the findings may prove especially useful when assessing the severity of the colonies/cracks as both depth and length of the dominant cracks are available. Another example of the CSCC colonies is shown in Figure 5 below. Four distinct areas of CSCC are visible in the data and then upon excavation shown as four separate crack features/colonies.

**Figure 5.** CSCC Features in Close Proximity, with clear separation between them in the data, avoiding over-clustering of the colony.

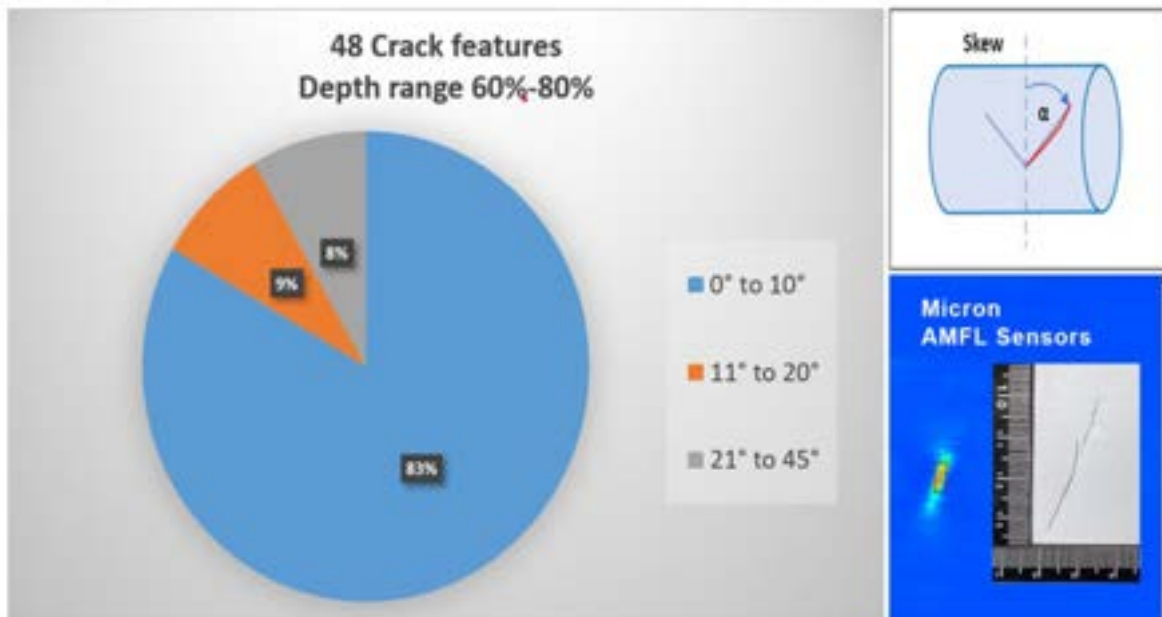
As an initial effort to determine the extent or ratio to which cracks appear either perfectly circumferential or at off angles, a sample of features that ranged in depth from 60 to 80% were plotted against its predicted angle from the vertical and its predicted skew angle verified through excavations. Figure 5 below shows a summary of the findings. While most of the features were located between zero° and 10° off the pipe circumference, 17% of them were found at skew angles greater than 11° and up to 45°.

**Figure 6.** Summary of the Most Recent off Angle CSCC Findings, and first database of confirmed cases and ratios of circumferential SCC to off-axis SCC.
