➤ **Integrity Management of off-axis SCC Through an ILI System and Engineering Assessment**

**Ron Thompson<sup>1</sup>, Andrew Corbett<sup>1</sup>, Guillermo Solano,<sup>1</sup>  
Richard Kania<sup>2</sup>**

<sup>1</sup> Novitech Inc., <sup>2</sup> KanEnergy Partners Inc.

**Pipeline Pigging and Integrity Management Conference**

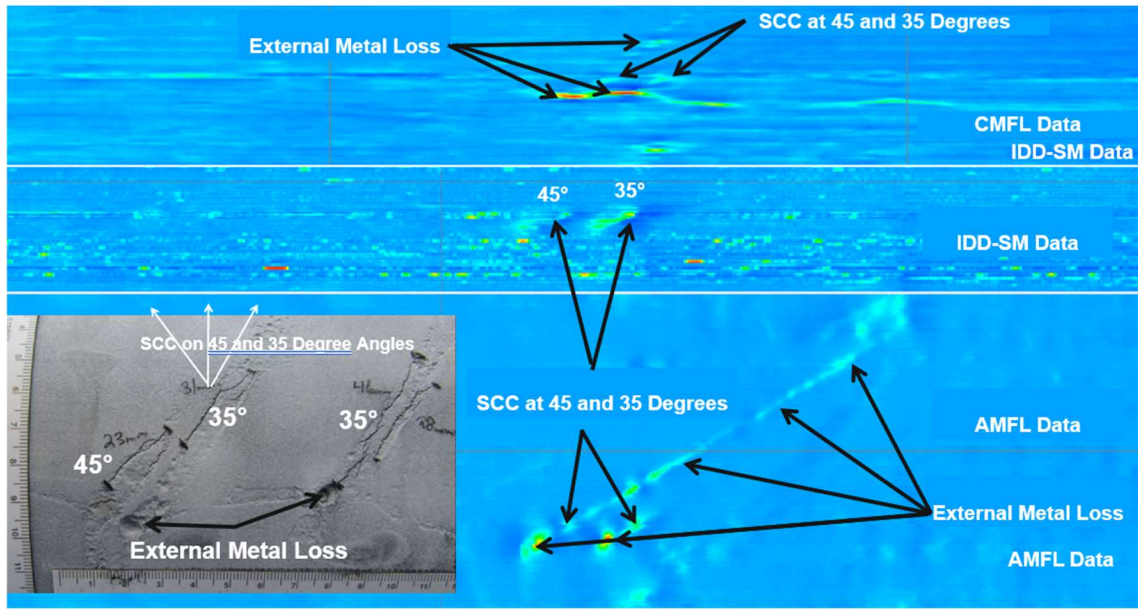
Figure 1 demonstrates the detection and discrimination of CSCC cracks that are at 35° and 45° off angle to the circumferential axis of the pipe. The AMFL and IDD-SM<sup>SM</sup> magnetic field and signal response vs. background level is clearly visible and was precisely quantified as well as AMFL data that clearly depicted the areas that were external corrosion.

**Figure 1.** Detection of an Off Angle CSCC features.

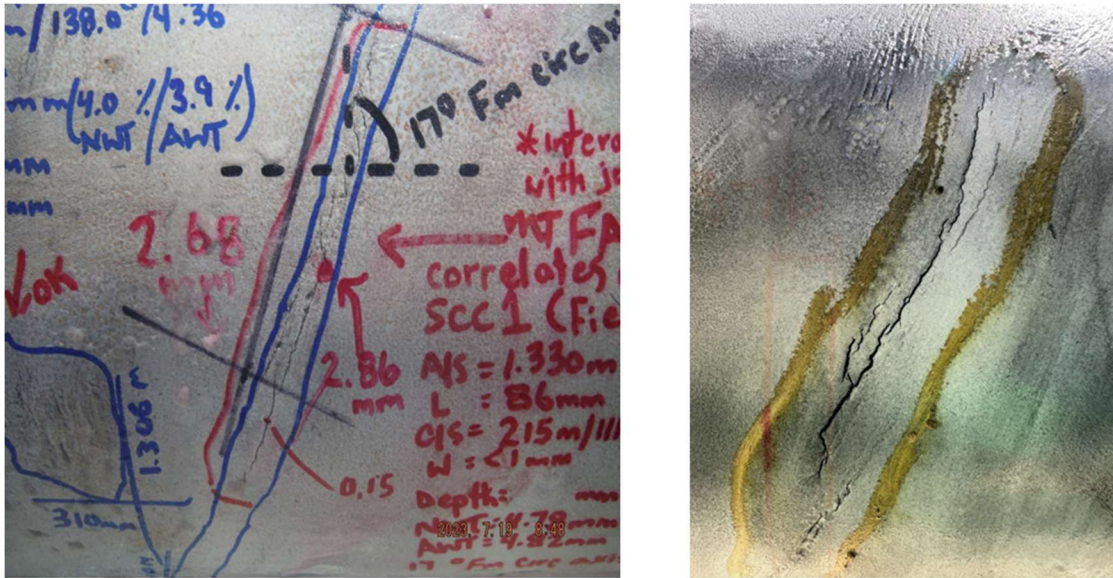
Figure 2. Example of CSCC Features Located at 17° and 27° off the Pipe Circumference.

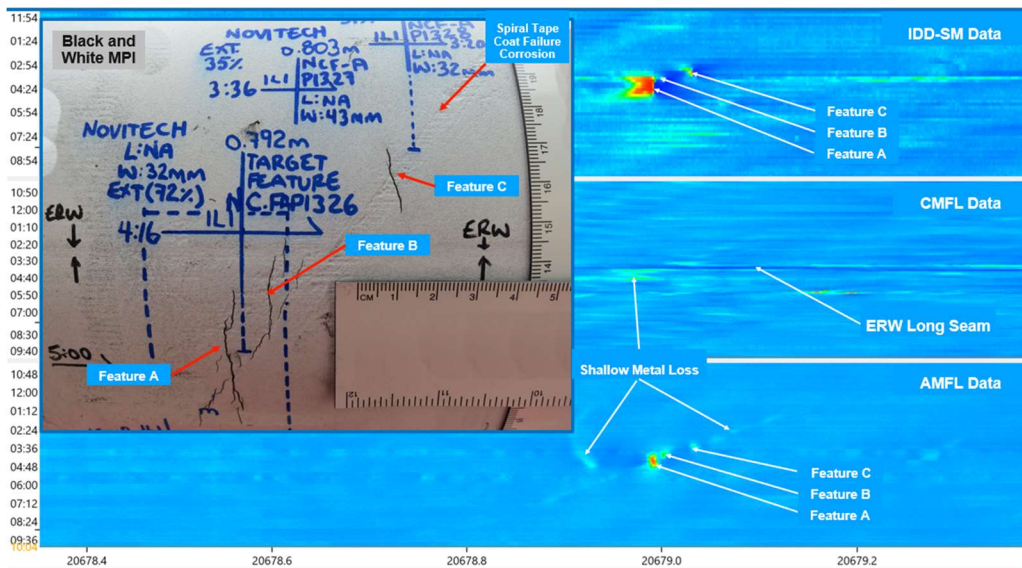
As more excavations are completed, pipeline operators started to collect additional data at the digs sites to further understand the stresses contributing to the crack orientation. Since the crack feature orientation indicates the presence of additional sources of stress on the pipe and additional investigation is needed for appropriate mitigation activities. These investigations are even more relevant for areas where the CSCC is located in straight pipe with no obvious geotechnical or IMU bending strain indications. This presents unique challenges for the excavation and in-situ examination.

Figure 3. CSCC Feature in an Area with no Obvious Bending Strain Indication.

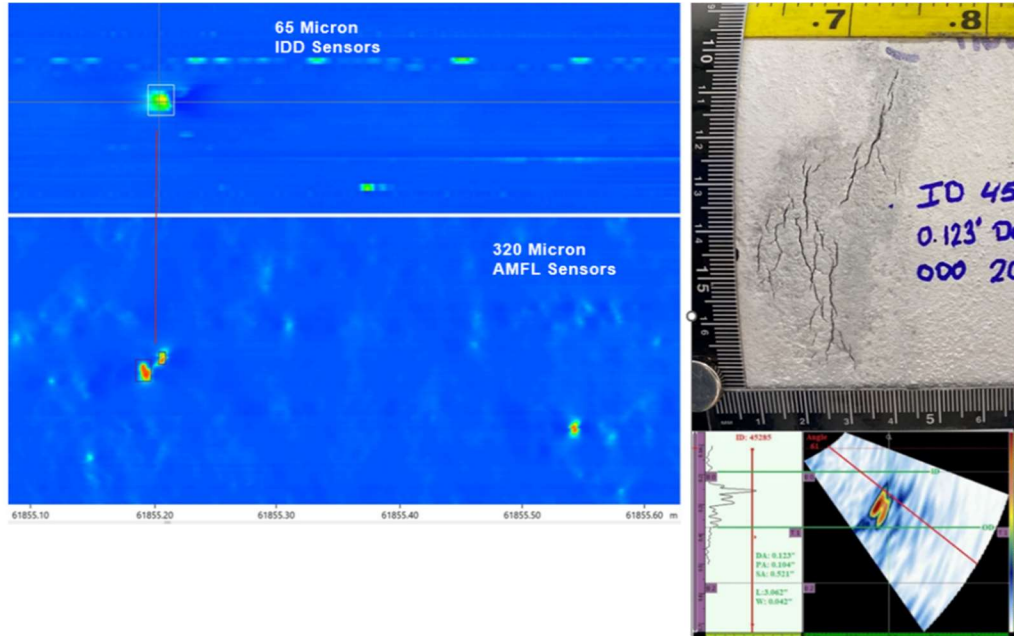
SCC features are very often found in colonies or groups of cracks in close proximity to one another. The CSCC features exhibit similar behaviour where the cracks are not only found as an individual indication, but also as colonies with several cracks in close to one another. An example of such a group of cracks is shown in Figure 4 below, where the dominant cracks are well visible in the data.

**Figure 4.** CSCC Feature Colony/Cluster.

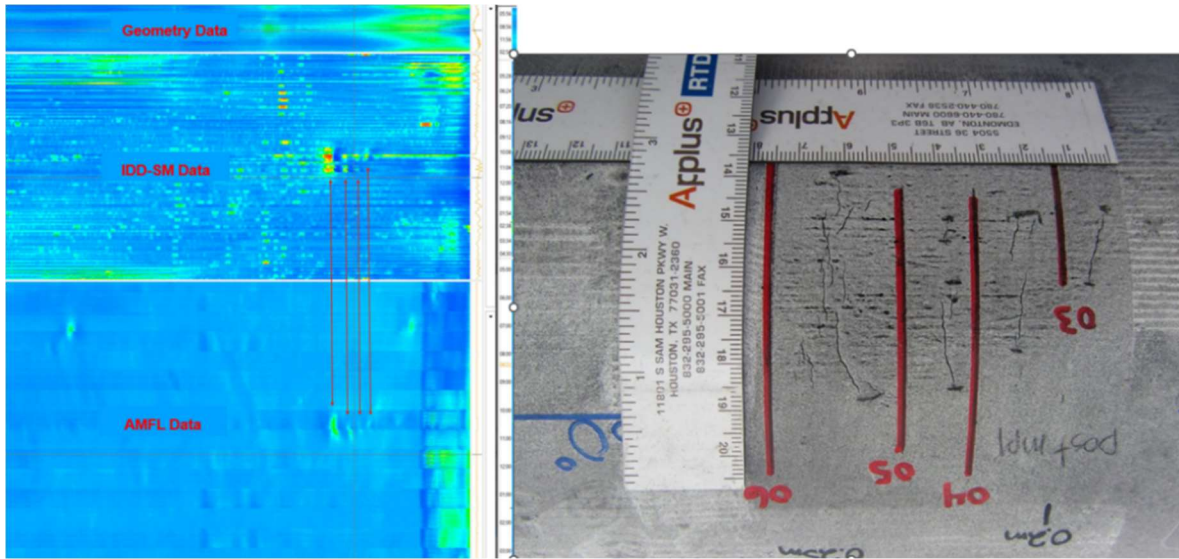
The resolution of the MFL system, combined with the use of up to five data sets, AMFL, CMFL, IDD-SM<sup>SM</sup>, Geometry and IMU, can allow for de-clustering a crack colony when spacing between features exceeds 20 mm, while sizing each of them accurately. This characteristic of the findings may prove especially useful when assessing the severity of the colonies/cracks as both depth and length of the dominant cracks are available. Another example of the CSCC colonies is shown in Figure 5 below. Four distinct areas of CSCC are visible in the data and then upon excavation shown as four separate crack features/colonies.

**Figure 5.** CSCC Features in Close Proximity, with clear separation between them in the data, avoiding over-clustering of the colony.

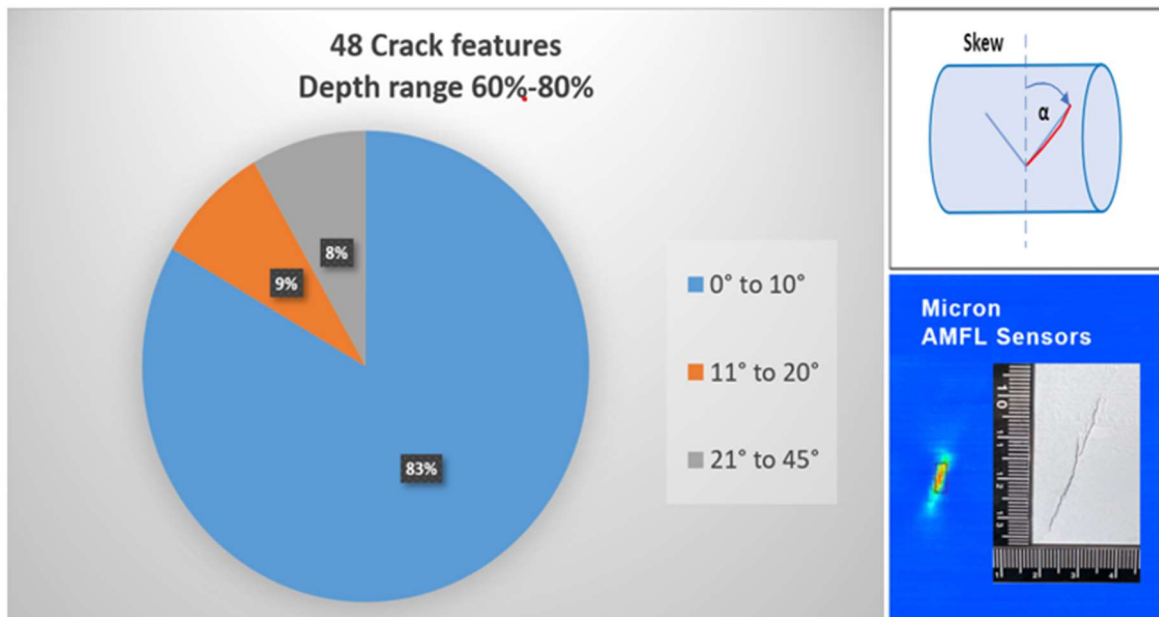
As an initial effort to determine the extent or ratio to which cracks appear either perfectly circumferential or at off angles, a sample of features that ranged in depth from 60 to 80% were plotted against its predicted angle from the vertical and its predicted skew angle verified through excavations. Figure 5 below shows a summary of the findings. While most of the features were located between zero° and 10° off the pipe circumference, 17% of them were found at skew angles greater than 11° and up to 45°.

**Figure 6.** Summary of the Most Recent off Angle CSCC Findings, and first database of confirmed cases and ratios of circumferential SCC to off-axis SCC.
