# Non-contact and non-destructive testing of unpiggable pipelines from the ground surface

By Mark Glinka, Steffen Päßler, Michael Baumgart and Gerd Rettschlag

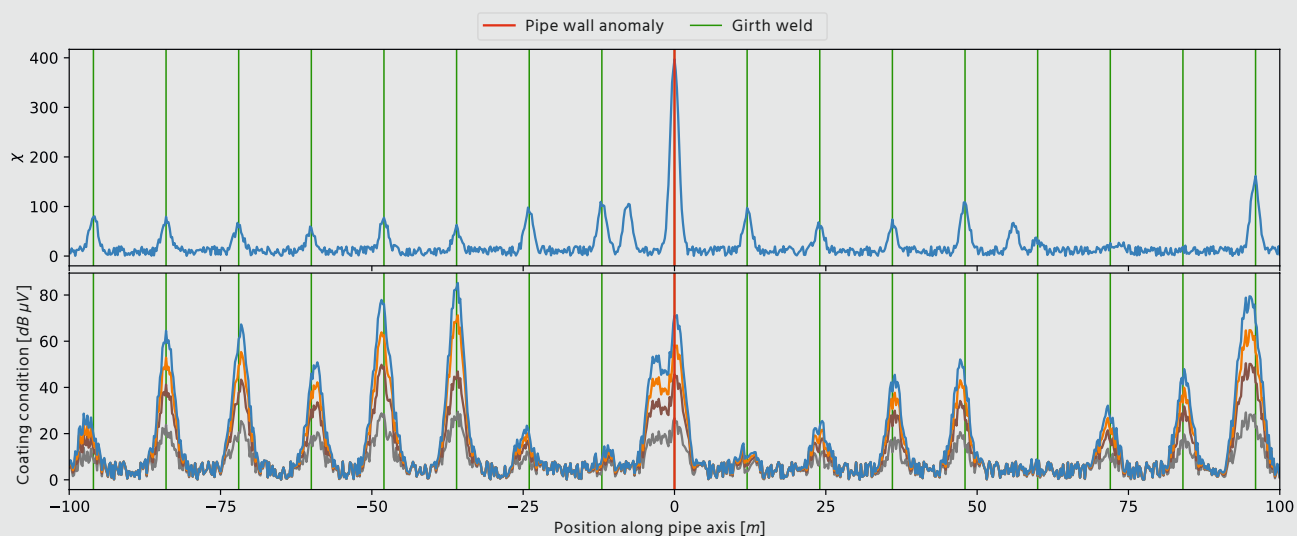
**Figure 5:** Extract from the results of the CMI inspection FGL 101

missioning of the pipeline on an approx. 30 km-long section between gate valve 1 and gate valve 9. In the inspection report, anomalies in the pipe wall and in girth welds were listed in addition to coating holidays. In this pipe, the anomalies with the highest rating were girth weld defects (cf. **Figure 5**). These were also classified as such in the final report sent and verified in October 2020. X-ray and ultrasonic tests were carried out on the exposed pipe wall. All anomalies detected by EMPIT were confirmed. A total of six girth welds were found that needed to be repaired.

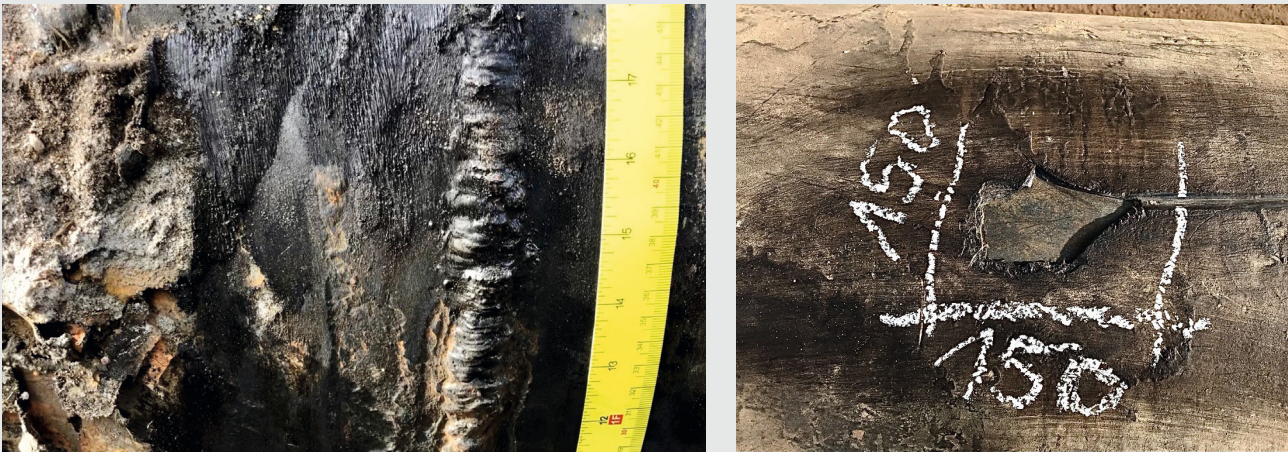
**Figure 6:** Girth weld anomaly detected with CMI (left) and coating holiday (right)

The excavations were also used to validate the condition of the coating reported by EMPIT. As a result, all the coating holidays listed in the report could be verified. The relative sizes in dB  $\mu$ V also matched the dimensions of the faults in reality (cf. **Figure 6**).

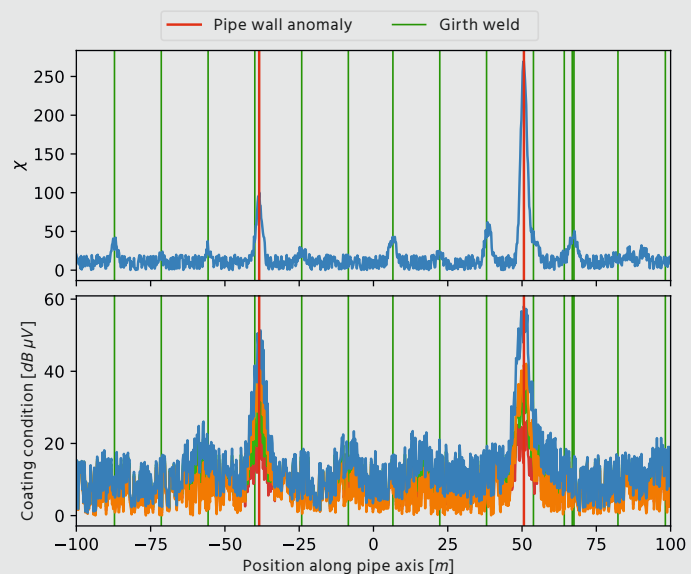
The results of the inspection showed that the approx. 10 km-long pipelines are in an almost anomaly-free condition. The probability of failure of the pipelines was increased in only two places. Coating holidays in combination with pipe wall anomalies were detected, just

**Figure 7:** Plot of the detected anomalies

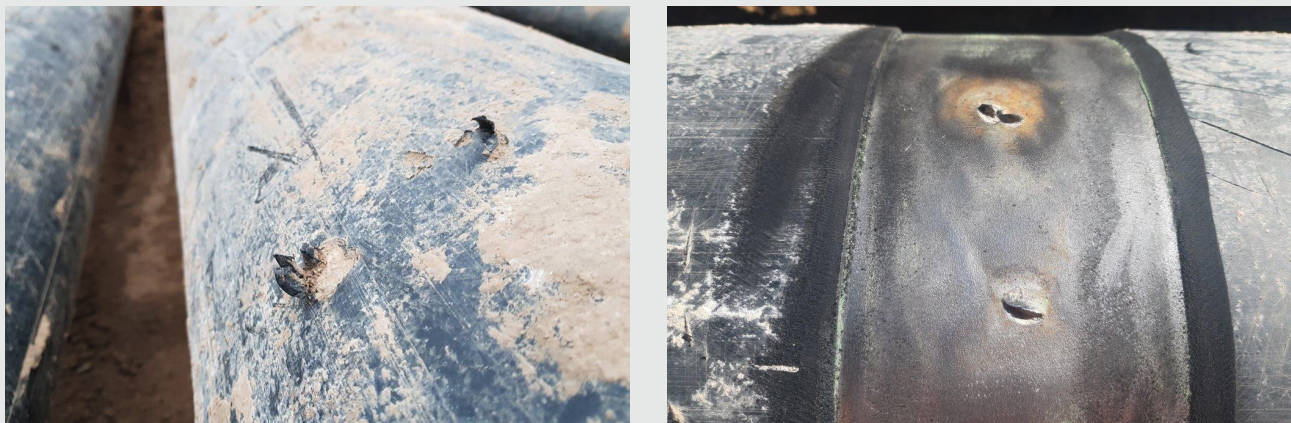
as later excavations verified. The position +51 m in **Figure 7** shows the pipe wall and coating defects shown in **Figure 8**. At the end of 2020, EMPIT was able to further develop its pipe integrity model. In this final report, recommendations for action were formulated for both locations. The result: repair of the defects is not necessary. The responsible authorities at Dow Olefinverbund GmbH nevertheless decided to carry out excavations at both positions in order to be able to conclusively assess the performance of CMI. Both the positions of the coating holidays and the pipe wall anomalies were confirmed in the course of the excavations (cf. **Figure 8**). The acceptance by TÜV Süd confirmed the overall good condition of the pipeline and that the anomalies found did not affect pipeline safety.

Figure 8: Coating holiday and underlying pipe wall anomaly (position +51 m in Figure 7)

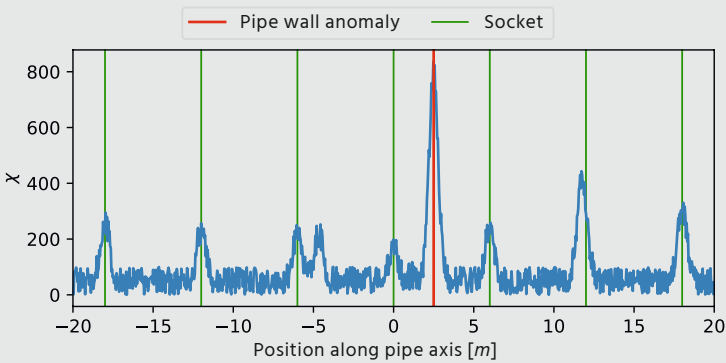
Figure 9: Verified anomaly with 95 % metal loss

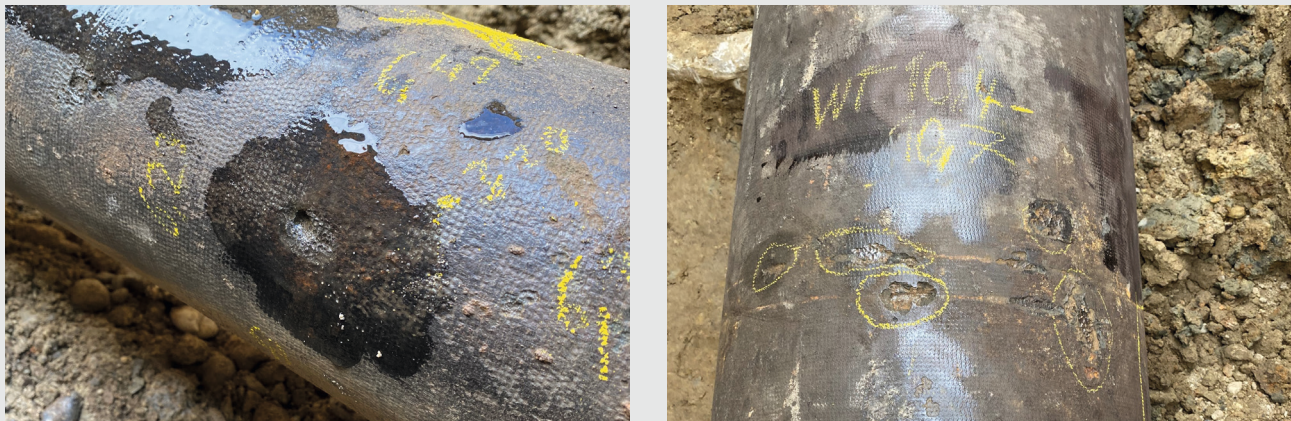
Figure 10: Two detected defects in the town of Grenchen, Switzerland
