A case study in the detection and sizing of circumferential stress corrosion cracking

Pipeline Pigging and Integrity Management Conference

Abstract

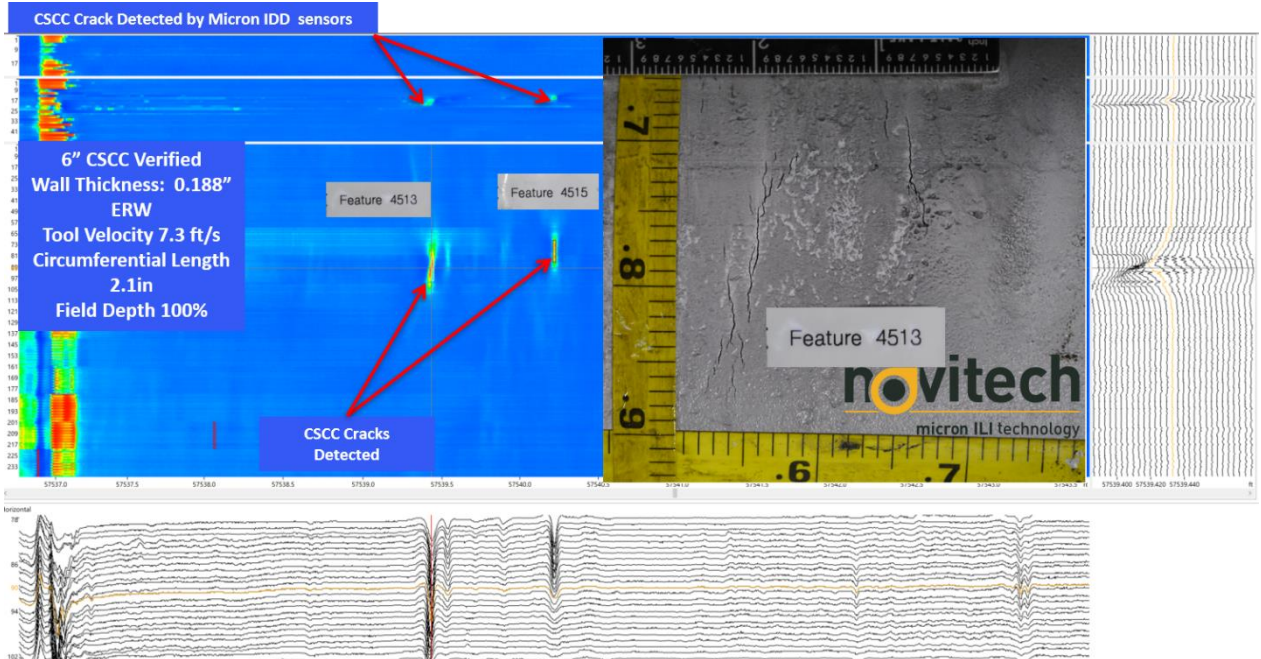
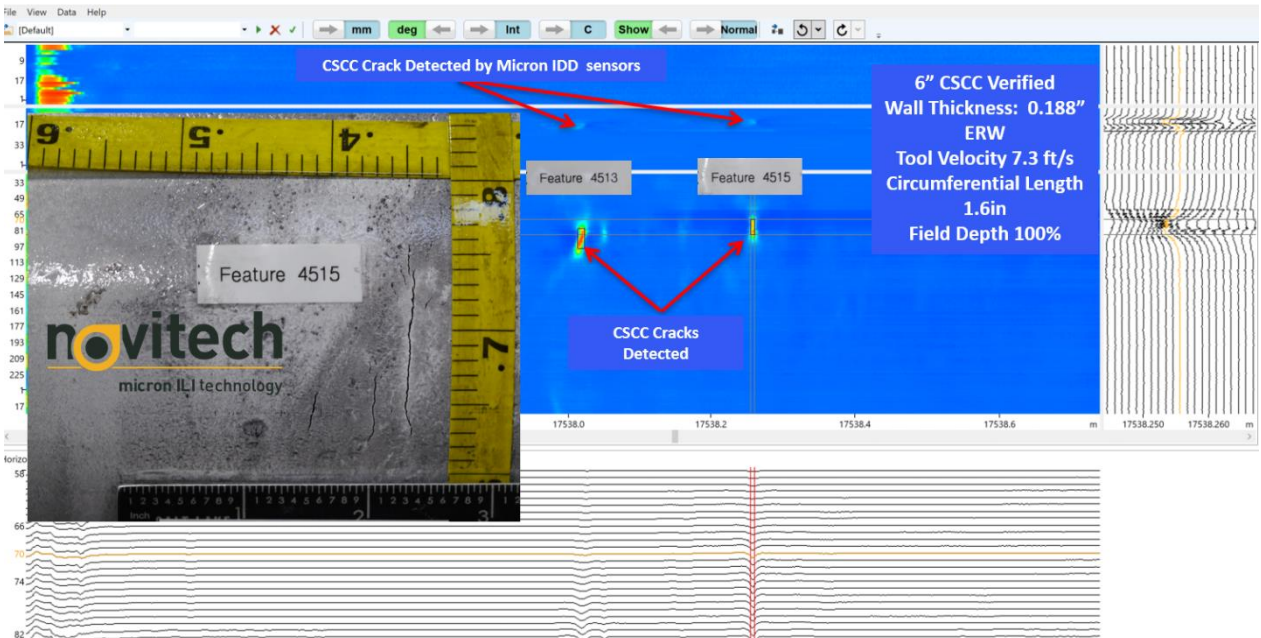
The following figures are examples of excavated features identified as CSCC.

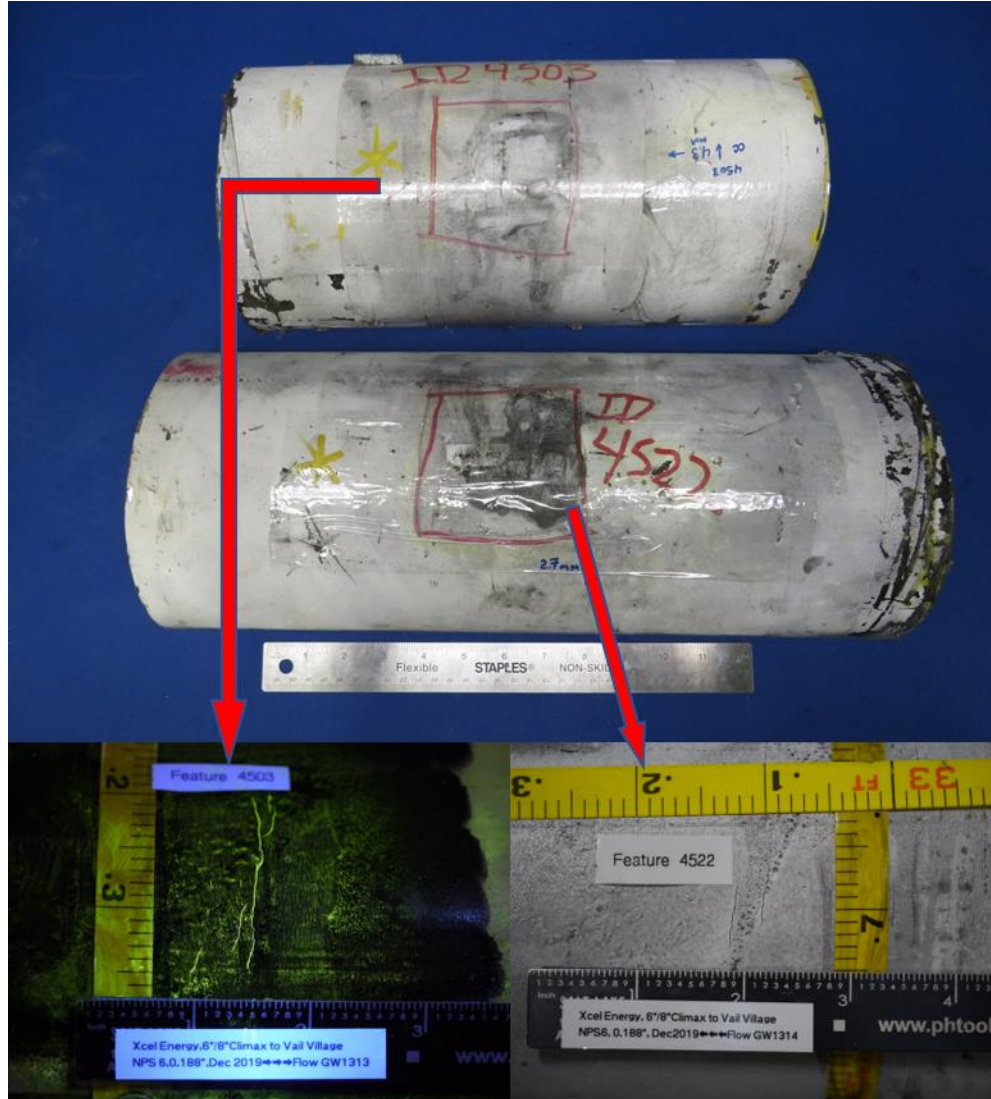
Figure 8: Specimens for Metallurgical Testing

Two sections of pipe with CSCC feature Ids 4503 and 4522 were submitted for third party metallurgical testing. The following excerpt from the final report confirms stress corrosion cracking.

“The cracks on both pipes exhibited a transgranular, branched morphology consistent with stress corrosion cracking (SCC). In particular, sodium and sulfur were detected within the cracks., Sodium and sulfur-based compounds are known to cause SCC within carbon steels, yet other compounds which may cause cracking cannot be detected by EDS⁴ (i.e. ammonia).” [7]

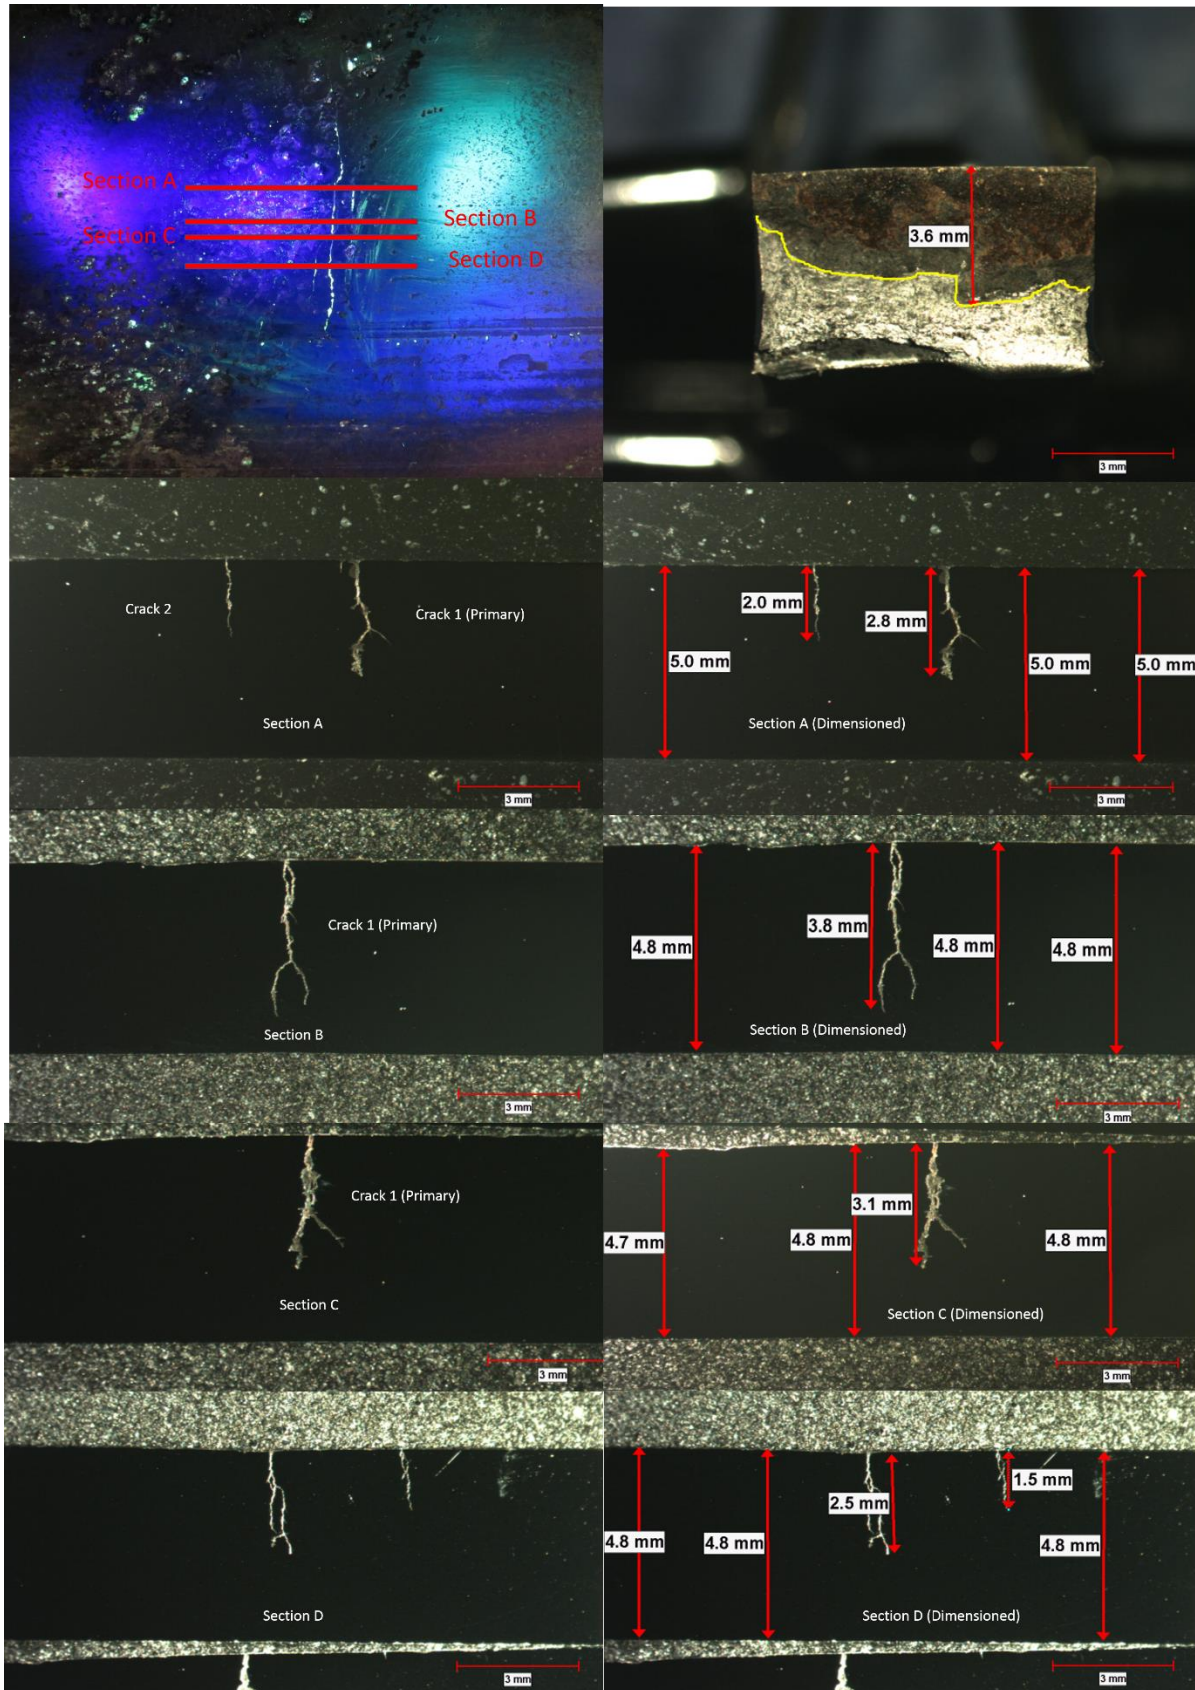
Figure 9: Macrographs Displaying Cross Sections from Feature 4503

Each ILI identified feature is broken down to separate cracks in the colony. The depth accuracy for “Company 1” NDE PAUT is +11.9% for feature Id 4503 and +5.3% for feature Id 4522. The depth accuracy for “Company 2” NDE PAUT is slightly more reasonable at +10.3% for feature Id 4503 and +2.0% for Id 4522. These results do however show a trend to overestimation and an error variance that may well exceed industry perception.

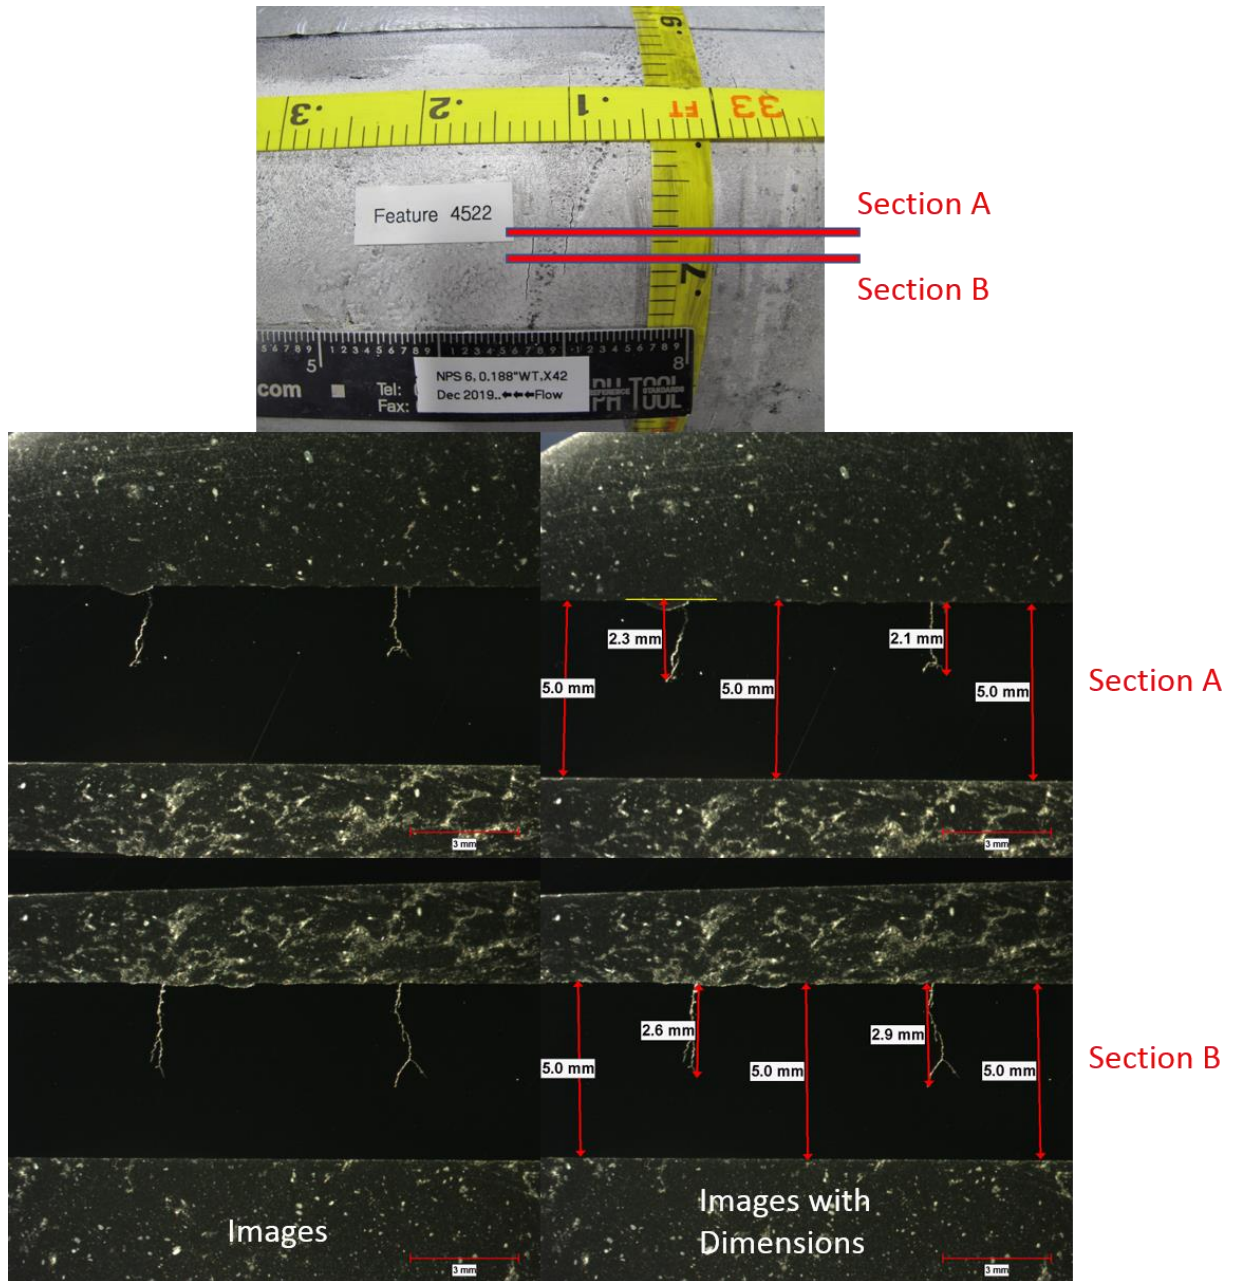
Figure 12: Macrographs Displaying Cross Sections from Feature 4522

Note that the circumferential dimension of Id 4522 reported by NDE is a composite of both cracks in the colony. Due to the merging of ILI indications caused by signal spread (see Figure 14), an ILI characterization would do the same.

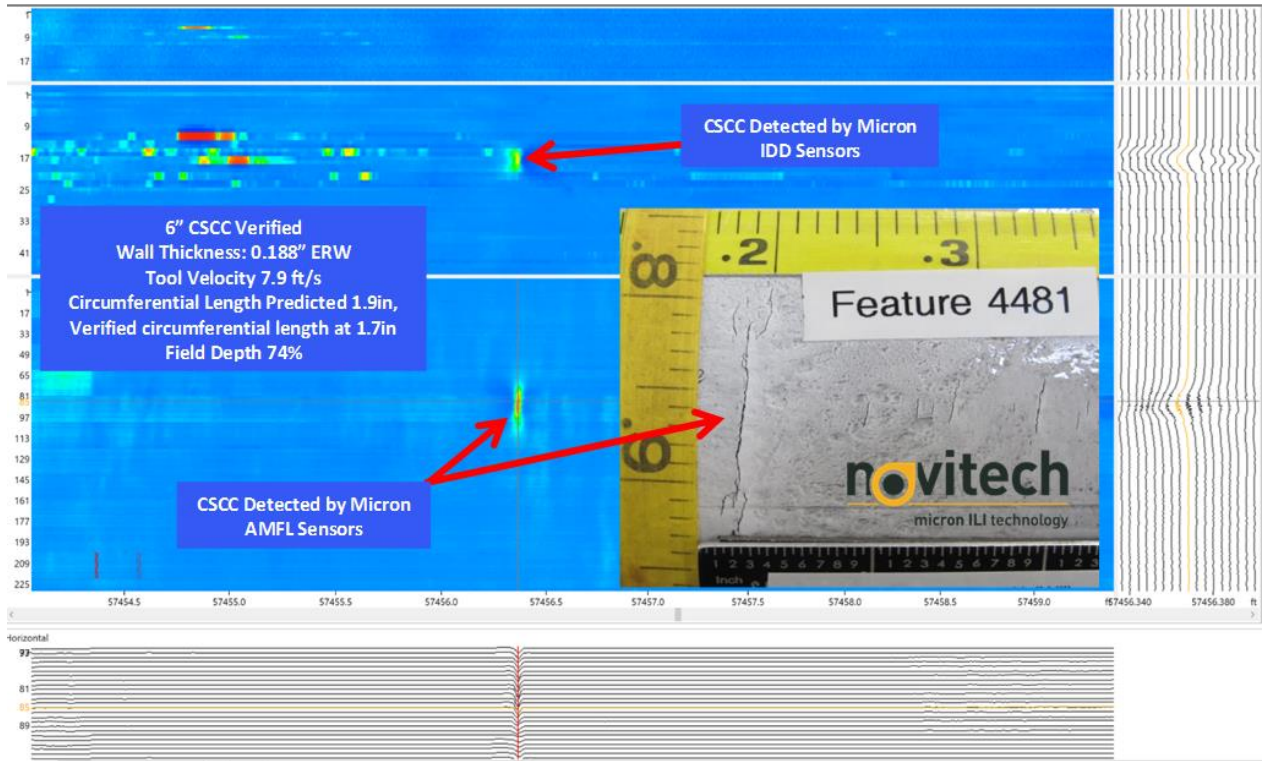
Figure 15: Feature 4481

Reviewing the NDT results in Table 1, it is shown that features with a circumferential width greater than about 0.7 inches (18mm) are detectable in both AMFL and IDD data. Those less than this are not visible or measurable in one or both sensor types. Of this group, the shallowest indication is measured as 36% (ID 4485 at 0.9 inch (23 mm) circumferential width). This implies that these two thresholds must be surpassed before consistent detection can be achieved.

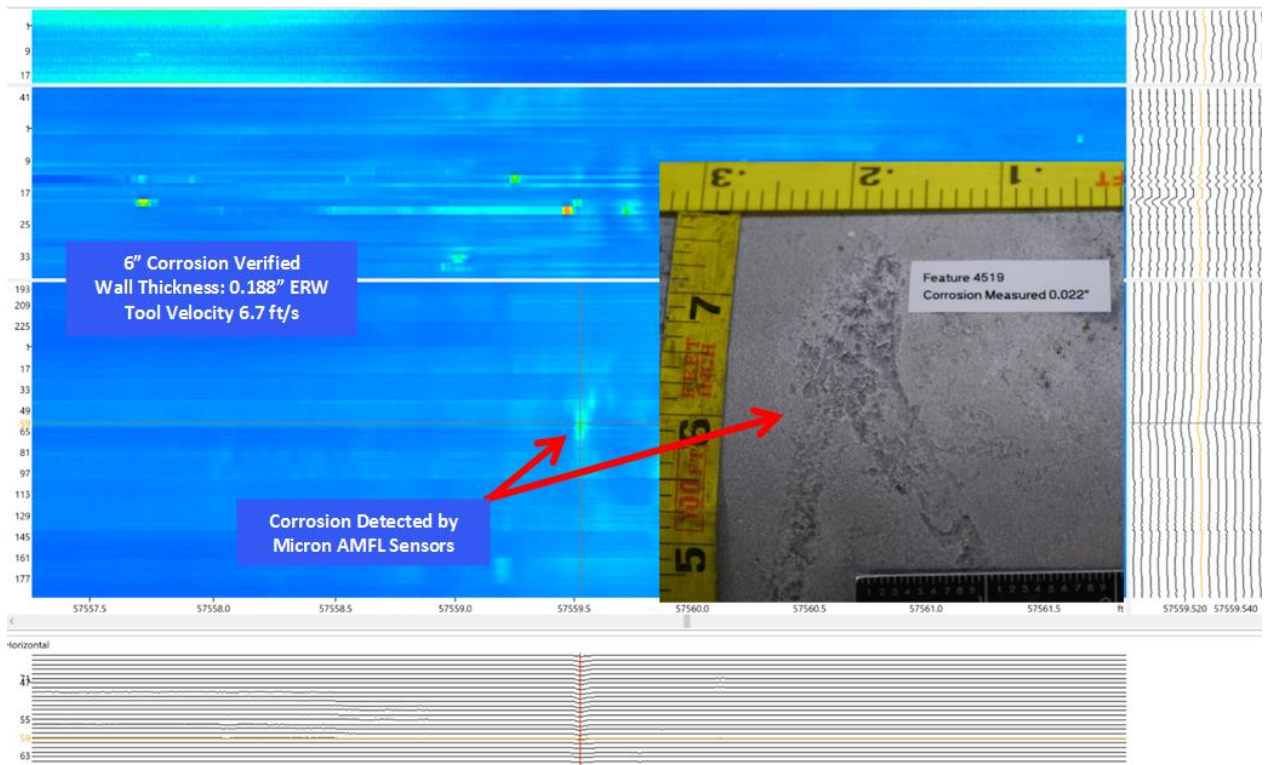
There was one false CSCC positive in the excavation, Feature Id 4519 which was reported as a Narrow Circumferential Anomaly (NCA or low probability CSCC) 0.9in long by 2.3in wide by 16% deep. The median sample spacing at this item is 1.1mm (0.042in), with a tool velocity of 2.0 m/sec (6.6 ft/sec). This anomaly is at a field bend, satisfying one of the ranked susceptibility factors. Figure 16 shows that there is no indication showing in the IDD data for this item, lowering the probability that this is CSCC. An image of the excavated pipe and ILI data is shown in Figure 16.

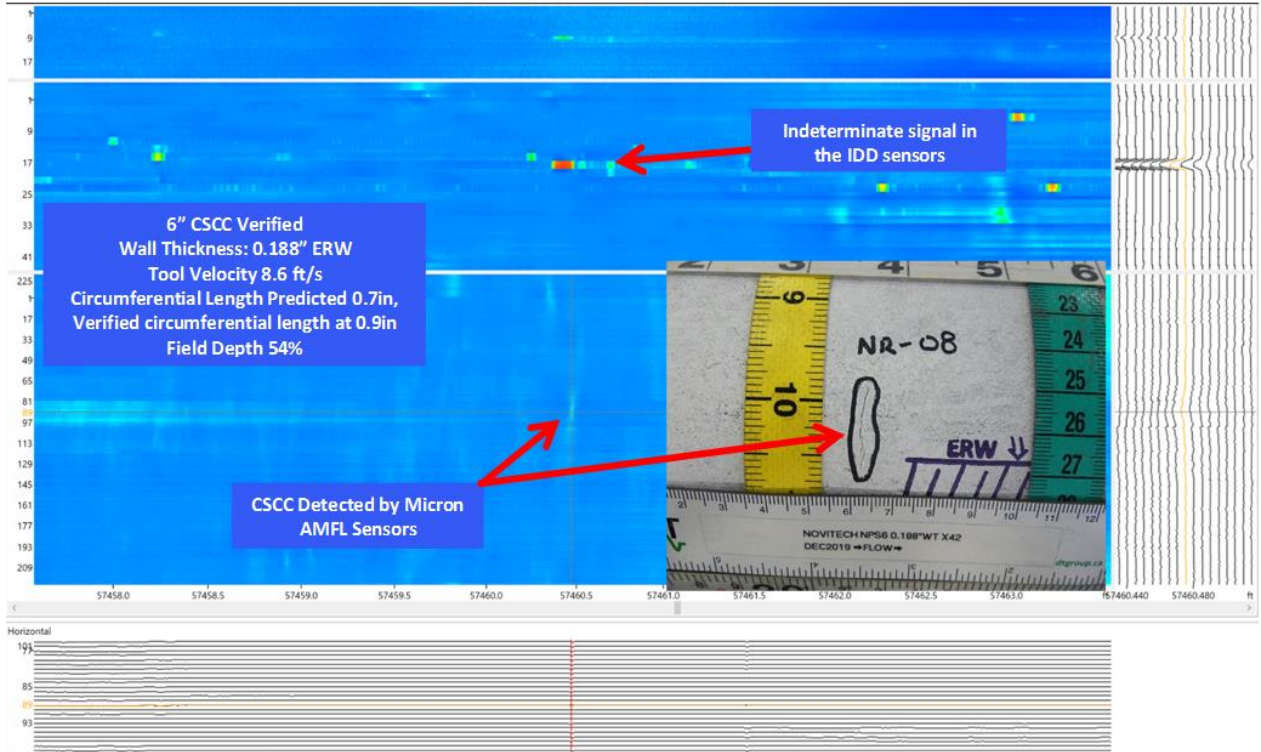
Figure 17: Mis-classified Feature NR8/4484.

There were 12 CSCC features that were reported as corrosion. Two examples of this are NR8/ID 4484 and NR14/ID 4516⁶. Data for NR8 shows an indeterminate signal in the IDD sensors; noise due to possible debris. Data for NR14 shows a faint but clear signal in the IDD sensors. Both features were measured at 54% deep, supporting that a meaningful IDD detection threshold is possible. If future developments support a depth threshold for visibility in the IDD array, at the very least a severity indicator can be implemented to guide integrity excavation priority. As previously noted, the shallowest confirmed CSCC was Feature ID 4485 at 0.9 inch (23 mm) circumferential width and 36% of wall thickness depth (Figure 6). The development of characterization algorithms would further enhance ILI effectiveness by the introduction of depth monitoring over a series of ILI inspections.

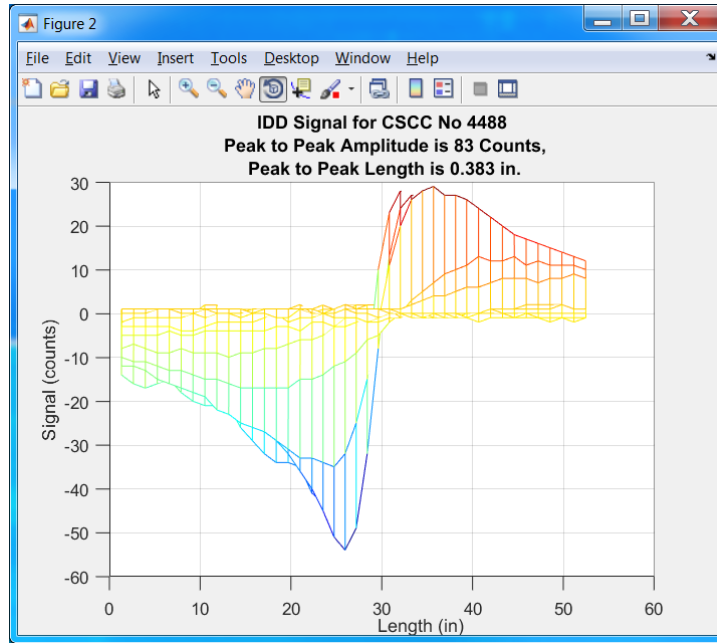
Figure 19: Typical IDD Signal for CSCC (Feature 4488)

This next example shown in Figure 19 (Feature 4488) shows a peak-to-peak amplitude that is more than the amplitude of that in the AMFL data. As the Hall effect sensors are oriented to measure the radial component of the flux leakage field, the bipolar nature of the signal is evident.

In the short-term the existence of this signal will serve as an indication of CSCC severity. Future research will focus on if this will help refine depth and length characterization. Feature 4488 was measured for depth using phased array ultrasound at 100% of wall thickness.
