Pipeline Integrity Management of CSCC using multiple ILI technologies

by Ron Thompson¹, Ray Gardner², Katrina Dwyer², Richard Gonzales²,
Andrew Corbett¹, Guillermo Solano¹

Pipeline Pigging and Integrity Management Conference

February 22-26, 2021

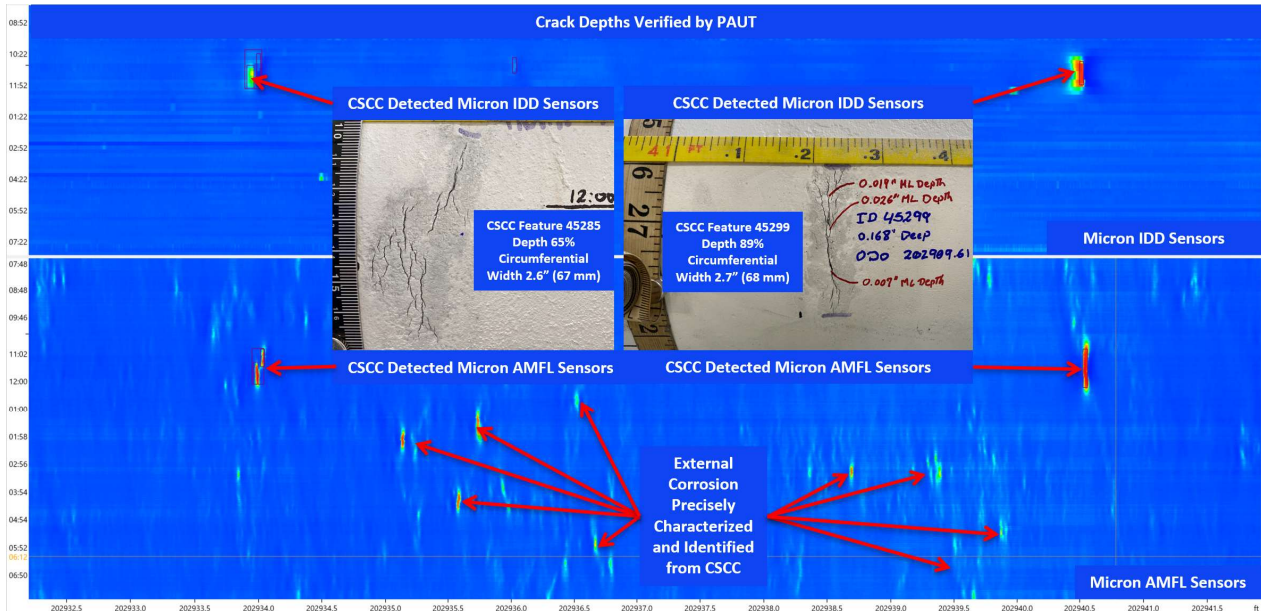
Figure One below provides an example of the graphical representation for the AMFL and IDD signal responses as detected by the tool (amplitude based). The overall system provides a distinct response to an anomaly vs. the background level allowing for clear identification and discrimination of CSCC colonies, even when surrounded by hundreds of metal loss anomalies.

Figure One: Discriminating CSCC Amongst Hundreds of Metal Loss Anomalies

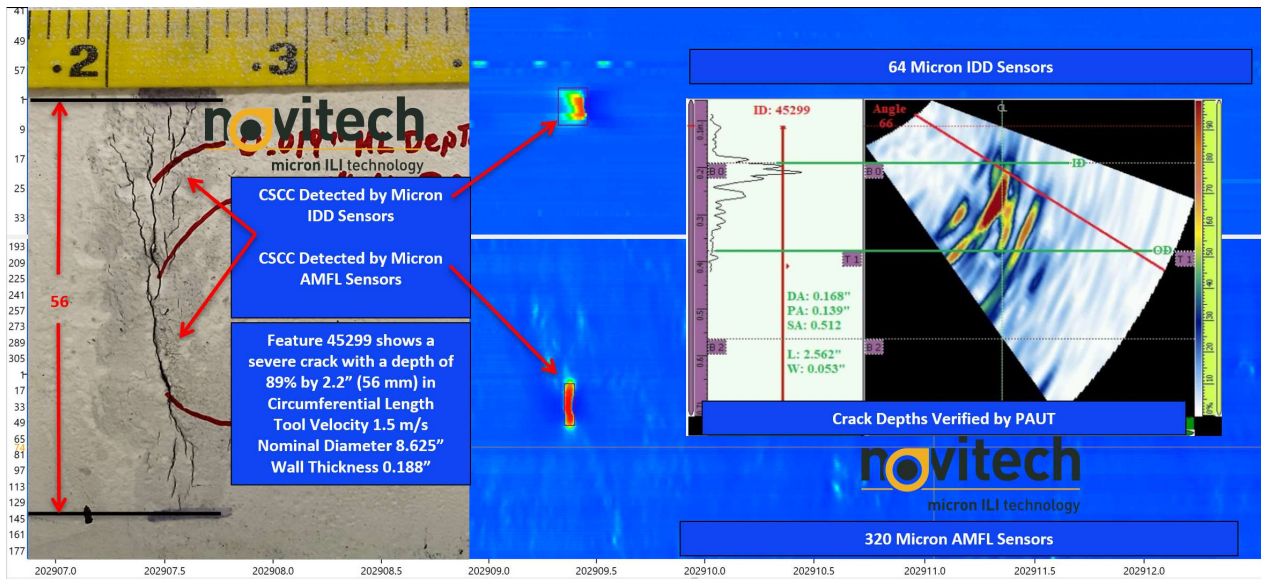
Figure Two below illustrates how the integrated multi-modular approach confirms the presence of CSCC while ruling out false positives such as sensor lift off and surface roughness. Specifically, the combined AMFL and IDD sensor modules are also being used to help rank the severity of CSCC from detectable, severe, to very severe.

Figure Two: Severity Ranking Using both AMFL and IDD Sensor Systems

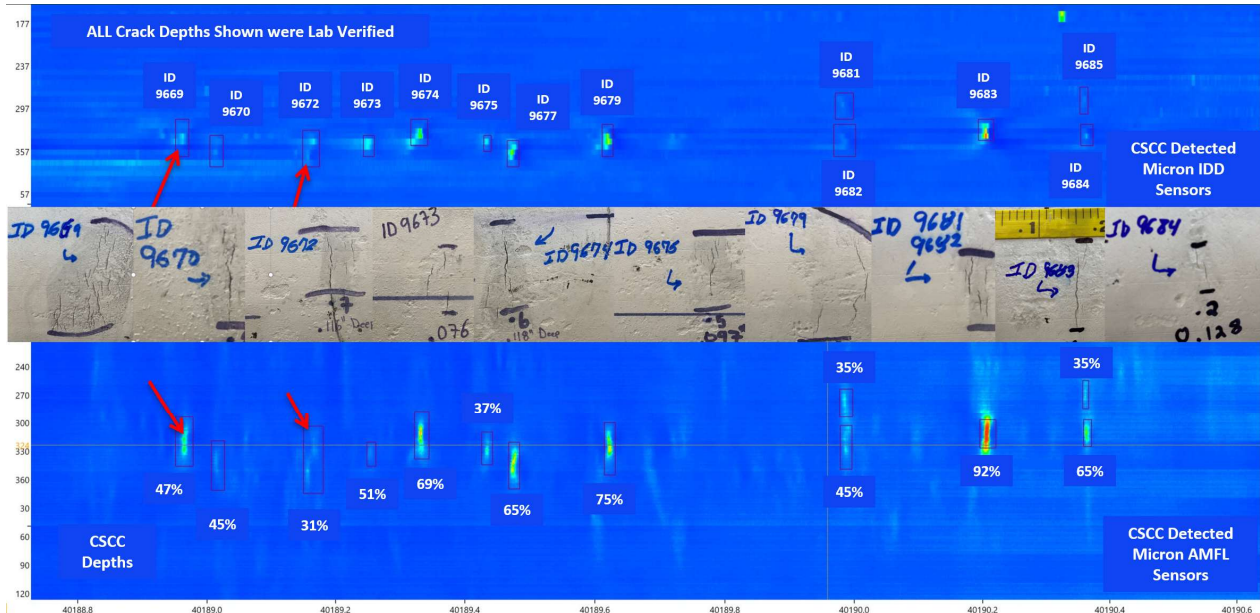
Figure Three further illustrates CSCC detectability, with a high POD and POI. At this location, the ILI system successfully identified the occurrence of 12 CSCC locations in a row that were axially aligned and in close proximity to each other.

Figure Three: Conformation of High POD and POI Showing 12 Consecutive CSCC Locations

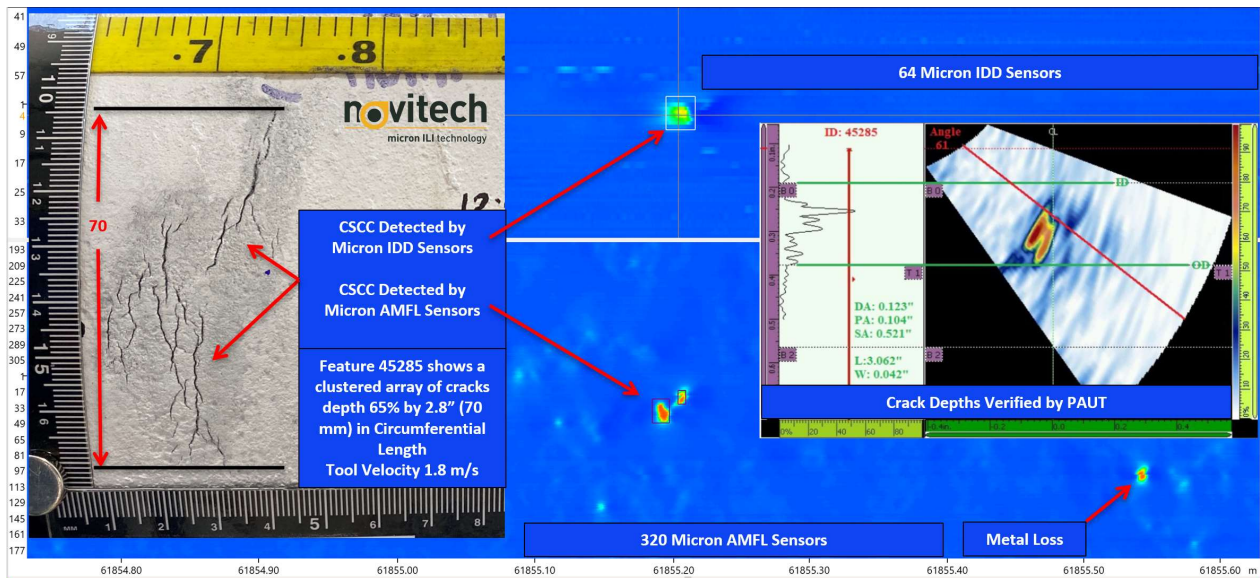
Figure Four illustrates the ILI system’s resolution, as individual crack colonies that are separated by approximately 0.5” (12.7 mm) or more can be differentiated from each other and identified as individual crack anomalies. AMFL signals from tighter crack clusters blend into a single reportable anomaly.

Figure Four: Detectable Resolution Between Cracks

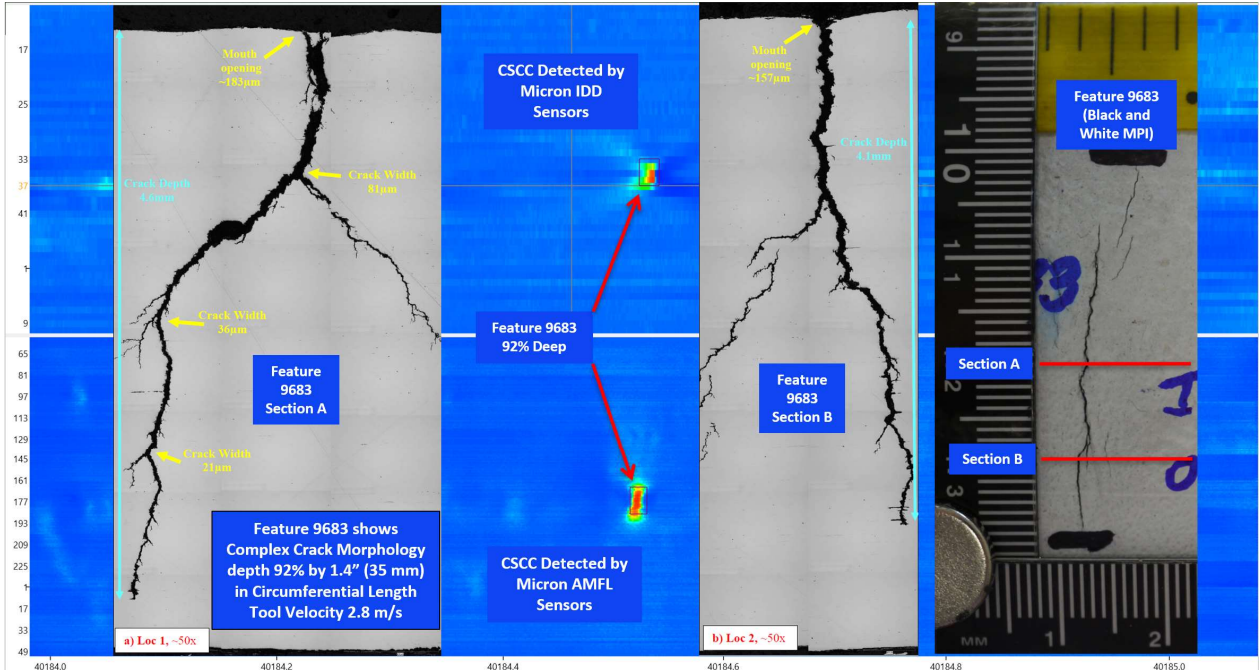
The transgranular crack morphologies and minor branching for all the samples matched well with stress-corrosion cracking (SCC) [4]. Crack openings were found to be ranging from 11 to 183 microns as shown below in **Figures Five** and **Six** below.

Figure Five: Crack openings were found to be ranging from 11 to 183 microns

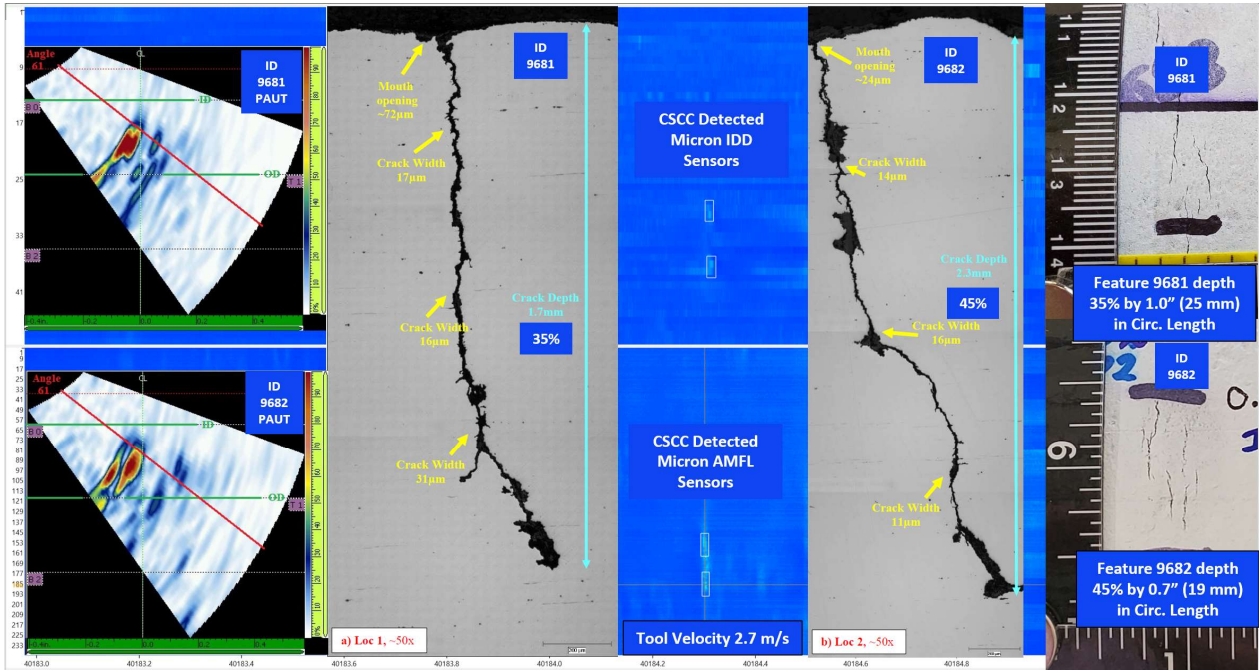
Figure Six: Crack openings were found to be ranging from 11 to 183 microns

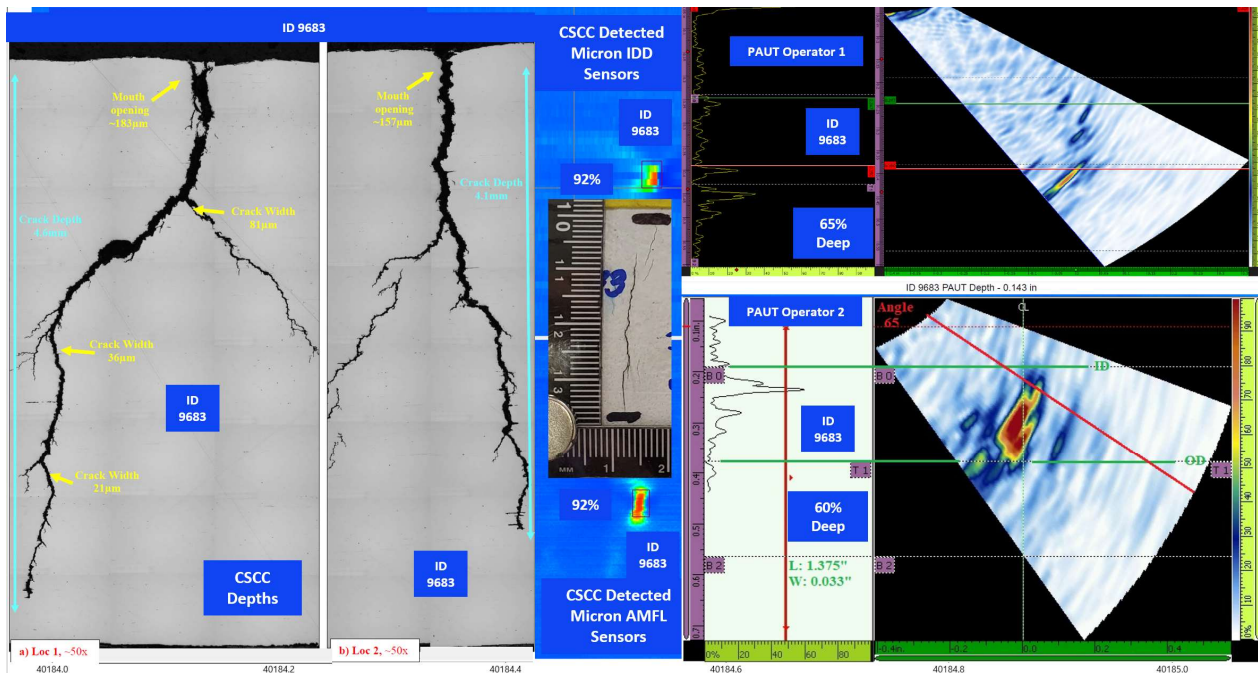
Figure Seven shows two separate PAUT scans that consistently undersized a CSCC indication at 60-65%, while laboratory results proved it to be 92% in depth.

Figure Seven: PAUT Compared to Laboratory Results

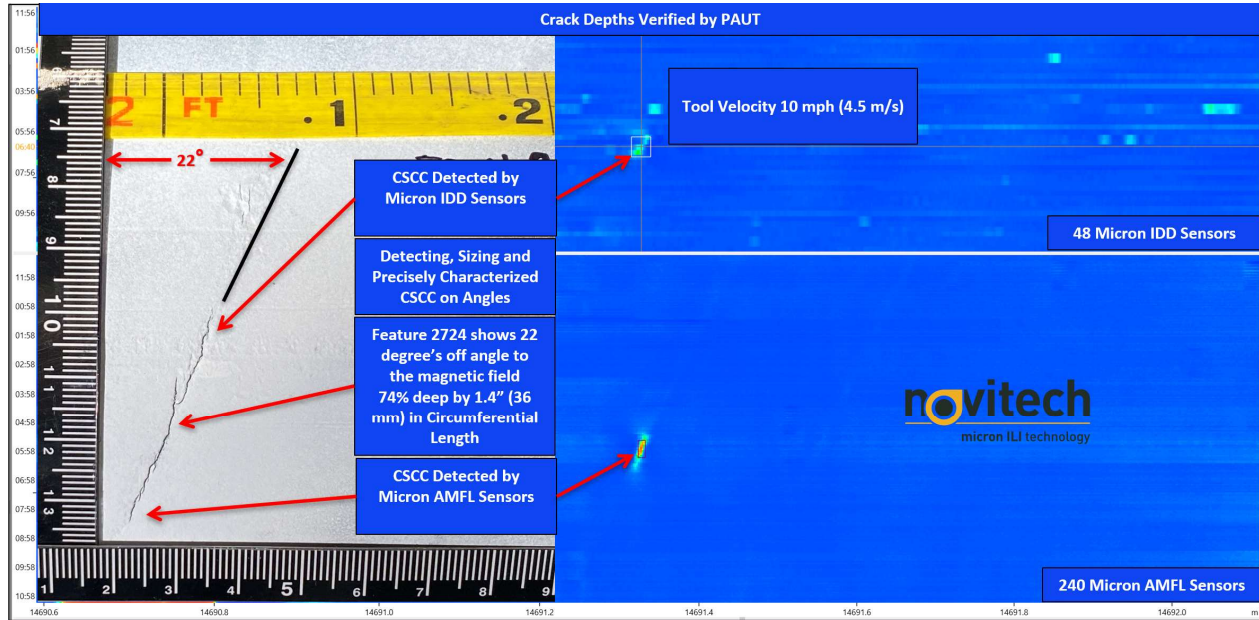
Figure Eight demonstrates the detection of a crack that is at 22 degree’s off angle to the circumferential axis of the pipe. The AMFL and IDD magnetic field and signal response vs. background level is clearly visible and was precisely quantified.

As an example, the indication shown in **Figure Eight** was detected with the tool traveling at 10 mph (4.5 m/s). Given that this study was conducted in natural gas transmission and distribution lines this was particularly valuable as the tool velocity can often exceed 9 mph (4 m/s).

Figure Eight: Detection and Sizing of Off Angle CSCC at 10 mph (4.5 m/s)

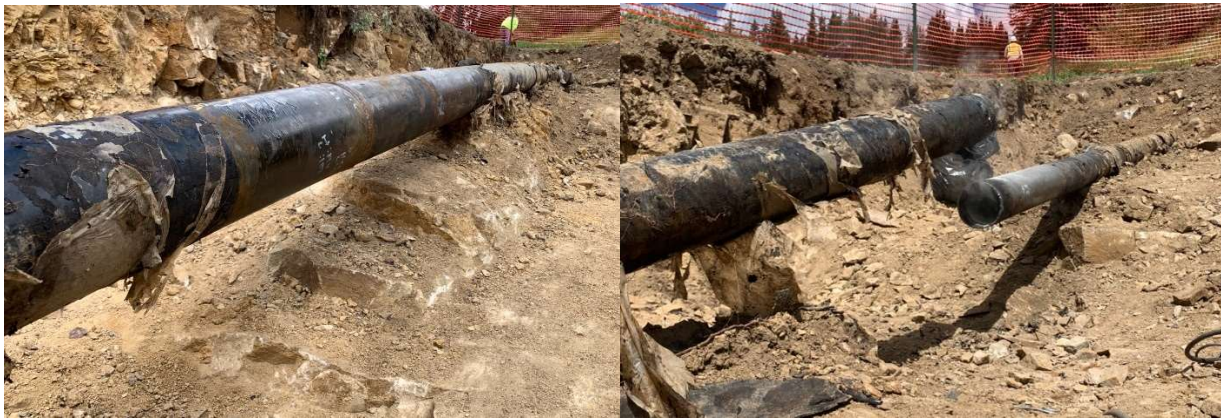
In many cases, residual bending stress in the pipeline resulted in the pipeline shifting up to 14 inches as overburden was removed. Additional temporary pipe support material was retained onsite during excavation to ensure the pipe could be adequately supported for in-situ examination. Further, when pipeline cut-outs were performed, attention was given to stabilize the pipe to manage additional shifting. **Figure Nine** shows pipeline shifting following an initial pipeline cut.

Figure Nine: CSCC Indication Excavation Before and After Initial Pipe Cut
