DETECTING ACTIVE EXTERNAL CORROSION FOR HARZWASSERWERKE GMBH

INSPECTION OF A WATER TRANSMISSION PIPELINE DN 600 USING CURRENT MAGNETOMETRY INSPECTION (CMI)

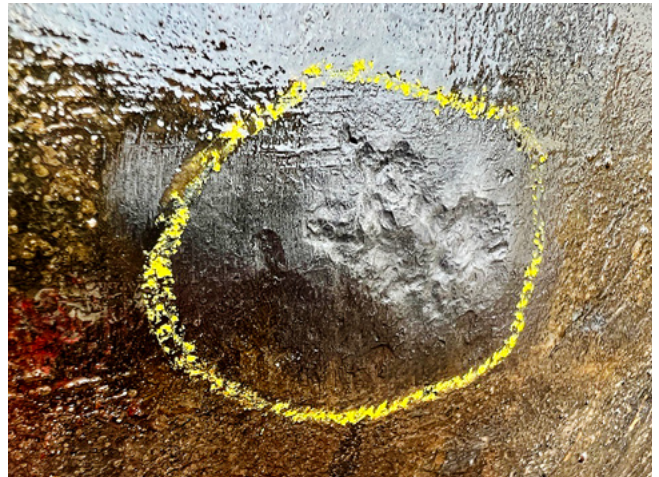
In general, it was determined that the specifications of CMI could be met at every validated point. Thus, during the three reference excavations, in addition to coating defects, two external pipe wall anomalies and one deformation were identified (see Figure 2 and 3). The same applies to the comparison with already known pipe wall defects. These could be reliably detected by CMI.

Figure 2: Verified anomaly, ext. corrosion at 3 o'clock, at a coating defect

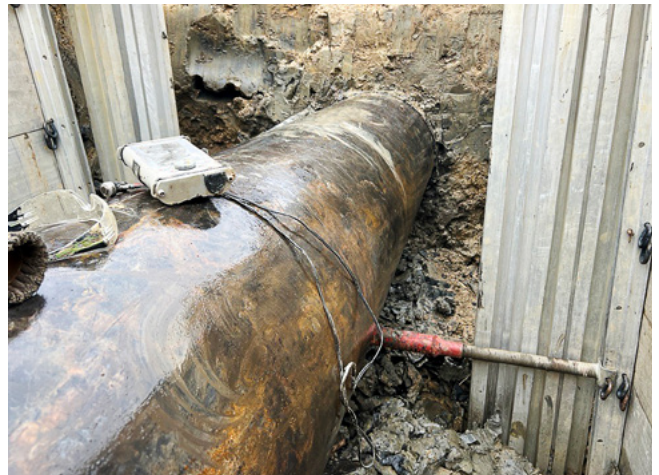
Figure 3: Exposure of internal anomaly, int. corrosion at 5 o'clock
