COMMENTARY ON TECHNICAL PROGRESS REPORT v 1.2

The aim of the requested tests is to get an impression on the performance of a HDPE crack suppression coating product that is planned to be used in Borouge Ruwais plant cracked stub-ends. The notched pipes that were coated in Tech-Bond (USA) were performed for Hydrostatic Pressure Testing (HPT)

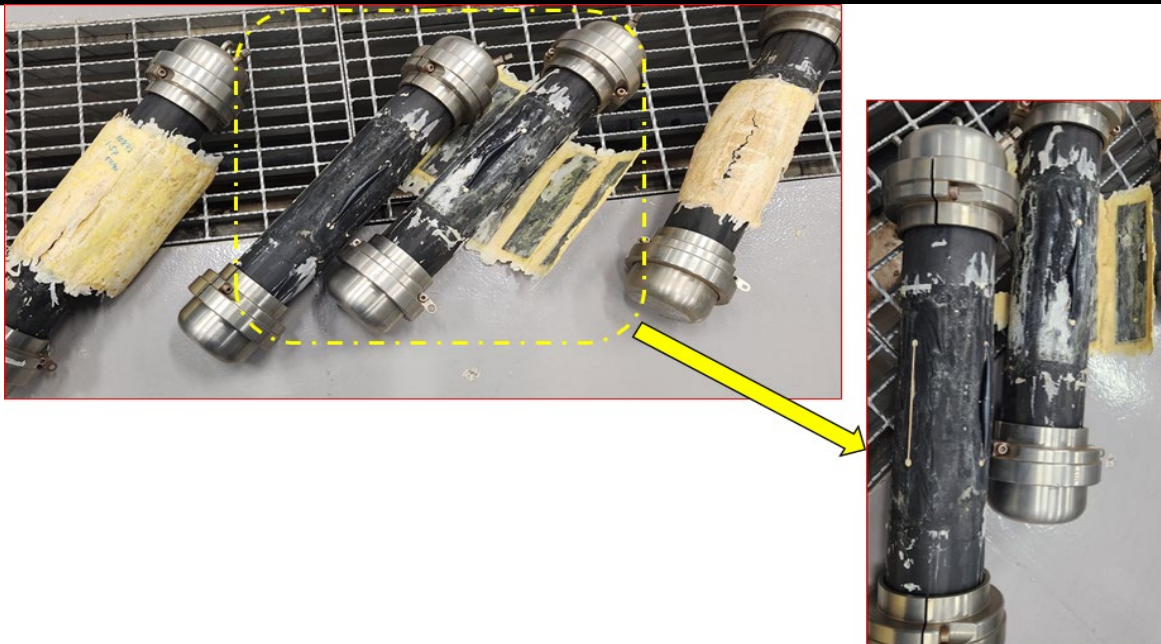
Figure 3. Primary Test – Failure Pipes for HPT test at 180 °C

Figure 3 on the Primary Test has two pictures. The picture on the left side of the page shows:

1. A blown out crack.
2. A crack where our Poly Fill is still maintaining the structural integrity of the pipe.

It is important to note that, even with the blowout, the crack did not propagate. Our circles of Poly Fill are still at each end of the crack. Blow outs can be prevented by wrapping the cracked pipe.

Outside of certain solvents, the only things that breaks bonds is energy. One form of energy is vibration. It has been documented high levels of sustained vibration can break the bonds of cyanoacrylates. At 1800 psi, it is our belief that the vibration, in combination with what the affect that the heat had on the pipe and the adhesive, caused the “peel” to occur.

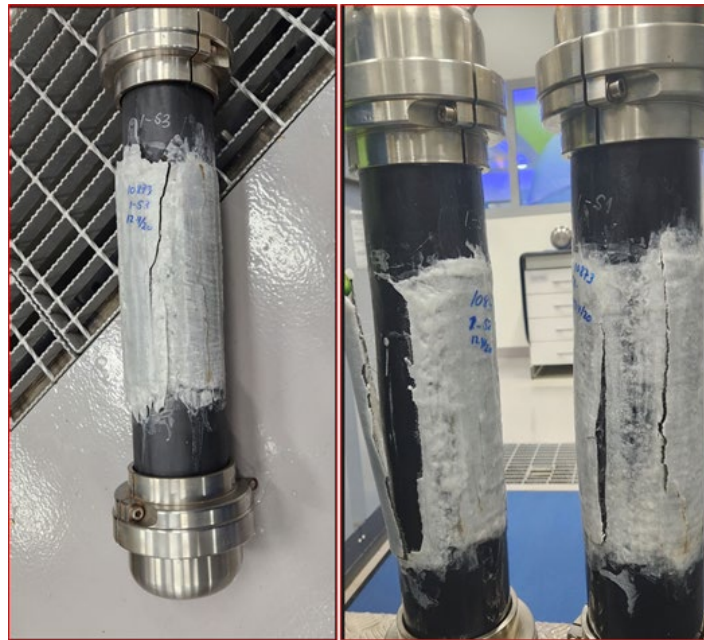
Figure 4. Primary Test – Failure Pipes for HPT test at 20 °C

On these pipes, we want to wait for the failed samples to be returned to examine the samples before we comment.
