Challenging ILI for a Sour Gas Service Pipeline

Mussab A. Al-Nammi, Khalaf M. Al-Anazi, Mohammed A. Rabeeah
Saudi Aramco

Proceedings of the 2025 Pipeline Pigging and Integrity Management Conference.

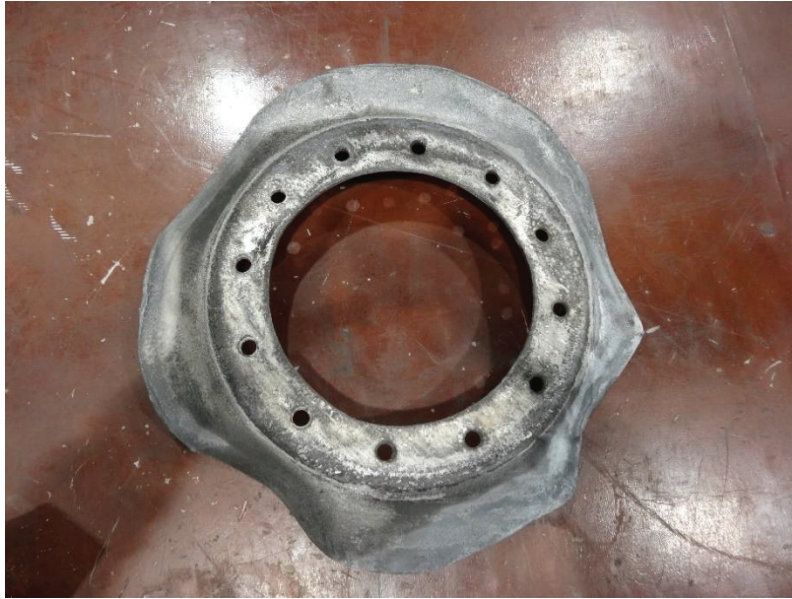
Figure 1. 1st Gauging Run Gauge Plate

Gauging Run Results
Gauge Plate before the Run:	471 mm
Gauge Plate After Run:	426 mm
Debris Found:	1000 kg
Tool’s Minimum Internal Diameter:	431 mm
Minimum Pipeline Internal Diameter During Run:	468 mm
Tool Length:	0.94 m

The minimum gauge plate diameter found after the run and the excessive sludge debris retrieved was not acceptable to proceed with the MFL run. Additionally, the guide and sealing discs were damaged. The below *Figure 1* and *Figure 2* illustrate the damages.

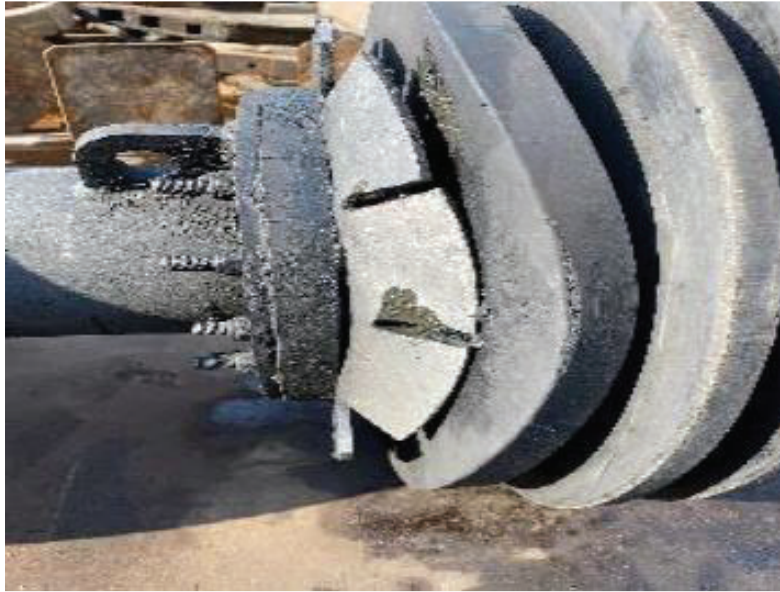
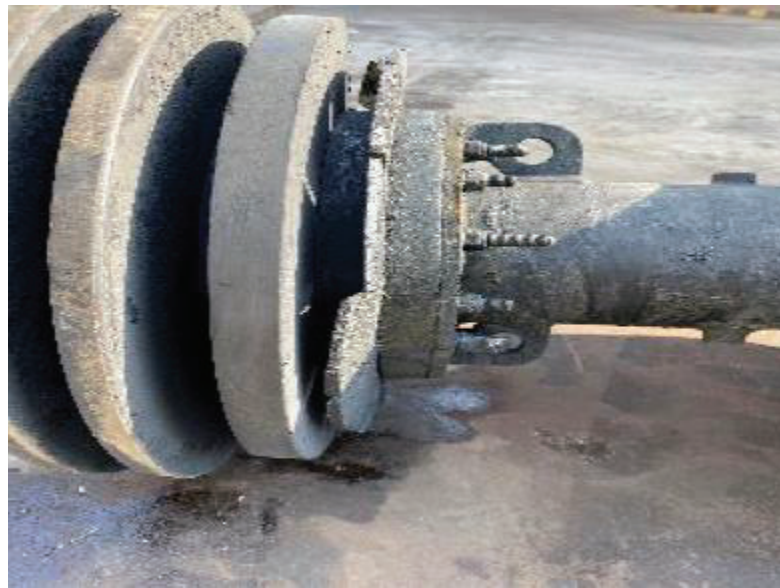
Following the last gauging run, it was assumed that the hit indication was due to valve misalignment. A second gauging run was conducted after ensuring proper alignment for the valves. The below *Figure 3* and *Figure 4* show the gauge plate condition after the run. The gauge plate experienced hits and the minimum bore identified was 397 mm along with 20 KG of debris.

Figure 3. 2nd Gauging run – Gauge plate after run

Figure 4. 2nd Gauging run – Gauge plate after run (Other Side View)

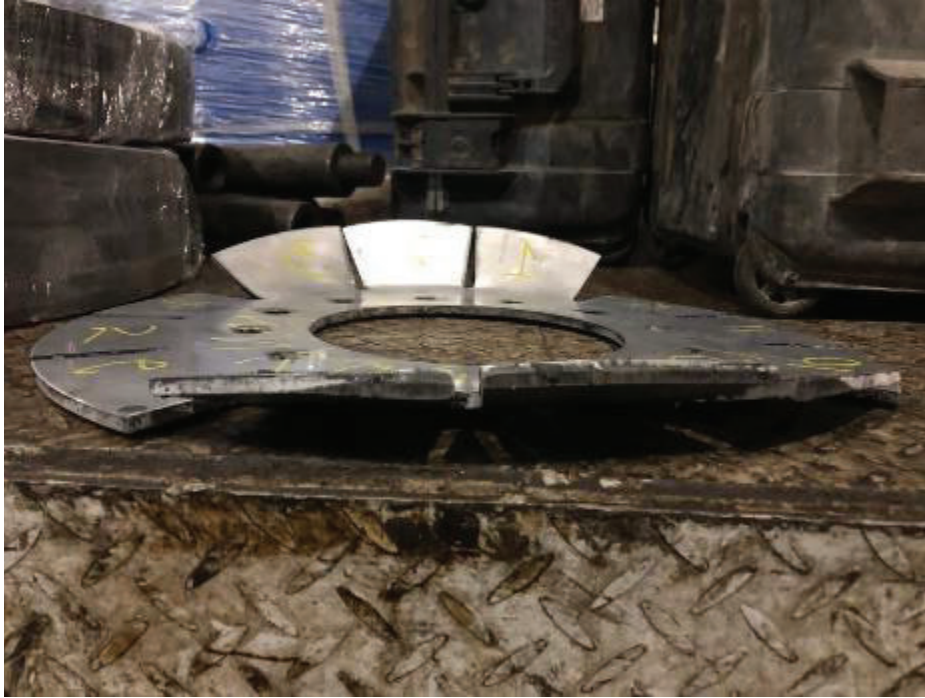
A few Bi-Di runs were conducted by the operational proponent as part of their regular pigging program, and capitalizing on this, a third gauging run was conducted with a 1.5D bend plate fitted on the tool. The below *Figure 5* and *Figure 6* show that the gauge plate and the bend plate were retrieved from the pipeline with hits. The minimum bore was 394 mm and the debris amount were 150 KG.

Figure 5. 3rd Gauging run gauge plate

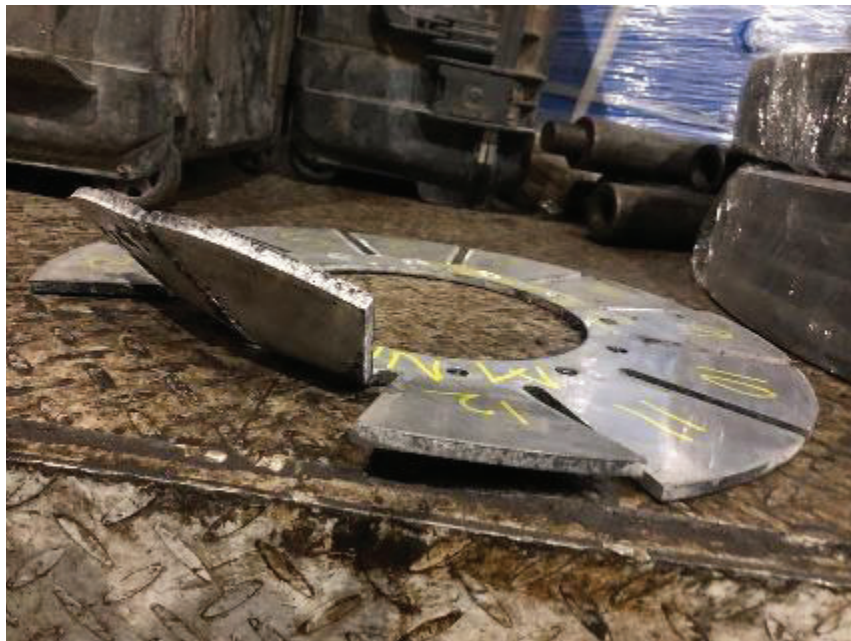
Figure 6. 3rd Gauging run bend plate

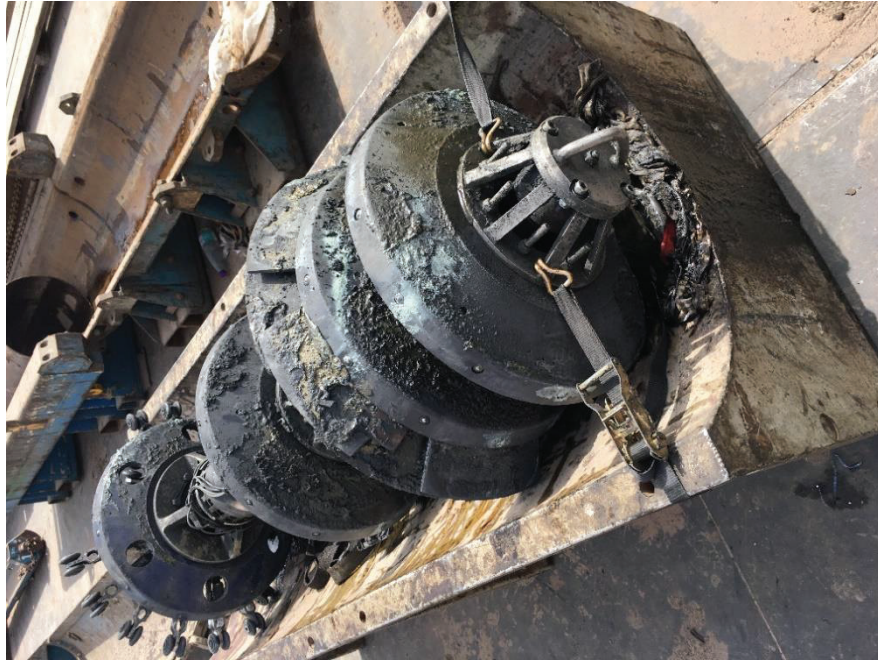
Figure 7. 2nd Caliper tool condition (Front)

As can be seen from the above tool images, the caliper experienced damages due to the high H₂S in the pipeline and due to the heavy debris. Moreover, the tool was retrieved large amounts of sludge debris. The three caliper arms in *Figure 8* were damaged as retrieved from the pipeline. The average velocity during this run was 2.5 m/s, and the tool stalled in the line multiple times during the run, which allowed more time for the H₂S to noticeably affect the tool. There were instances of significant sensor lift-off due to debris.

Nonetheless, the caliper tool measured the internal restrictions in the pipeline, and it was found that the minimum detected pipeline ID was 436.33 mm. It should be noted that the sizing of this internal diameter reduction could be exaggerated due to the debris present in the pipeline, but what can be concluded is that there is a major restriction in the pipeline from the heavy debris.

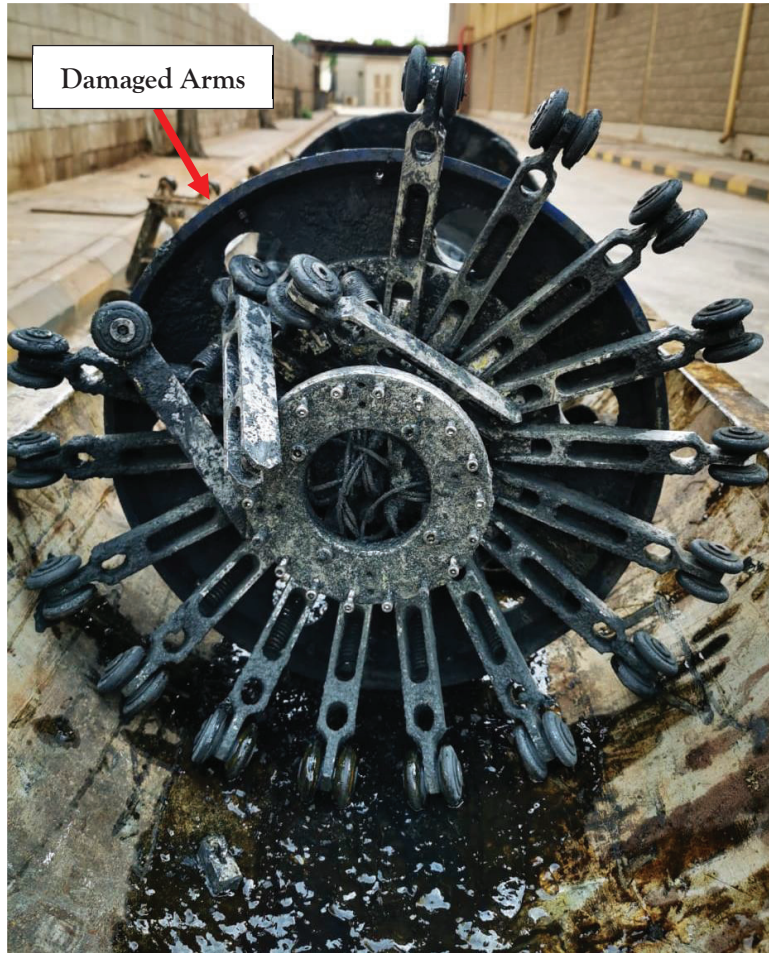
Figure 8. 2nd Caliper tool condition (Back)

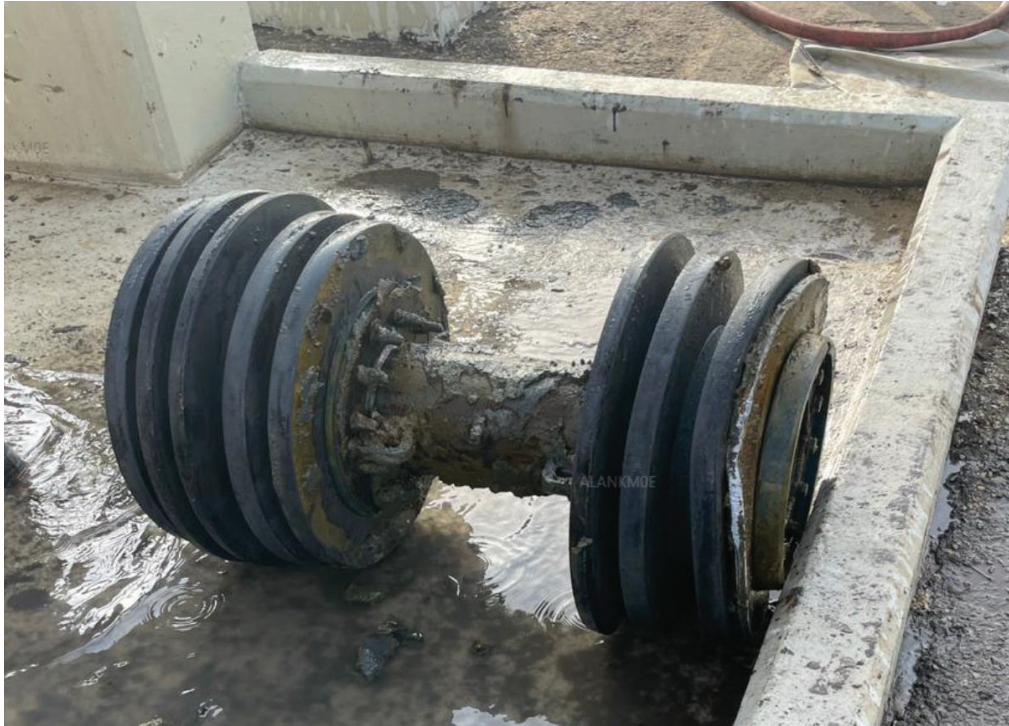
Figure 9. First cleaning tool (After run)

Figure 9 above shows the first tool design used as cleaning after the run, which has a standard Bi-Di design. The tool was received with mechanical hit indication showing that mechanical restriction still exists in the pipeline.

Three cleaning tools were prepared – two tools with similar design and the third tool was prepared to be the next more aggressive design to maintain daily cleaning campaign. The target was to receive consistent amount of debris for two consecutive runs before deciding to go for the MFL ILL.

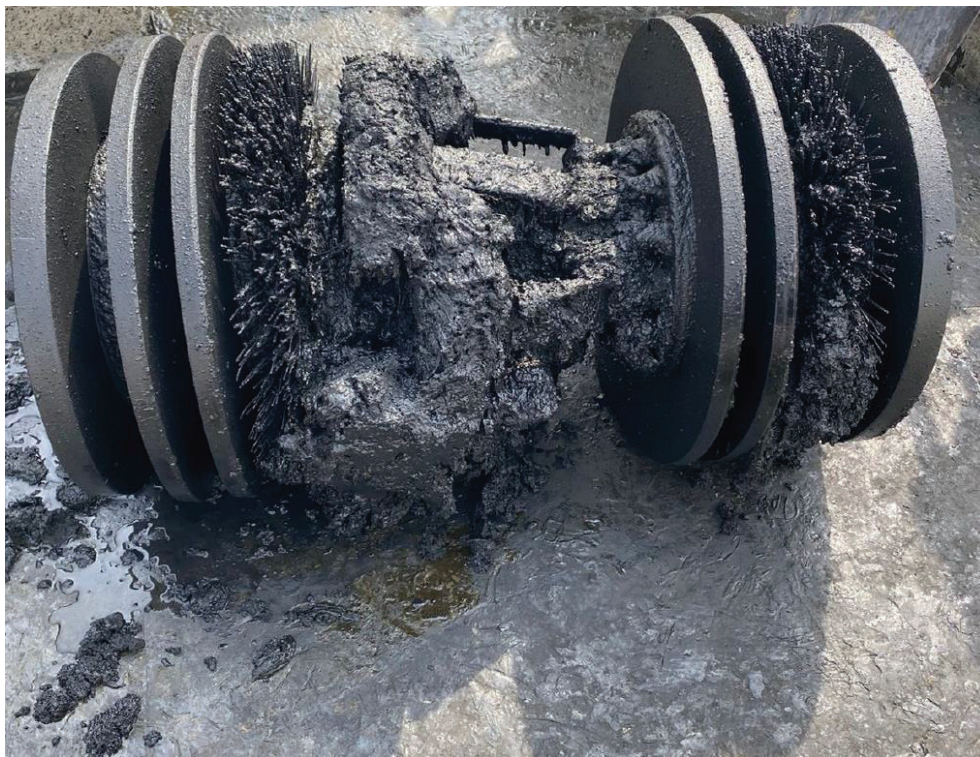
Figure 10. Last cleaning tool (After run)

Figure 10 above shows the last cleaning tool design after the run. As more cleaning runs were conducted, more aggressive cleaning elements were added (Stiffer disc material, ring brushes and spring-loaded arms).

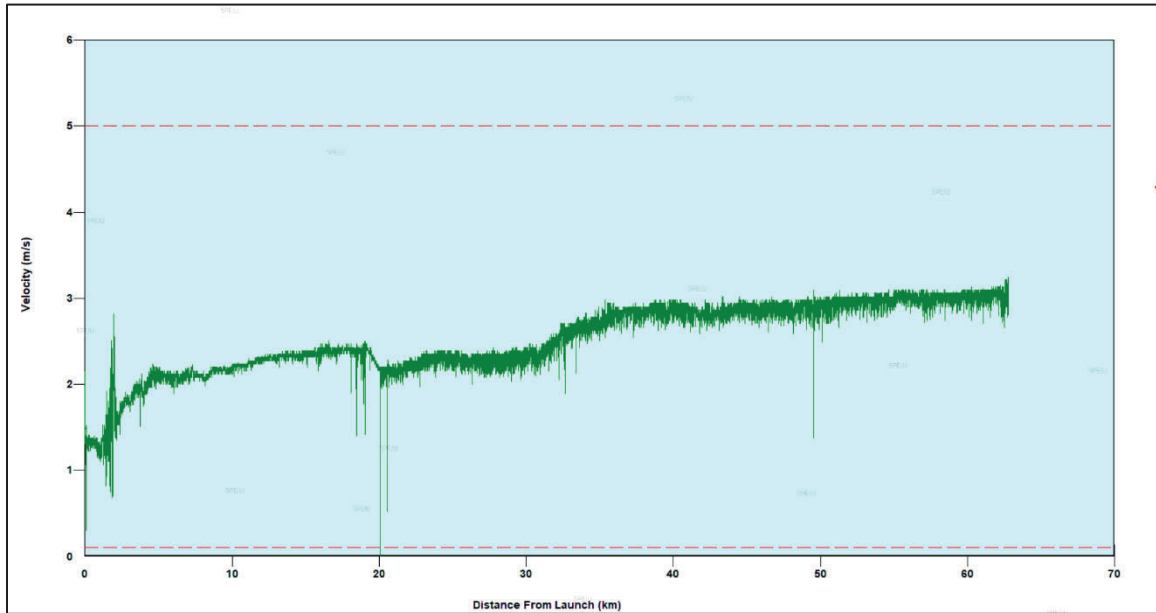
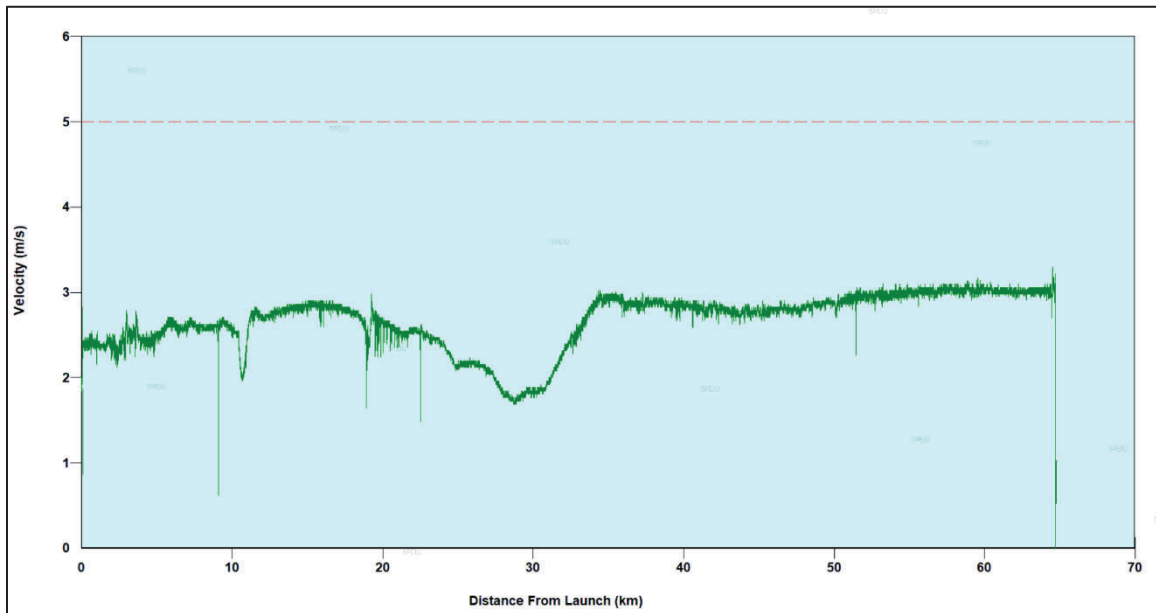
We can see from the below speed charts of Caliper# 2 and Caliper# 3 (*Figure 11* and *Figure 12* respectively) that the tool movement in Caliper Run# 3 has become more steady and has less excursion which indicates better cleanliness conditions. This proved the effectiveness of the cleaning campaign.

Figure 11. 2nd Caliper run speed chart

Figure 12. 3rd Caliper run speed chart

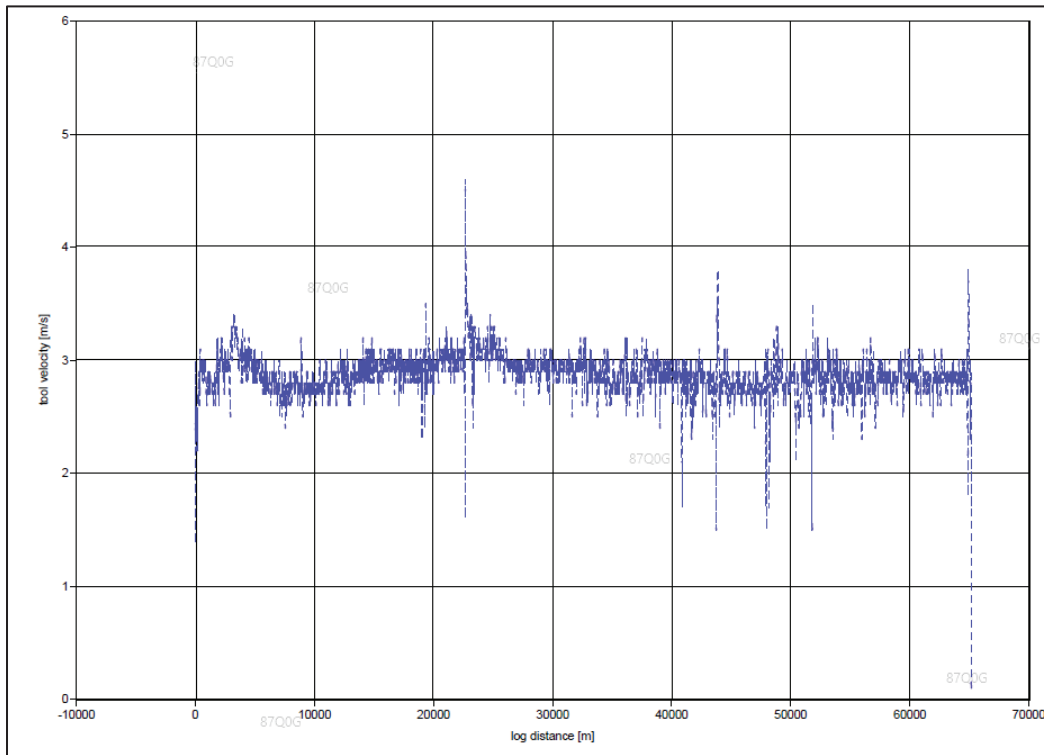
Figure 13. MFL ILI Speed Chart

Considering all abovementioned factors, it was decided to launch the MFL ILI tool after the flow reduction window was secured capitalizing on the effectiveness of the conducted aggressive cleaning campaign. In order to not affect the company's operation, hot-tap and stopple materials were prepared to be ready as a contingency plan in case if the tool got stuck and cut and replace if required. The MFL ILI run was conducted successfully with an average speed of 2.9 m/s for the MFL tool as per *Figure 13* below.

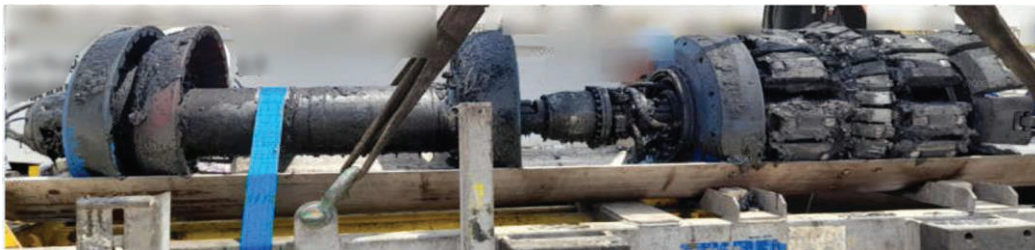
Figure 14. MFL Tool After Run

The MFL inspection was successful and achieved acceptable data quality standards. The data quality assessment shows that no significant data loss was observed and that the magnetization level was within an acceptable range. Despite the debris on the tool show in the above *Figure 14*, the debris did not affect the data quality, and thus, the cleaning campaign and the solution to the heavy debris present in the pipeline was successful and achieved a successful revalidation.
