When Third-Party Damage Strikes! An Investigative Approach Using Carbon Fiber Composite Wrap as an Acceptable Method of Repair

Travers Schwarz¹, Steven Kinikin¹, James Fetherolf¹, Davie Peguero²,
Jackson Herrod²

¹Sacramento Municipal Utility District

Proceedings of the 2025 Pipeline Pigging and Integrity Management Conference.

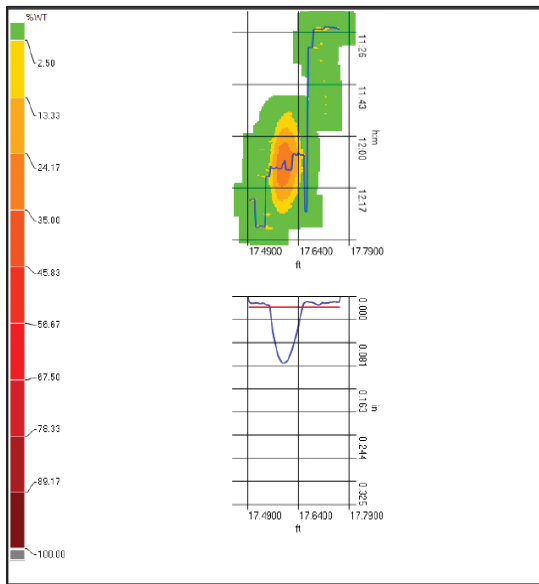
Non-destructive testing (NDT) was performed on the defect area. The defect area was 3D scanned for length, width and depth dimensions of the defect area (Figure 1) & (Figure 2).

Figure 1. 3D Scan of defect area.

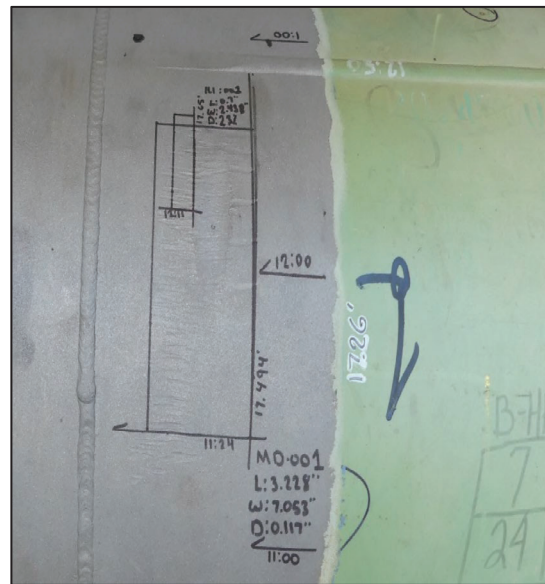
Figure 2. In situ measurement of defect area.

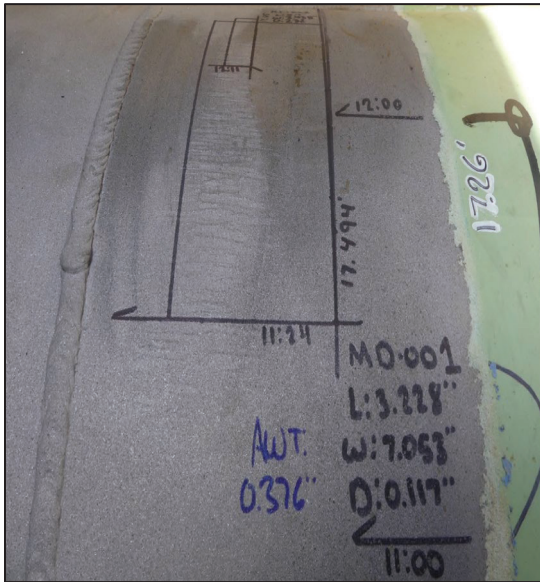
The stress risers within the defect area were removed with a hand file (Figure 3) & (Figure 4). No grinding was performed on the defect area.

Figure 3. Defect area with stress risers.

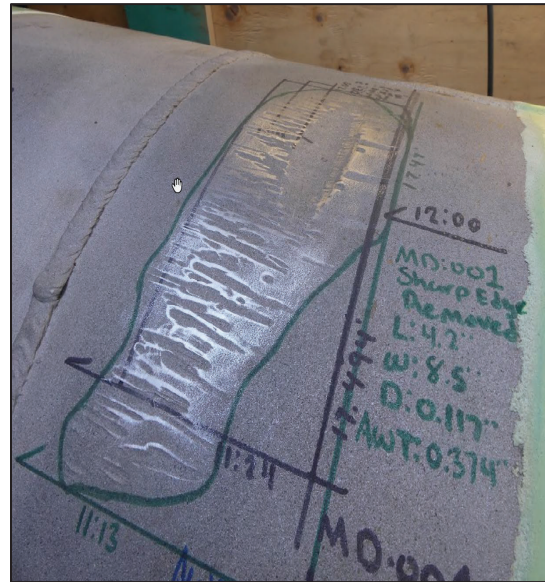
Figure 4. Defect area no stress risers.

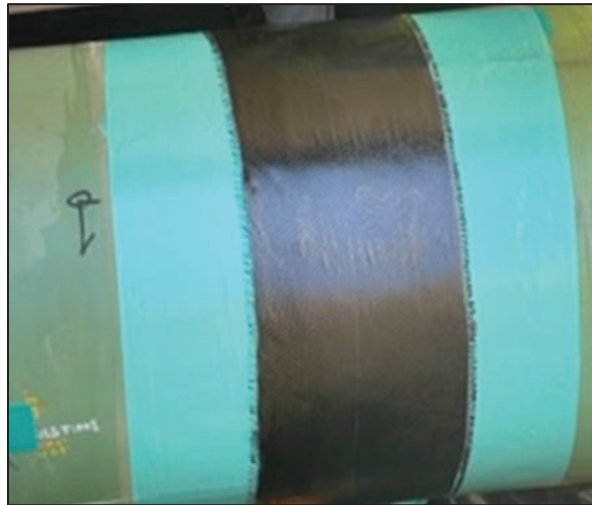
Figure 18. Nonmetallic composite repair in the field.

The axial length of the repair laminate is determined by [Equation 11] and [Equation 12] listed in ASME PCC-2-2022 [401-3.4.8]. [3] It is important that the repair laminate extends beyond the damaged region and adheres to good metal surface. The composite repair overlap was 6 inches, and the total axial length of the repair was 16 inches (Figure 17) and (Figure 18).

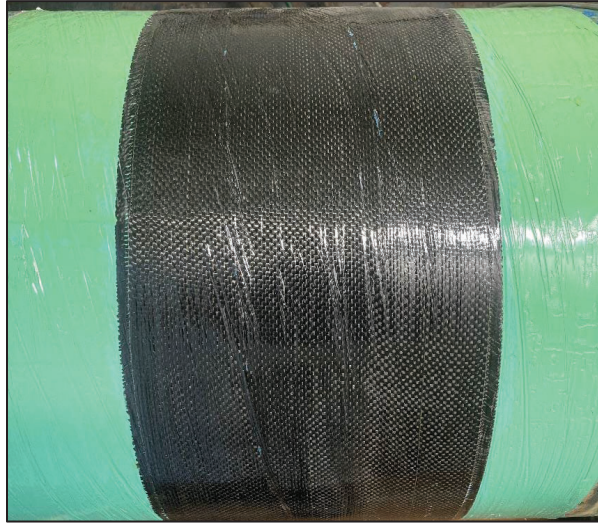
The target test parameters were set to cycle the pressure 40,000 times between 250 psi and 700 psi at a rate of 10 cycles per minute. (Figure 20) presents the data recorded from the pressure transducer attached to the pump, showing the pressure variation over the course of one minute. From this data, it is evident that the actual test parameters achieved were 40,000 cycles between 175 psi and 700 psi at a rate of 15 cycles per minute. (Figure 21) shows the condition of the composite wrap after completing the 40,000 cycles, with no visible signs of damage or fatigue.

Figure 21. Post Test Inspection

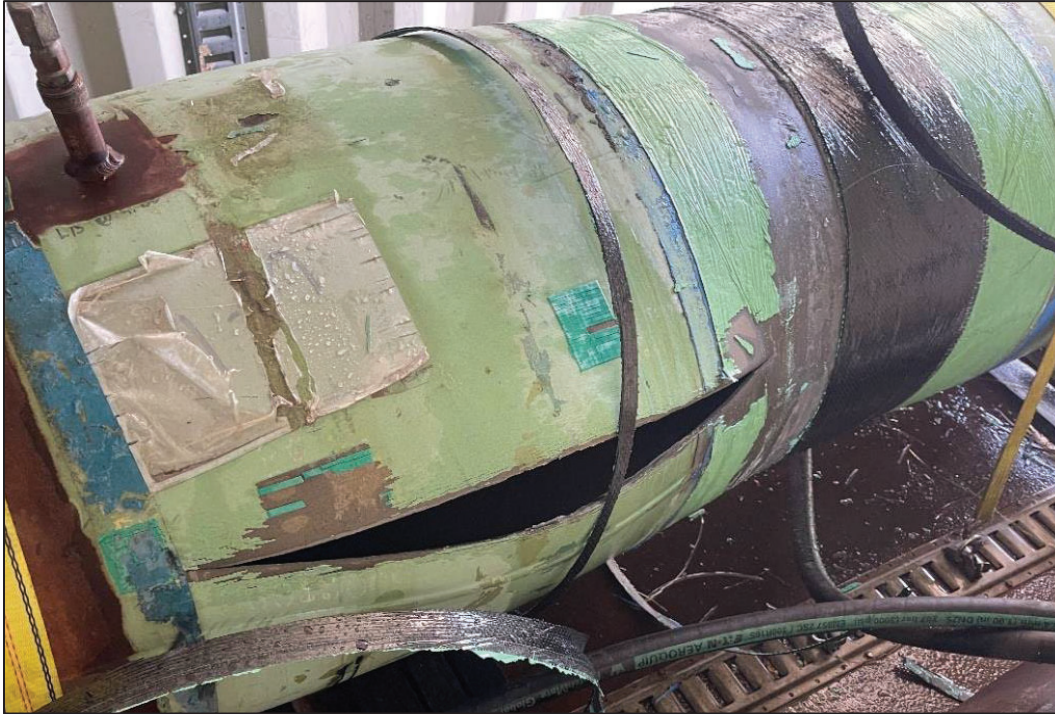
As the pressure increased, the pipe began to balloon, causing the carbon fiber repair to detach or "pop" off. This is reflected on the pressure-time graph as inverted spikes. These "pops" correlate with the visible damage to the carbon fiber repair seen in (Figure 23), where the thin rings of carbon fiber that broke off with each failure event can be observed.

Figure 23. Rupture Zone

- Due to the Poisson's effect, we see in (Figure 23) that the pipe diameter increased while the pipe section length decreased before bursting at the longitudinal midsection of the pipe.
- The failure pressure of the pipe correlated closely to the pipe MTR record. Table 3
- The higher yield pressure and rupture pressure of the pipe could be attributed to some strain hardening when the pipe was originally hydrotested during commissioning.
- The defect repair remained integral to the pipe after the pipe exceed its material limit.
