Cleaning and ILI of a Heavy Wall Subsea Pipeline with Improved Differentiation Between Debris and Corrosion

Pipeline Pigging and Integrity Management Conference

February 12-16, 2024

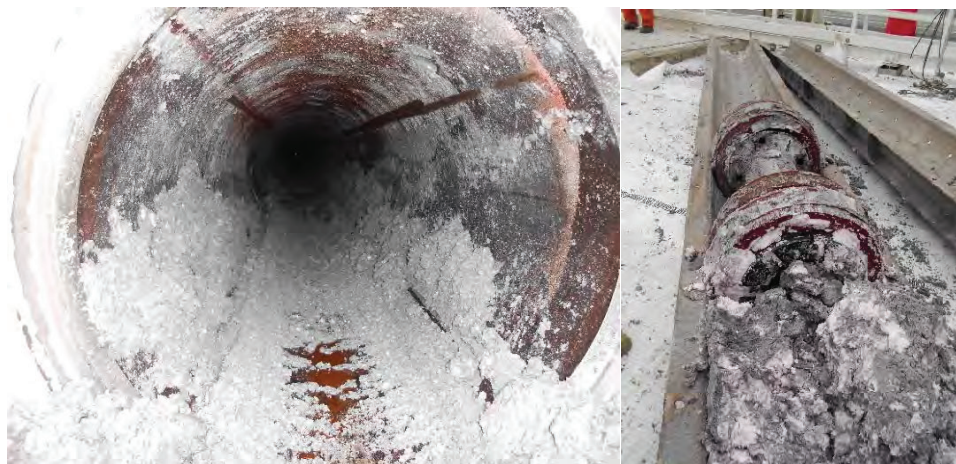
The pipelines had several cleanliness challenges. There have been several pigging operations between 2016 and 2020 in which dewatering pigs and debris mapping tools were used. However, the data from the debris mapping tool and debris observed after cleaning did not assist with the decision to run a 3rd party MFL inspection, nor help interpret the compromised data received. The probability of identification (POI) was limited and no clear differentiation between corrosion and debris was possible. Hence, the previous inspections were not fully successful, and the data couldn't be used for a full evaluation of the clients' problems.

Figure 1-2. Examples of previously removed debris.

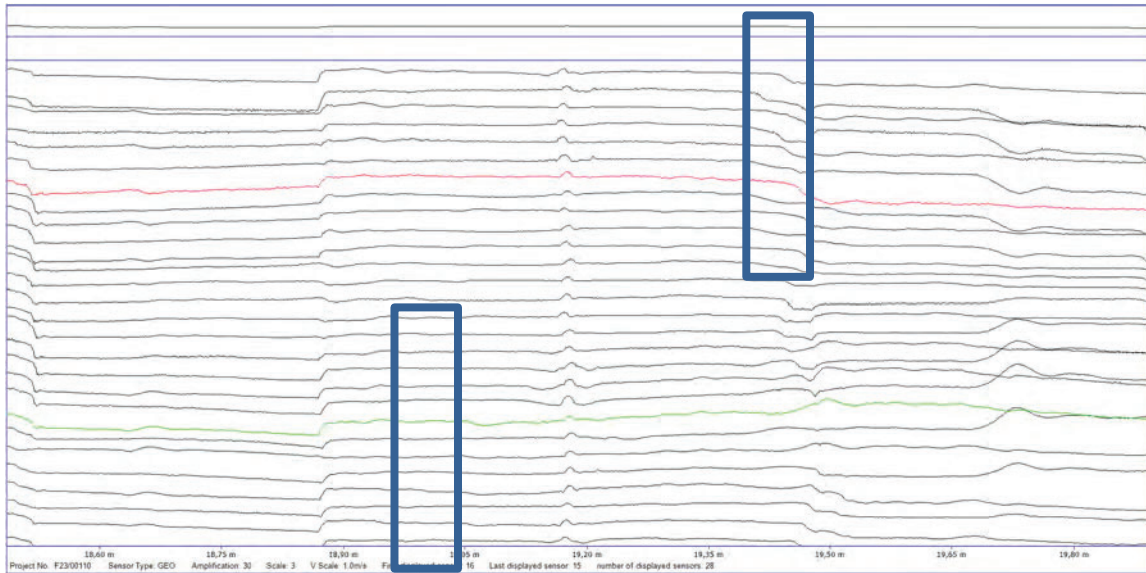
The characteristics of this spool piece were used to reflect situation “D” as part of the large-scale tool testing. The combined ILI tool was pulled several times through the pull test line and data sets of the introduced four (4) different measurement technologies were recorded. The first data screenshot below shows the geometric (GEO) data of the ILI tool. Each line represents a sensor. The debris within the internal metal loss didn’t exceed the inner pipe wall and didn’t cause any ID reduction. Accordingly, the GEO sensors don’t show any reaction and show no ID reduction. Instead, they show a constant ID. The location of the anomaly is marked with a blue rectangle.

Figure 8. GEO data – blue rectangle shows anomaly location (red/green sensors = 12h/6h).

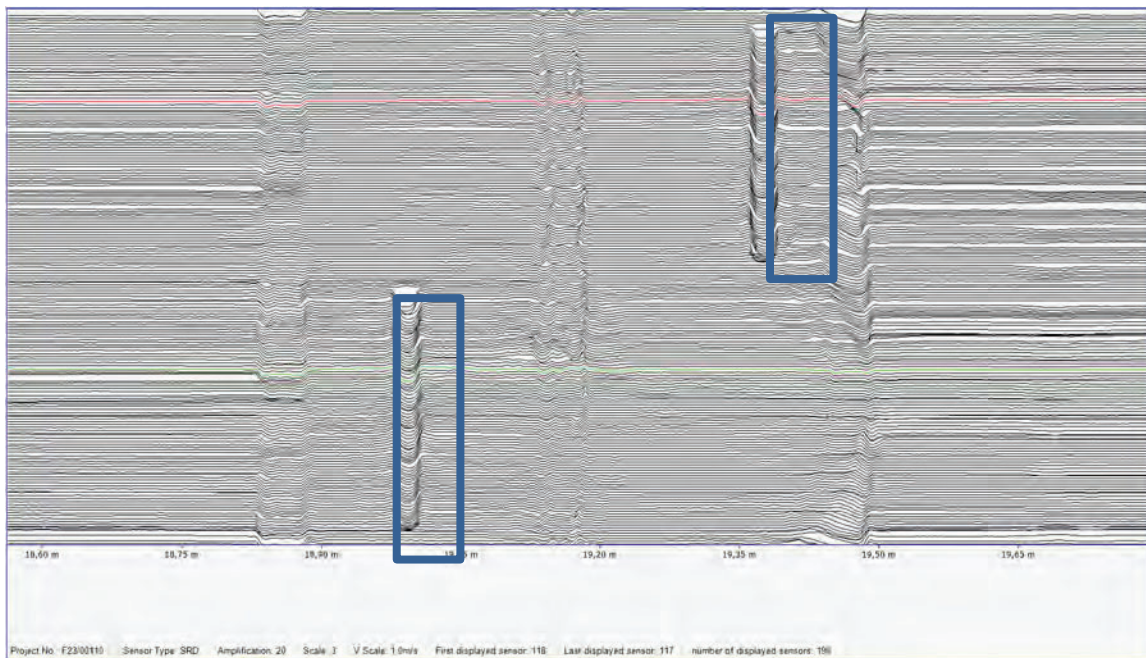
In contrast to the GEO sensors show the wall-guided magnetic sensors clearly the internal metal loss. These sensors measure through the artificial debris.

Figure 9. Wall-guided magnetic sensors data – blue rectangle shows anomaly location (red/green sensors = 12h/6h).

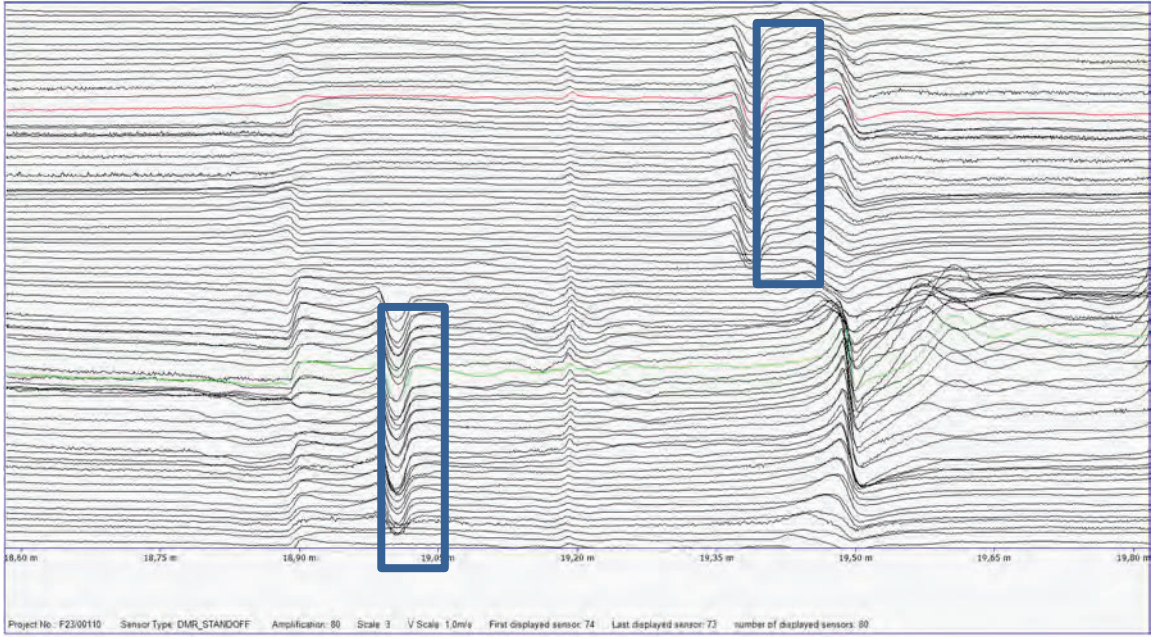
The same behavior can be observed on the stand-off magnetic sensors. These sensors ignore the debris and measure clearly the internal metal loss.

Figure 10. Stand-off magnetic sensors data - blue rectangle shows anomaly location (red/green sensors = 12h/6h).

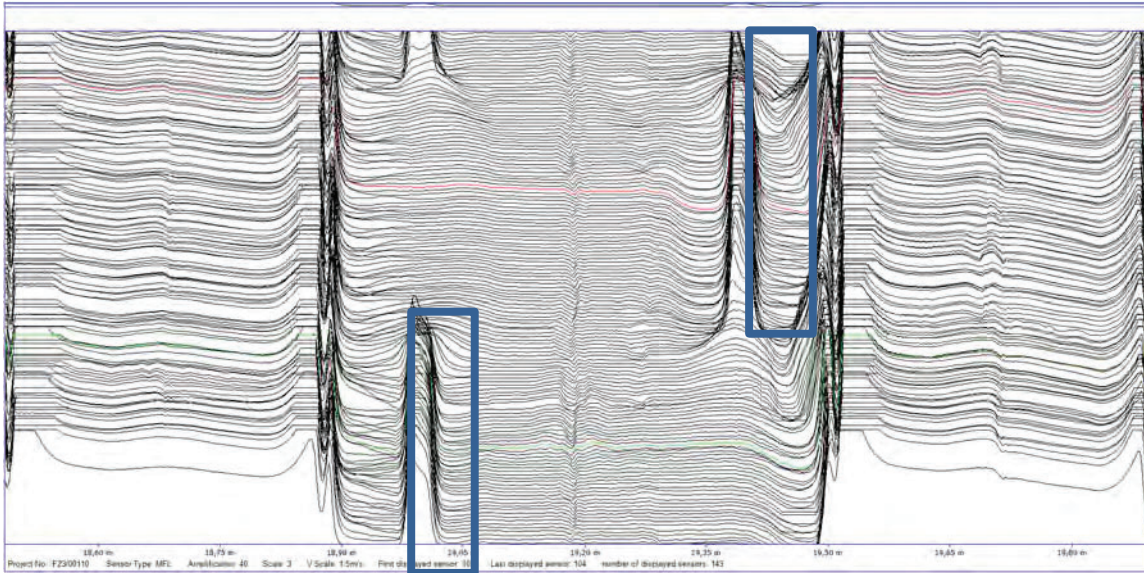
The heavy wall MFL magnetizer was able to magnetize the 27.3mm wall thickness and clearly detect and size the internal metal loss anomalies. The internal debris did not influence the magnetic field and the sizing of the metal loss worked according to performance specifications.

Figure 11. MFL sensors data – blue rectangle shows anomaly location (red/green sensors = 12h/6h).

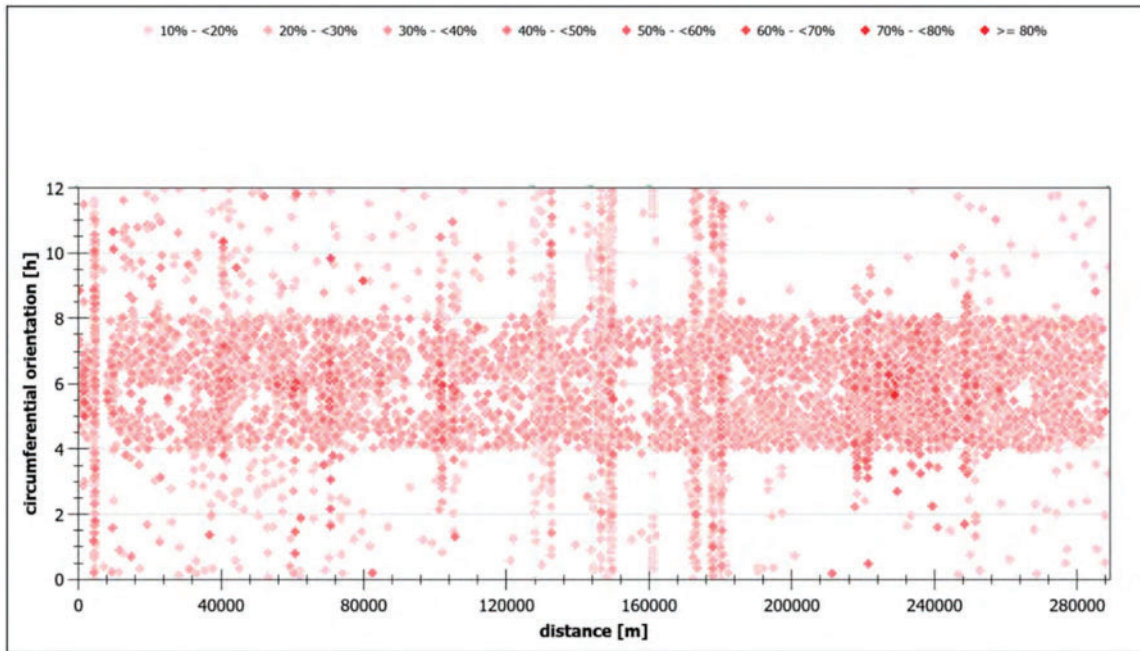
Prior to the project an extended preliminary reporting time of four weeks was agreed, which was recommended due to the size of gathered ILI data. The preliminary report was sent accordingly and fourteen (14) metal loss indications equal to or above 60% were reported. Correspondingly to the operations report, the preliminary report re-confirmed that there is no debris-based influence on the data.

Figure 13. Distribution of metal loss over the pipeline length and circumference.

A typical 6 o'clock pattern of internal metal loss anomalies over the pipeline length and circumference can be seen. 3P Services did additionally perform an estimated repair factor (ERF) calculation according to ASME B31.G to provide the operator further data for their integrity assessment. These results are visualized below.

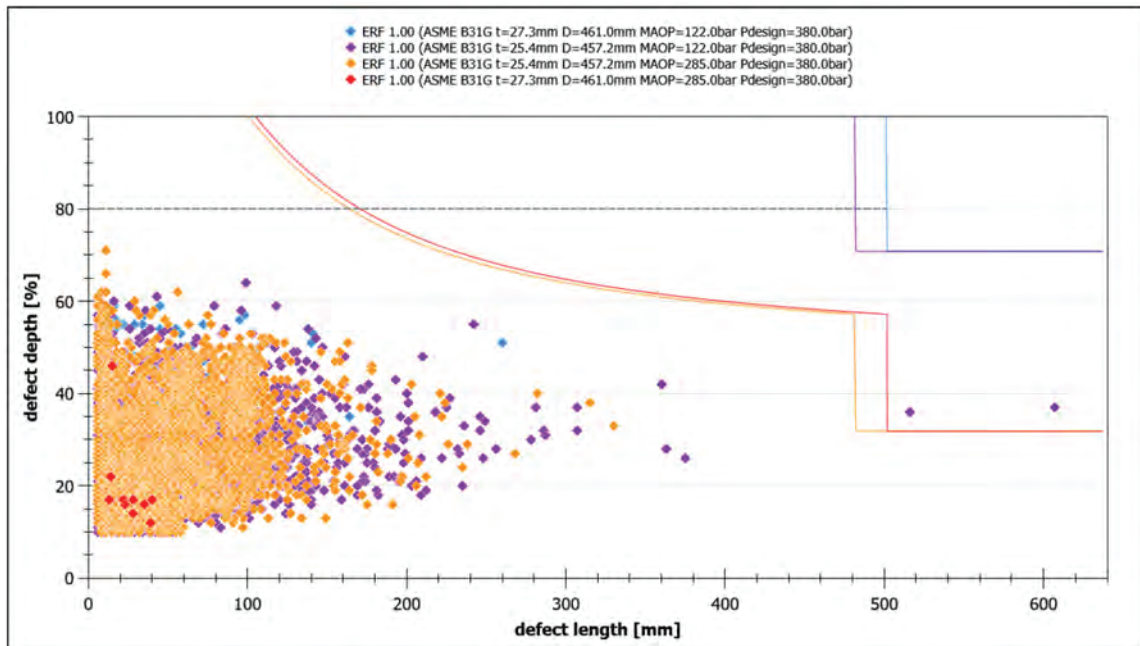
Figure 14. ERF sentenced plot.

The execution of the inline inspection with 3P Services' ILI tool allowed the operator to perform a full integrity management of his asset and take measures to operate the pipeline safely. A possible verification of reported indications is currently being assessed by the operator.
