# Hydrotesting in the Modern World – What Are We looking for?

**Rick Sugden**  
Kiefner and Associates, Inc.

## Pipeline Pigging and Integrity Management Conference

*Proceedings of the 2024 Pipeline Pigging and Integrity Management Conference.*

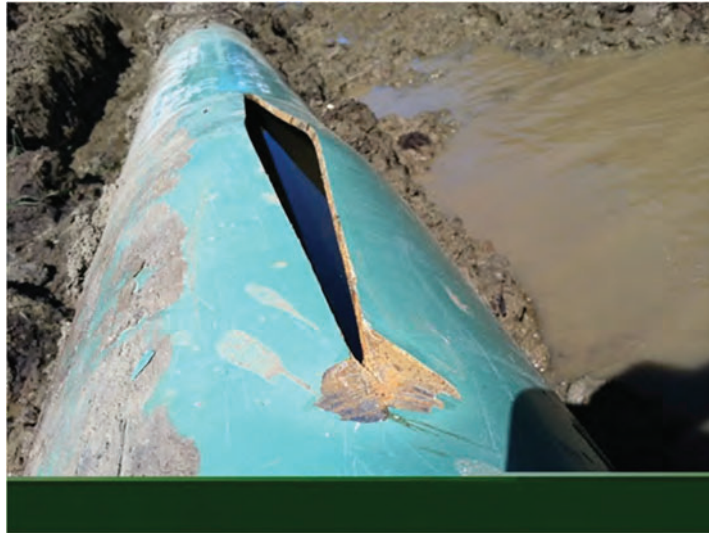
The first case is a 2012 installed 10.75-inch pipeline with 0.219" wall thickness and grade X42 seam failure. No failure analysis was performed, but the pipe was confirmed to have been manufactured in Turkey based on available MTRs for the construction of this pipeline. The photo, shown in Figure 1, and the note of the failure were found in pipeline construction files during the review for data integration purposes in 2020.

**Figure 1.** Case 1 - Seam failure of 2012 installed pipe during hydrostatic test

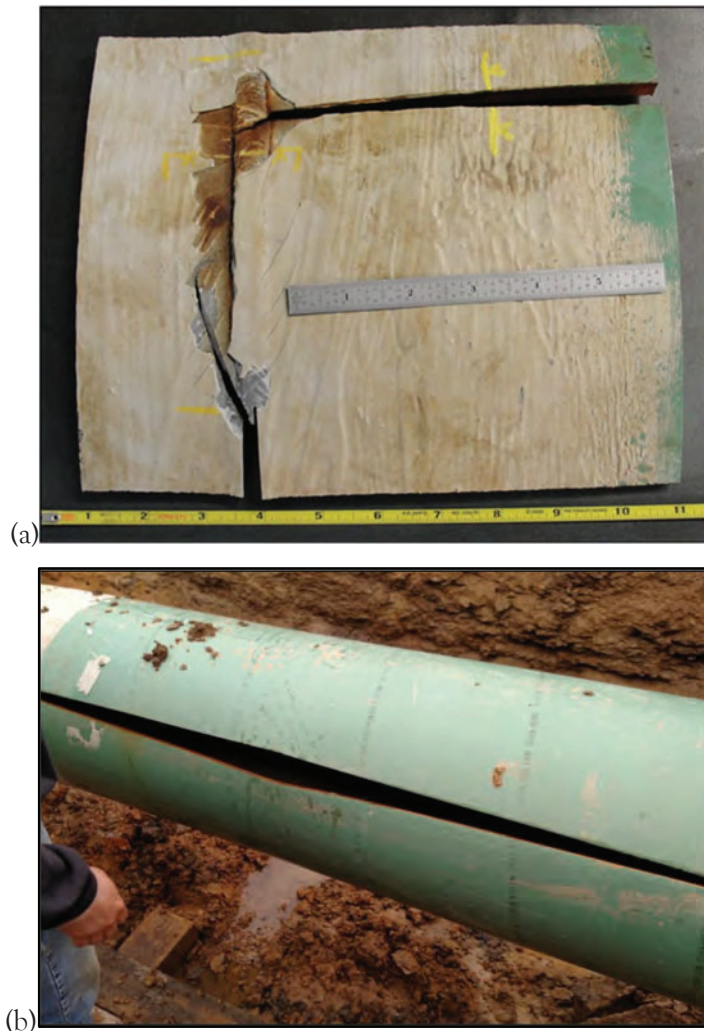
The second case is a 2015 installation of 20-inch 0.375" wall thickness and grade X65 that failed under hydrostatic test, and the failed pipe was sent for laboratory investigation of the failure. The pipe ERW seam was incompletely subjected to post-weld heat treatment as required by API 5LX. The pipe was manufactured in the US. The pipe failure was initiated by a lack of fusion of the long seam within ¼" of the girth weld. It is noted in the failure report that portions of the seam on this joint had post-weld heat treatment. Figure 2 shows photos of the failure.

**Figure 2(a-b).** Case 2 – Investigative failure photo (a) Seam failure of 2015 installed pipe under hydrostatic test (b)

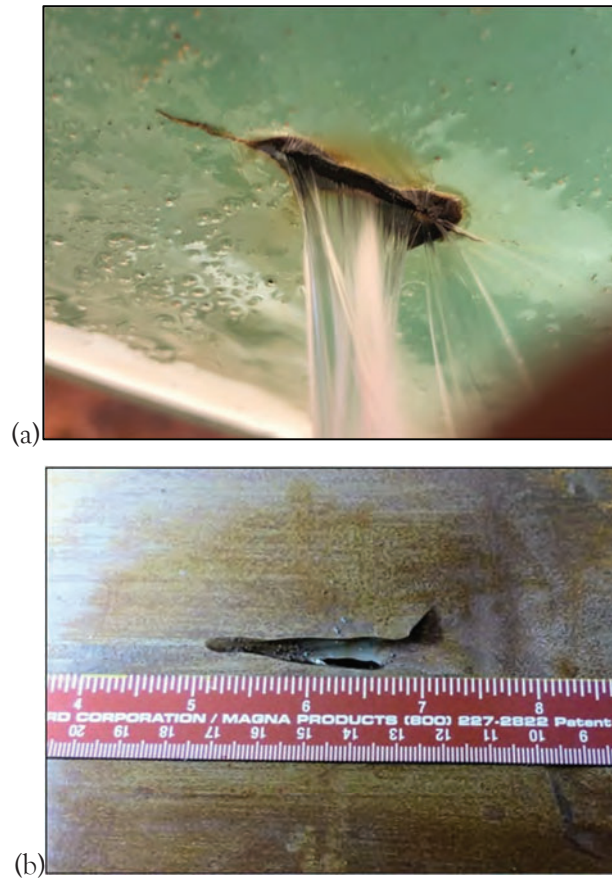
The third case involved a slightly more unusual type of failure; a newer pipeline was installed in 2019 API 5LX 8.625" with 0.250 wall thickness and grade X52. The pipeline failed under a new construction hydrostatic test by an erosion-corrosion mechanism. Results from the investigation of this failure noted significant debris and sand were found in and near the failure point. This caused a substantial concentration of high-velocity material erosion occurring during the pipeline fill, resulting in hydro test failure due to the loss of steel at the site, as shown in Figure 3 below.

**Figure 3(a-b).** Case 3 - 2019 erosion corrosion failure during commissioning hydrostatic test

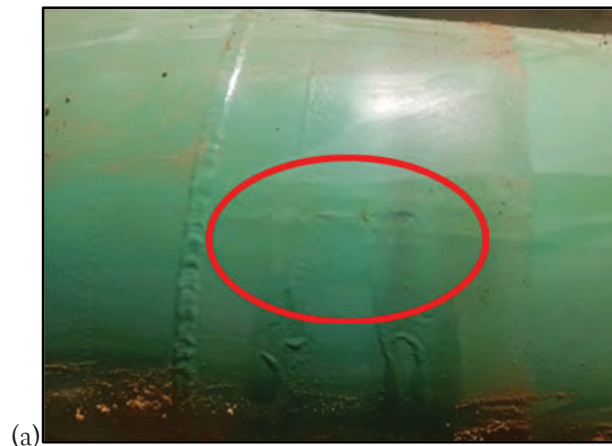
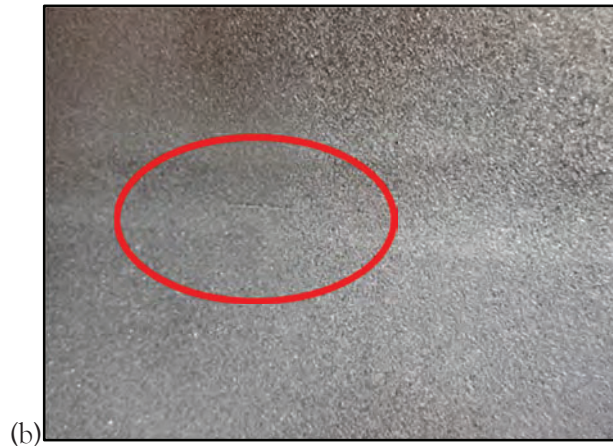
The fourth case involved a newer pipeline installed in 2019: API 5LX 20" with 0.375" wall thickness and grade X65 that failed from a lack of fusion of the long seam. The pipe was manufactured in the US. In this case, the failure initiated within 3" of the girth weld and was discovered when the pipe failed to maintain the maximum required pressure. However, the leak would seal up, and the pipeline would stop losing pressure when the maximum pressure was lowered from the test pressure to begin searching for the leak. This leak was challenging to locate due to the small size of the defect, resulting in a very low leak rate.

Figure 4(a-b). Case 4 - Lack of Fusion Long Seam failure of 2019 installed pipe
