# Internal Ultrasonic Pipeline Inspection for Outer Continental Shelf (OCS) Hazardous Liquid Gathering Lines

Mick Collins  
Intero Integrity Services

## Pipeline Pigging and Integrity Management Conference

February 12-16, 2024

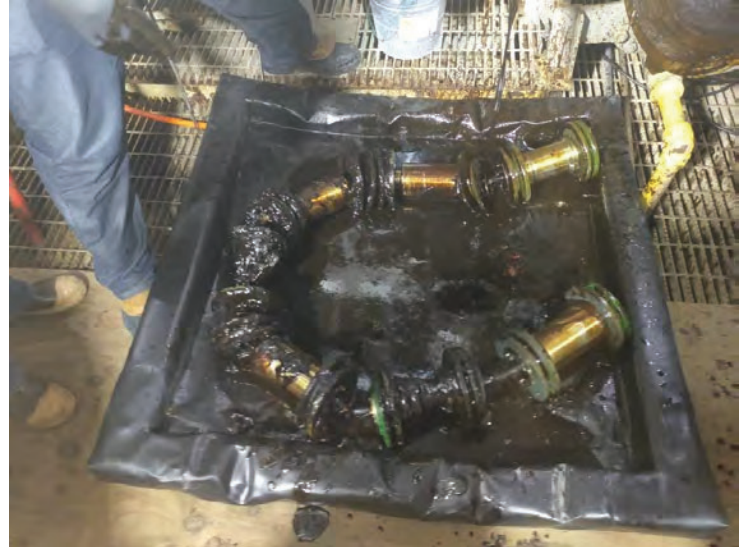
**Figure 4** - Condition of the tool when received in 2021

Another factor that all internal pipeline inspections must consider is the cleanliness of the pipeline. Crude oil pipelines cause a particular challenge, as when the product temperature falls, paraffin wax drops out to the product, obstructing both magnetic and ultrasonic sensors. Thus reducing or even wholly shielding and curtailing sensor detection capabilities. Figure 4 is a photograph of the actual Surveyor inspection tool after it was recovered during the 2021 inspection. Even though the tool contains levels of crude oil, the run was successful. It was later discovered that most of the oil covering the tool was from while waiting within the receiving barrel.

Preceding the 2021 inspection, Intero mobilized a number of cleaning tools, each designed to slowly remove debris at a manageable rate for the operator to receive. Overall conditions and debris levels were lower than expected, and the Surveyor UT tool was launched behind two cleaning tools to ensure a clear path forward.

Preceding the 2021 inspection campaign, Intero preselected a mix of cleaning tools designed to clean the pipeline safely before inspection. Over-aggressive cleaning or incorrect tool selection can remove amounts of wax/debris that would overwhelm the receiving capabilities of an offshore platform and, in extreme cases, completely block the pipeline. Common practice is for pipelines with known large amounts of paraffin drop-out to utilize chemical cleaning, and Intero has successfully deployed this method both onshore and offshore.

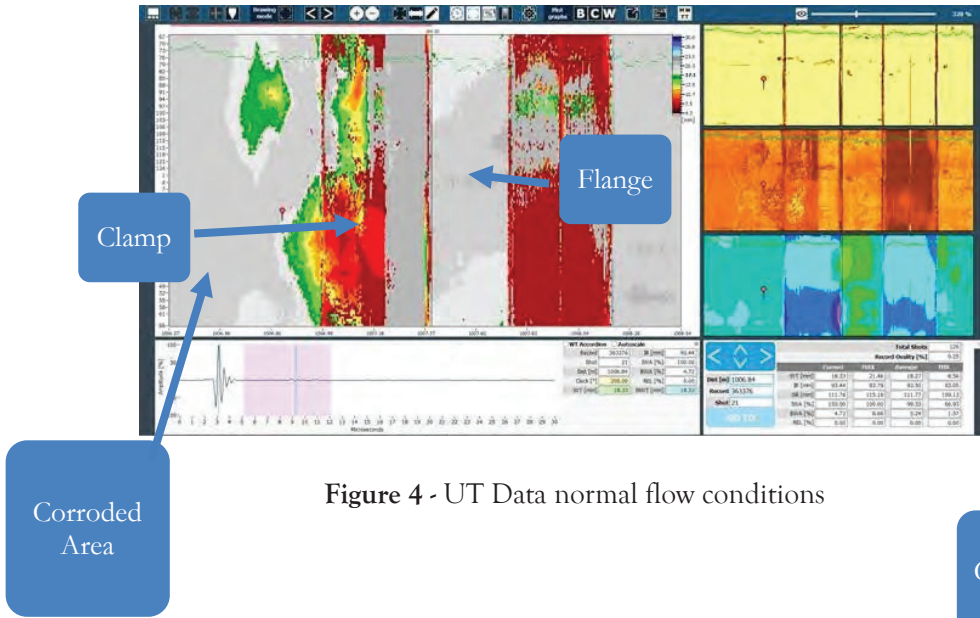
Figure 4 - UT Data normal flow conditions

Regardless of the technology deployed to inspect an asset, the final deliverable, the report, is the most significant aspect. The operational planning and cooperation between vendor and operator aim for successful data collection. Data sets from 2020, 2021 were compared to both data sets collected in 2022. Indeed, levels of external corrosion had spread from a volumetric perspective; however, interestingly, it was not significant from a depth perspective.

The operator deployed various external mitigation methods, one of which is using a bio-degradable spray to shield the splash zone area from the elements. This method has undoubtedly reduced the historical corrosion growth mechanism. Still, it could not wholly stop new low-level corrosion from being initiated, be it at a shallow sub-five percent wall thickness level. Also, this further superficial corrosion could have been there during the previous 2021 inspection, but it was too shallow to be detected in the complex mechanically supported section of the riser.
