To Dig or Not to Dig - Determining Which Dents Are Suitable for Engineering Critical Assessment per 192.712 (c)

Shanshan Wu¹, Jing Wang², Joseph Bratton¹, David Kemp¹, Luyao Xu¹, Greg
Quickel¹

Pipeline Pigging and Integrity Management Conference

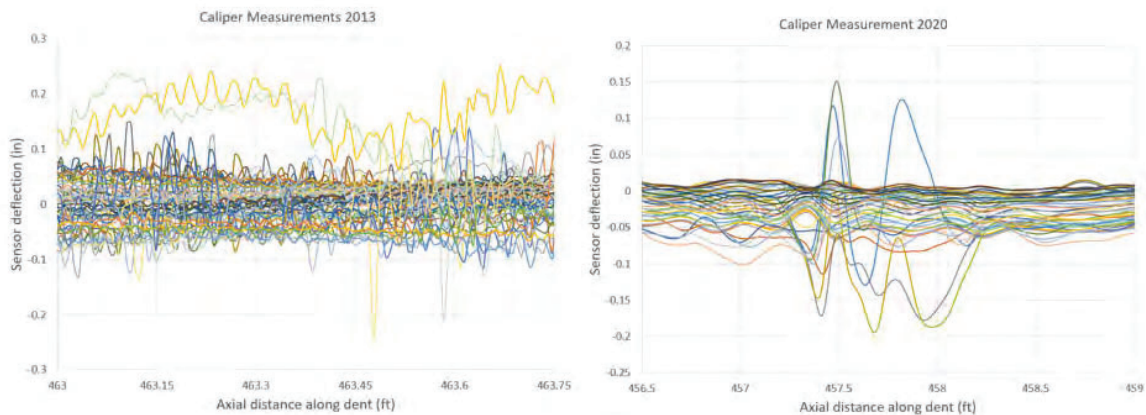
Figure 2. 2013 (left) and 2020 (right) Caliper Measurements Comparison

The first step of this dent ECA was to verify the high dent strain reported by the ILI vendor by reviewing the caliper measurements. The caliper measurements from the 2020 inspection of the reported dent did not seem to demonstrate typical characteristics of a dent. Therefore, the caliper measurements from the 2013 ILI were used to compare the shape of this dent between the two inspections. The 2013 inspection did not report this dent and commented the caliper sensor change at this location is likely due to the presence of debris. Figure 2 shows the side by side comparison of the caliper measurements at this feature location from the 2013 (left) and 2020 (right) inspections. As shown in Figure 2, there is no discernible dent shape that can be identified from the 2013 caliper measurements.

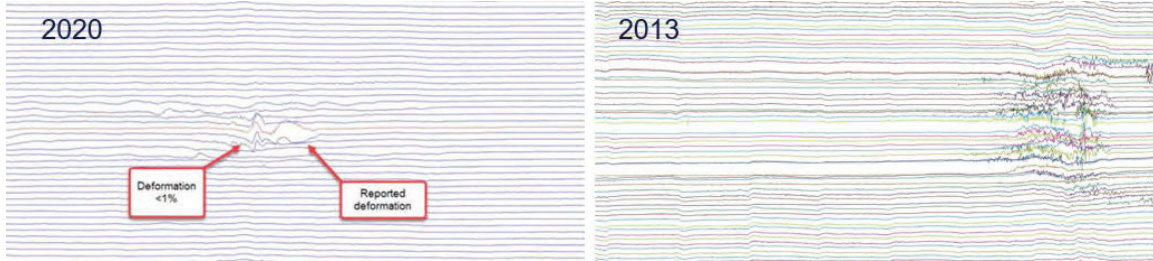
Figure 3. 2020 and 2013 Caliper Signal Data Comparison

In addition, the caliper signal data from both inspections was reviewed to further confirm whether this feature is a dent with debris or just debris. As a result of the review, similar findings were observed from the signal data comparison that no signal pattern in response to a typical dent could be identified. Therefore, it was believed this feature was debris which is consistent with the determination from the 2013 ILI vendor.

After communicating the results of the review to the 2020 ILI vendor, the ILI vendor performed a detailed review and confirmed the signal is more representative of debris and revised the ILI listing. Due to this review, the feature was reclassified and an ECA is not required.

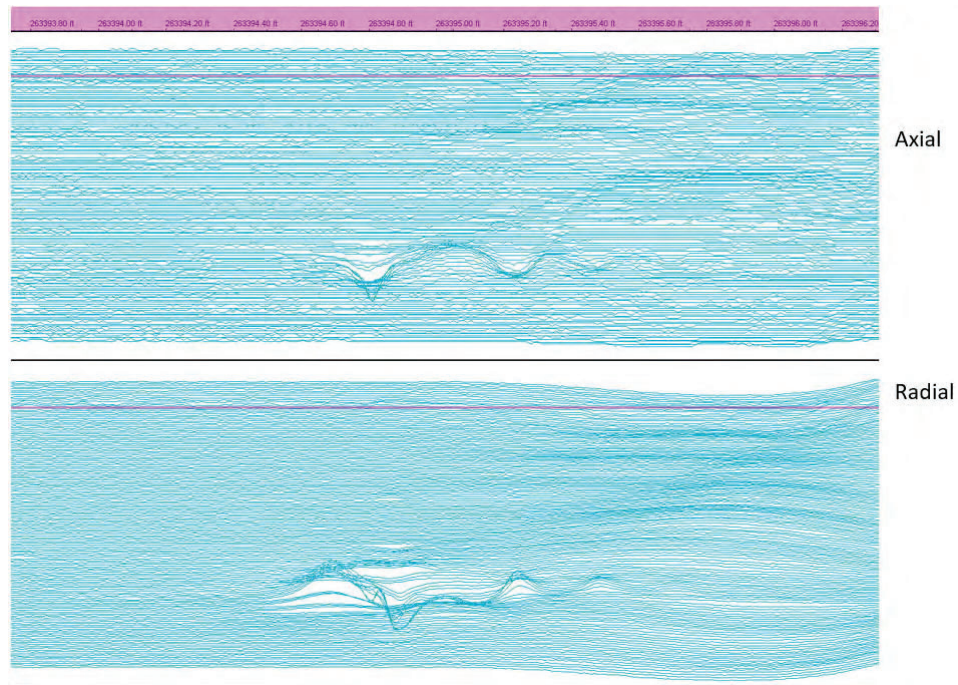
Figure 5. 2014 Signal Data

As a result of the review, the dent was visible in the 2014 signal data as shown in Figure 5 below. This finding proved the existence of the dent previously and thus the feature is not a new dent. Further investigation into the location of the dent by reviewing satellite imagery, it was found that this dent is located in an area with considerable ground disturbance, running through/adjacent to a plant providing ready-mixed concrete and related construction supplies. In addition, by comparing the relative metal loss location to the dent location based on the 2021 signal data, the metal loss is contained within the dent, as shown in Figure 6.

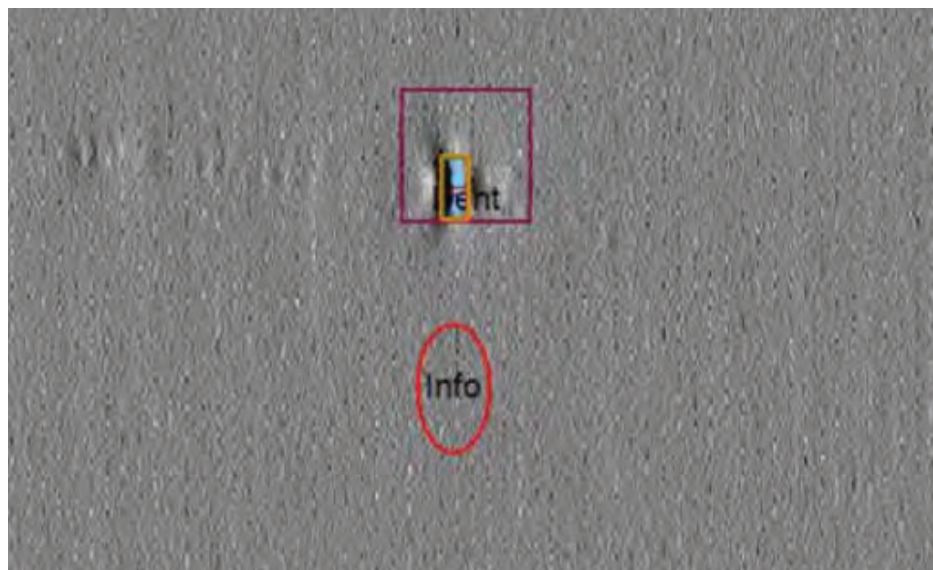
Figure 6. 2021 Signal Data

Based on the findings of the review, it was most probable that this feature was a dent with a gouge, which had likely been present in the pipeline for some time. Because it was decided that this dent would not be a good candidate for ECA, it was recommended for excavation. The dent was examined in the field and was found to be a dent with gouge with linear indications beneath the gouge, shown below in Figure 7.

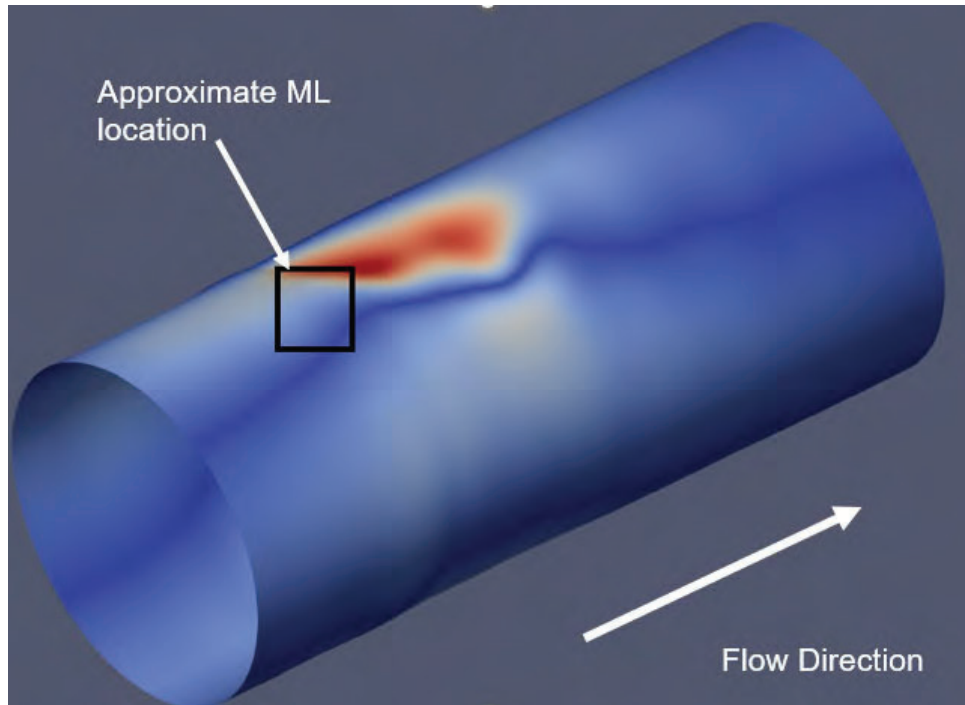
Figure 8. Case 3 Dent 3D Profile and the Relative ML Location

Since this dent with metal loss is at the bottomsides of the pipe, it is unlikely to be a dent with gouge. In order to further rule out the possibility of a dent with gouge, a 3D profile was created using the caliper measurements and the relative location of the associated metal loss. As shown in **Figure 8**, the associated ML is located at the upstream edge of the dent which suggested a lower likelihood for this feature to be a dent with gouge.

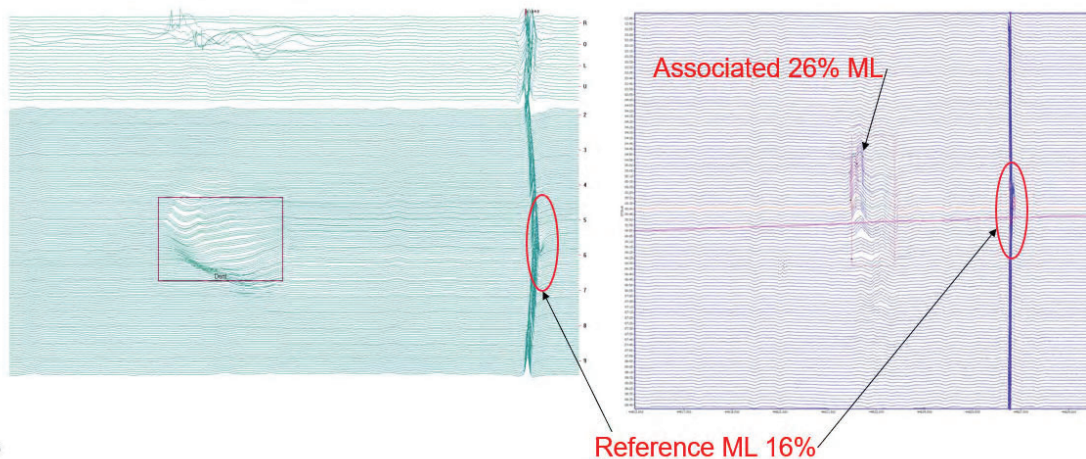
Figure 9. Case 3 Dent with Metal loss Comparison between 2014 and 2021 Signal Data

A signal review comparison was also performed using the 2021 ILI signal data and the previous ILI signal data from 2014. Based upon the comparison shown in Figure 9, the associated metal loss seemed to be a new metal loss feature in the 2021 MFL signal data. Therefore, the FEA model should conservatively account for the potential metal loss growth between the 2014 and the 2021 inspections. This step could have been very easily missed if the signal data comparison was not performed.

Based upon the findings that the associated metal loss is a new metal loss feature, this dent was scheduled to be excavated in March 2024. Therefore, no field data is available at this time.

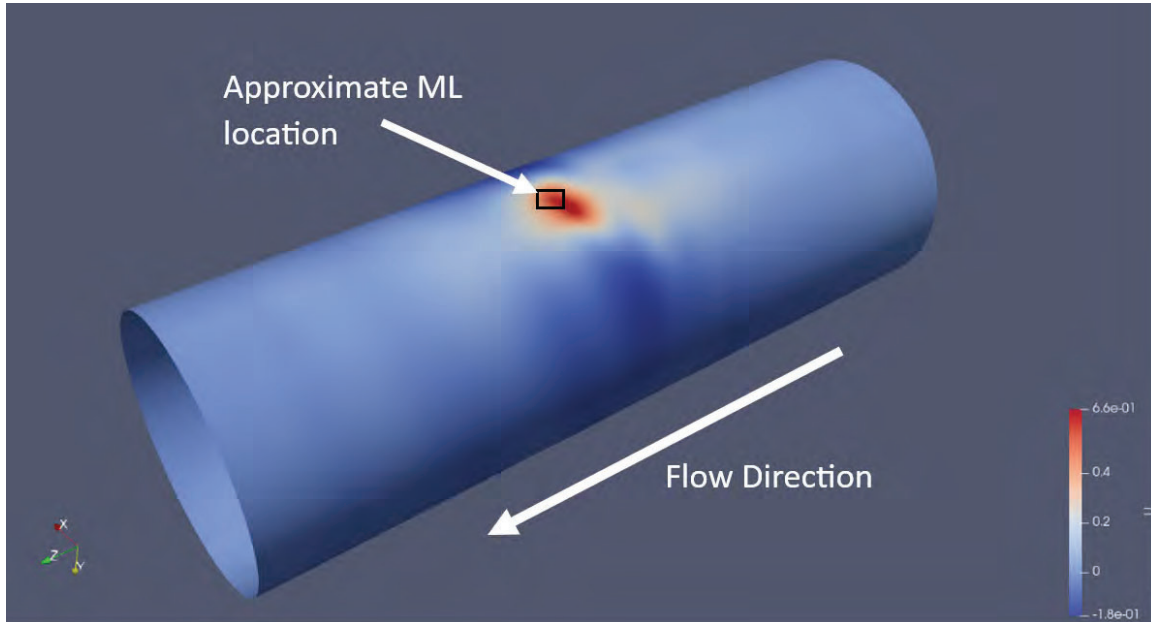
Figure 10. Case 4 3D Caliper Profile

The case 4 dent is a bottomsides dent with an ILI-reported depth of 2.5% OD, at 6:01 o'clock orientation with a dent strain of 5%. This dent is determined to interact with an external metal loss with a depth of 44% wall thickness. The case 4 dent 3D caliper profile is shown below in **Figure 10**.

This dent with metal loss is a bottomsides dent with relatively low dent strain. However, the fact that the associated metal loss is 44% of the wall thickness (significantly deep) and the metal loss is adjacent to the dent apex, practical engineering judgement raised a red flag that an ECA may not be reliable or conservative with the potential severity of the defect. The decision to excavate this dent with metal loss was decided rather than an ECA due to the background review.

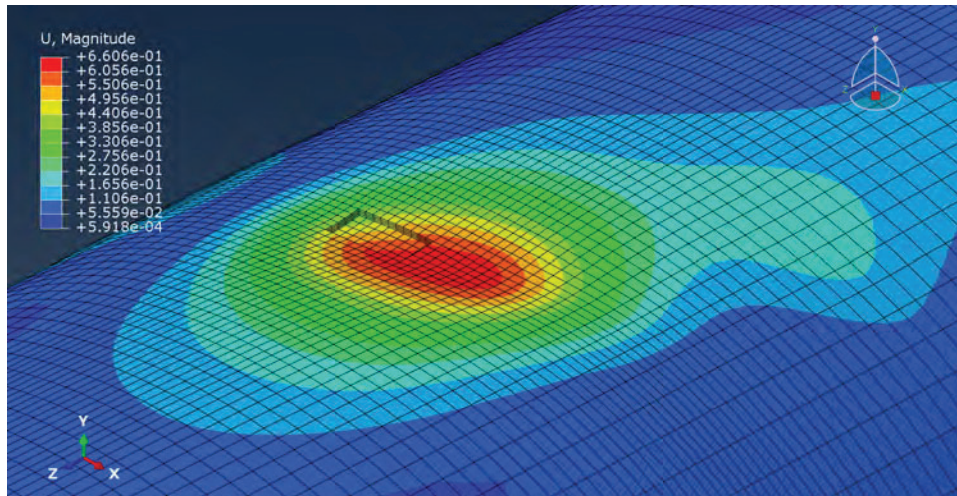
Figure 12. FEA Deformation of Case 4 Dent

The FEA model results for the dent deflection are shown below in **Figure 12** with the associated metal loss feature adjacent to the apex. The equivalent plastic strain distribution is shown in **Figure 13**, where it can be seen that the plastic strain area is concentrated at the dent apex region with a maximum value of 5.53%, which is close to the ILI reported curvature strain of 5%. Furthermore, there is no significant plastic deformation observed in the interacting metal loss region. The maximum hoop stresses as a function of internal pressure at the dent and the metal loss area were extracted and are shown below in **Figure 14**. The hoop stress for an un-dented pipe is also plotted in the figure as a comparison, where it can be seen that the presence of the dent and metal loss features generate a significant stress concentration. Further, the highest stress in the dented region is not located within the metal loss area.

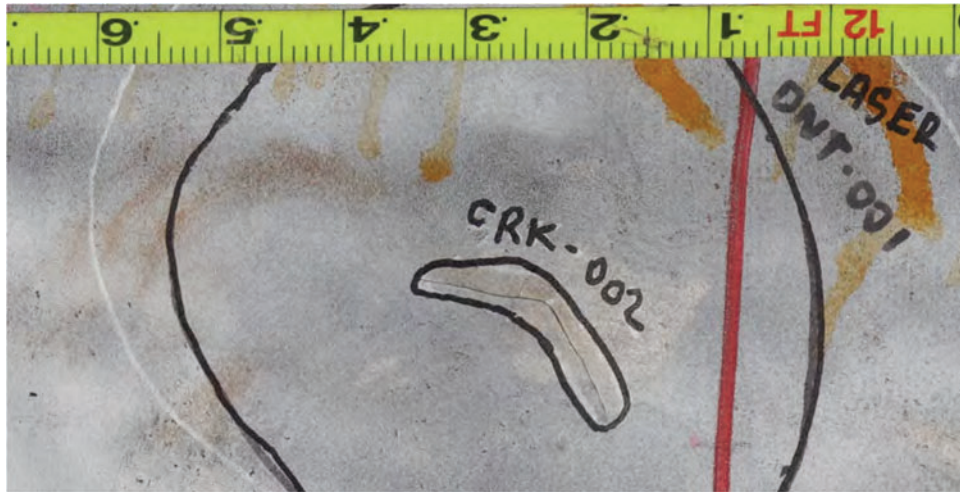
Based on the excavation examination findings and metallurgical analysis, a crack was found to be associated with the case 4 dent as shown in **Figure 15**. A portion of the pipe containing the dent was removed for a detailed metallurgical analysis and laboratory hydrostatic pressure testing. The results of the metallurgical analysis indicated that a crack was located at a bottomsides dent and is associated with the ILI reported metal loss. The hydrostatic pressure testing resulted in the crack failing at an internal pressure of 257 psig. **Figure 16** shows an image of the pipe actively leaking during the laboratory hydrotest at 257 psig.

Figure 15. Close-up Photograph of the External Surface of the Pipe Section Containing the Case 4 Dent, Showing a Crack at a Bottomside Dent

The crack was slightly longer on the internal diameter (ID) surface (2.5 inches long) compared to the outside diameter (OD) surface (1.9 inches long), indicating crack initiation at the ID surface. Beach marks on the fracture surface also are consistent with crack initiation at the ID surface and propagation to the OD surface. The beach marks also indicate that the cracking initiated at/near where the dent was the deepest.

The ID surface of the pipe would be in tension from a restrained bottomside dent (likely a rock dent) and is consistent with ID crack initiation. The failure pressure value, presence of an OD surface breaking crack prior to the hydrostatic pressure test, ID crack initiation, and no clear evidence of ductile features on the fracture surface indicate the crack was through-wall prior to the hydrotest. The through-wall crack depth is not consistent with the in-the-ditch (ITD) crack depth of 0.097 inches (34.5% of nominal wall thickness). The detailed geometry information of the case 4 dent and the interacting crack feature is listed in Table 2.

The most likely mechanism for crack propagation is fatigue, based on the location of the crack at the apex of the dent, the propagation direction from ID to OD, and the presence of beach marks on the fracture surface. There was no evidence of fatigue striations; however, the fracture surfaces were corroded, obscuring any fatigue striations that may have been present.

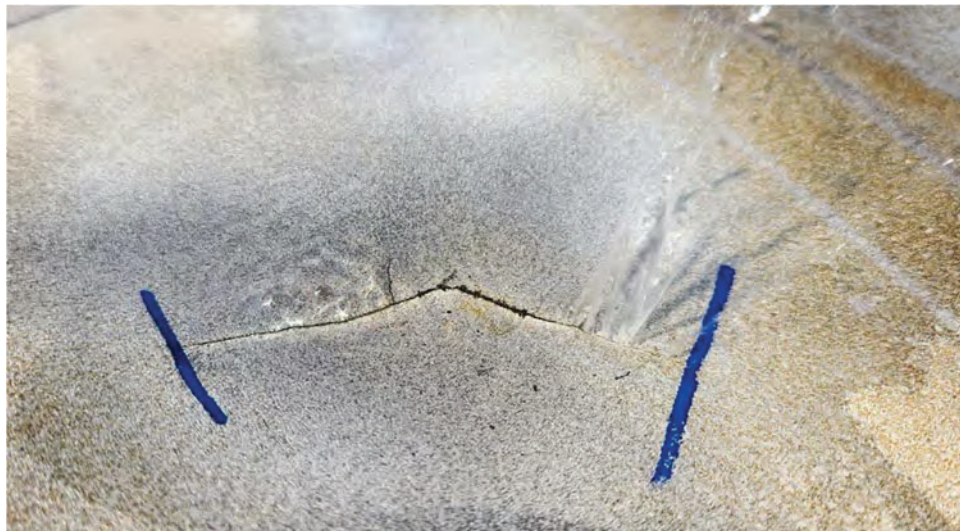
Figure 16. Close-up Photograph of the External Surface of the Pipe Section Containing the Case 4 Dent during the Hydrostatic Pressure Test Showing the Leak Location
