Integrity Management of Selective Seam Weld Corrosion in Gas Transmission Pipelines

Olivia Chung¹, Mick Ellem², Mark Sigley²
¹Quest Integrity, ²Firstgas Limited

Pipeline Pigging and Integrity Management Conference

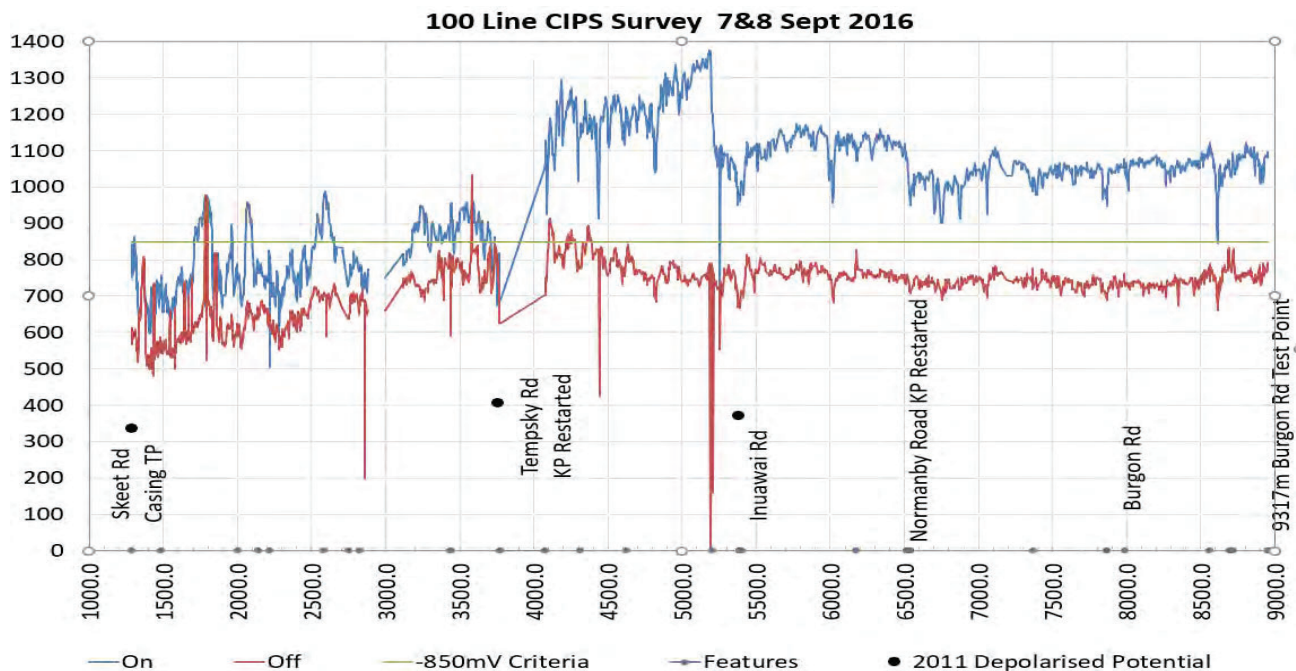
Loss of adhesion and increased permeability of CTE coating has resulted in a high incidence and increasing severity of corrosion in substantial sections of the approximately 600 km of pre-1971 constructed pipeline network. Coating was particularly degraded in this section downstream of a gas treatment plant by high gas temperatures. This resulted in a relatively high corrosion incidence that was only partially mitigated by cathodic protection (CP), due to CP current being limited by interference imposed on other operators' pipelines and CP shielding under disbanded coating, and exacerbated by wetting and drying of the pipe-wall under the permeable, disbanded coating. The effect of coating degradation on CP for the pipeline section downstream of the gas treatment plant is shown in Figure 2 and Figure 3.

Figure 1. 2016 CP potentials from Close Interval Potential Survey (CIPS) from 1300m (Skeet Rd) to 9 km.

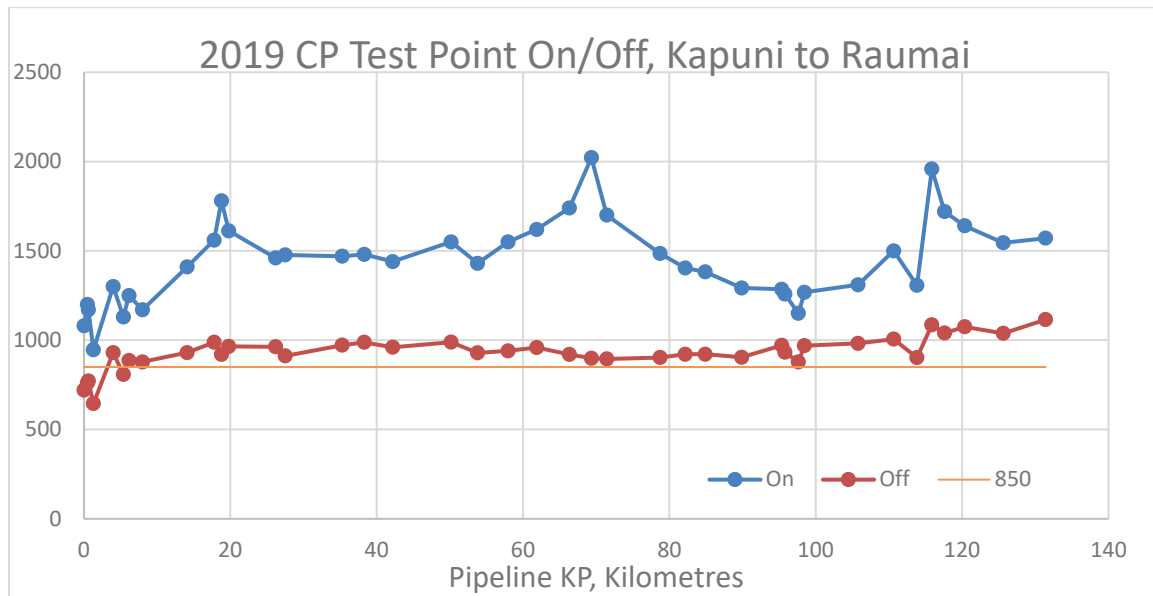
Figure 2. 2019 CP Test Point On/Off.

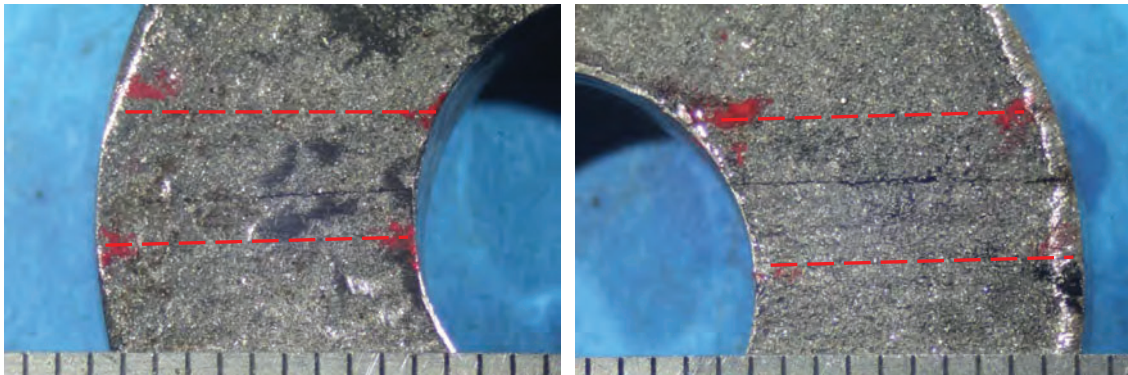
A metallurgical examination of coupons sampled from Site 6 and Site 34 along the excavated 8-inch pipeline was undertaken. Linear indications were detected by MPI within the longitudinal seam weld for the sampled coupons, see Figure 3 and Figure 4.

Figure 3. MPI indications detected for the Site 6 coupons. The approximate locations of the seam weld boundaries are shown by the red dashed lines. Scale bar increments = 1 mm.

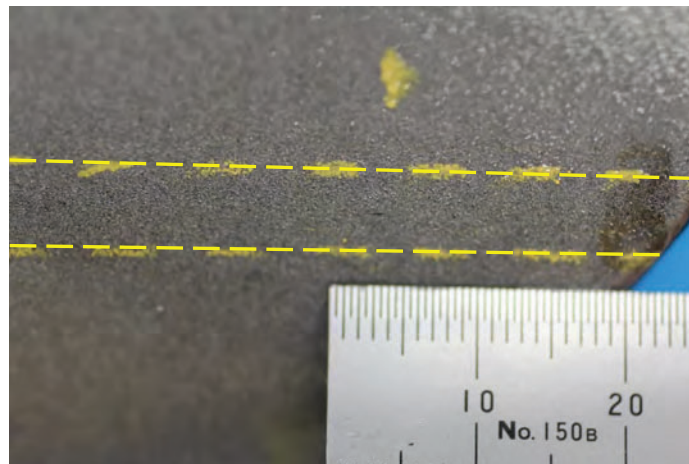
Figure 4. MPI indications detected for the Site 34 coupon. The approximate location of the seam weld boundary is shown by the yellow dashed lines. Scale bar increments = 0.5 mm.

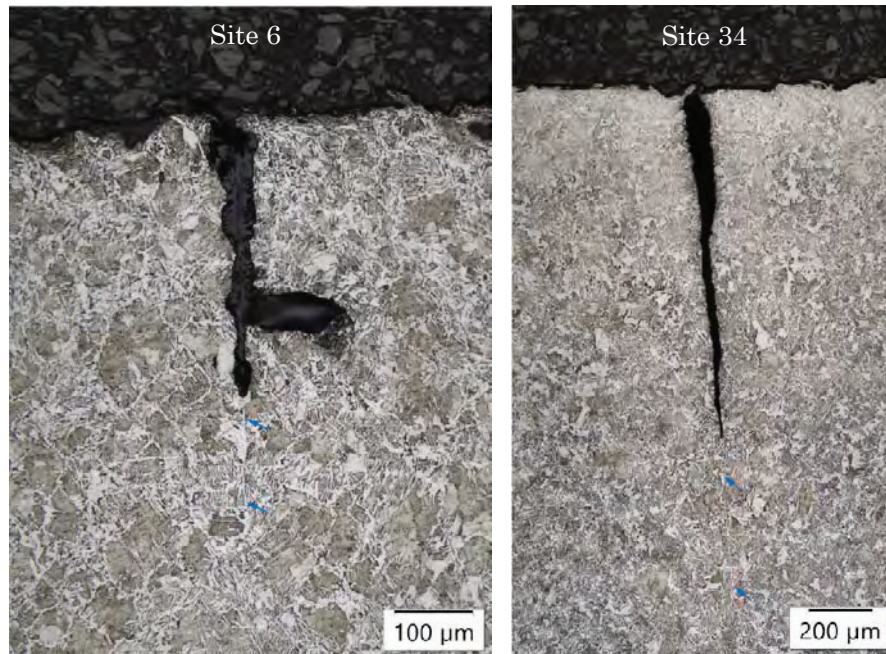
Metallurgical cross sections of the linear indications detected by MPI for these coupons confirmed these to consist of an oxide notch at the longitudinal seam weld bondline. These were predominantly at the external surface (as detected by MPI, see Figure 5) with a localised instance of internal corrosion coincident with the bondline observed at Site 6, see Figure 6. The observed notches and internal corrosion coincident at the weld bondline were indicative of selective seam weld corrosion (SSWC), which likely occurred as a result of in-service corrosion of material known to be susceptible to SSWC given the known issues with respect to the coating condition and associated CP changes along this section of the pipeline. The appearance of the external oxide notches was sufficiently sharp and narrow for SSWC to be active. The observed metallurgy and chemical composition at the weld did

Figure 5. Representative longitudinal seam weld cross sections. Notch features were observed at the bondline. The blue arrows indicate the narrow band of ferrite grains along the bondline.

The metallurgical examination also confirmed that the longitudinal seam weld was hourglass in shape, see Figure 5. This indicates that the weld was formed using a high frequency electric resistance welding (HF-ERW) process. It was noted that although HF-ERW pipe can also be susceptible to SSWC, particularly for earlier vintage HF-ERW, the threat of SSWC for these welds is not as common as that for direct current ERW (DC-ERW) or low frequency ERW (LF-ERW) [1][2]. No anomalous microstructures were observed across the longitudinal seam weld. In addition, no

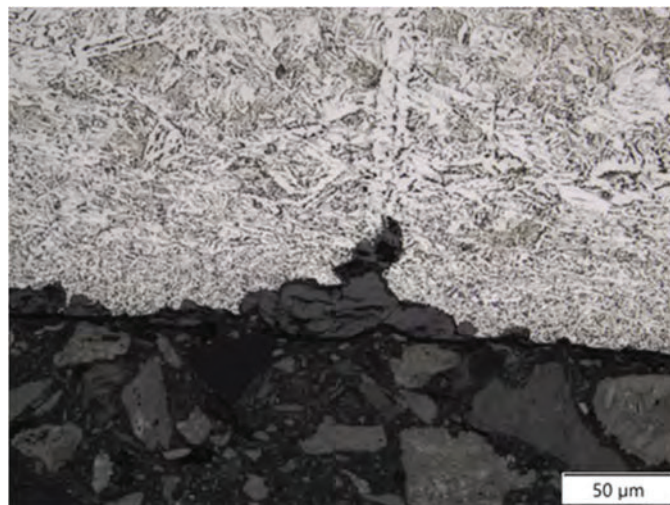
Figure 6. Localised notch at the internal surface, Site 6. The blue arrows indicate a narrow band of ferrite grains along the bondline.

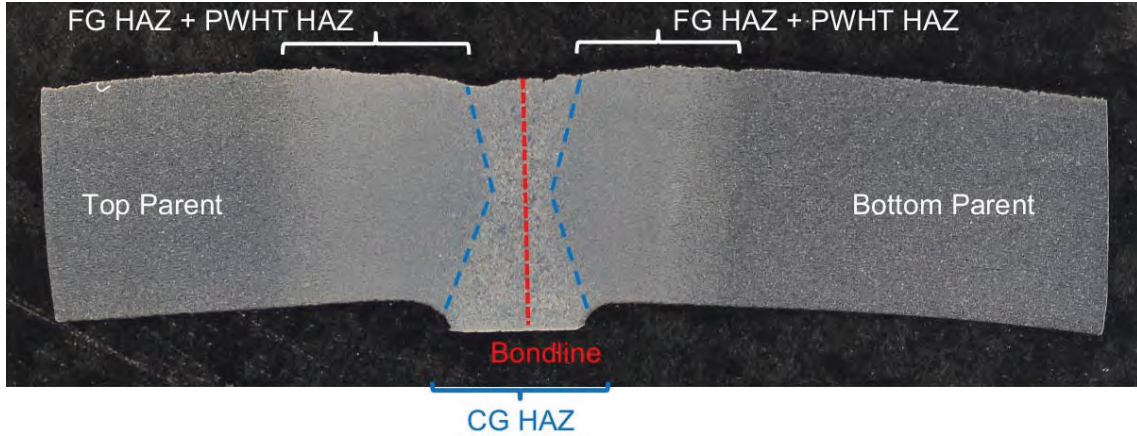
Figure 7. Representative seam weld cross section. Site 6 shown.

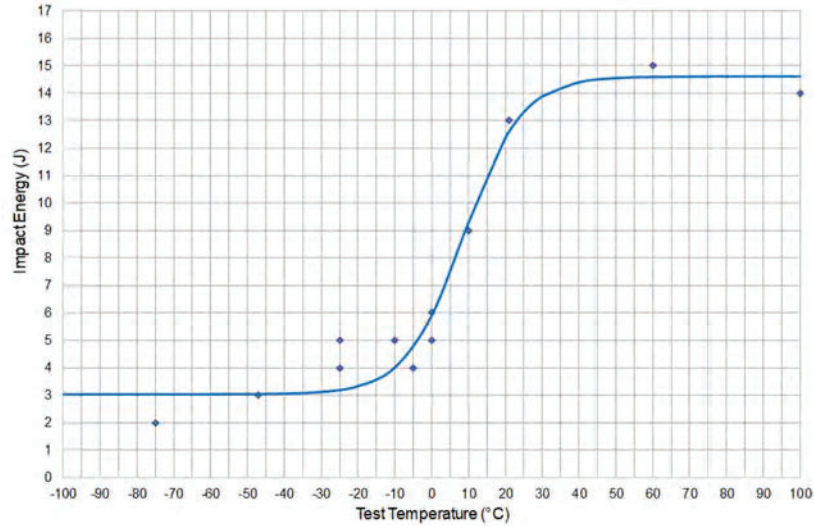
The CVN impact testing results obtained for the parent pipe is shown in Figure 8. Given that no impact properties are specified for API 5LX X42 material, the acceptance criterion specified in API 5L for PSL2 material was used. The CVN impact energy obtained at 0 °C for the parent pipe was less than the adjusted specified absorbed energy/impact energy acceptance criterion defined in API 5L. Similarly, the CVN impact energy obtained for the seam weld at 0 °C was also less than the adjusted specified absorbed energy/impact energy acceptance criterion defined in API 5L. These results likely indicate that the impact properties for the parent pipe and seam weld are at the lower shelf of the CVN transition curve at typical operation temperatures.

Figure 8. Charpy impact energy curve for the parent pipe material.

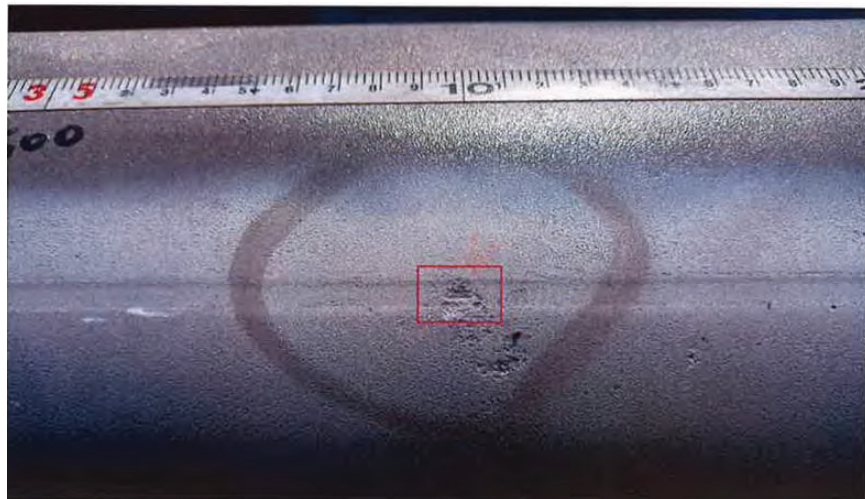
A possible linear feature within metal loss at the longitudinal seam weld was detected by ToFD and PA at Site 134 of the excavated pipeline. Linear indications had also been detected by MPI at this location prior to the ultrasonic inspection, see Figure 9. As a precautionary measure, this feature was removed by hot-tap repair and further metallurgical examination was undertaken for the sampled coupon.

Figure 9. Metal loss and linear indicated detected at Site 134. Image after MPI shown.

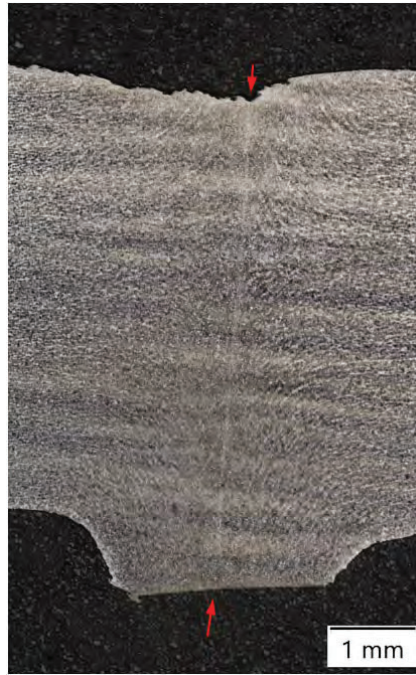
A representative cross section across the longitudinal seam weld of the coupon from Site 134 is shown in Figure 10. Further metallurgical examination confirmed that the feature detected at Site 134 was likely to be indicative of SSWC based on the grooving factor determined (i.e., comparison of the depth of the groove from corrosion at the bondline compared to the overall metal loss of the pipe material). It was noted that the appearance of SSWC at Site 134 differed from that observed at Site 6 and Site 34 and it was considered likely that the damage observed for Site 134 was representative of early stages of SSWC. This suggests that this level of SSWC damage may be at the limits of detection for the inspection methods used.

Figure 10. Representative image of the seam weld cross section at Site 134. The bondline is highlighted by the red arrows.

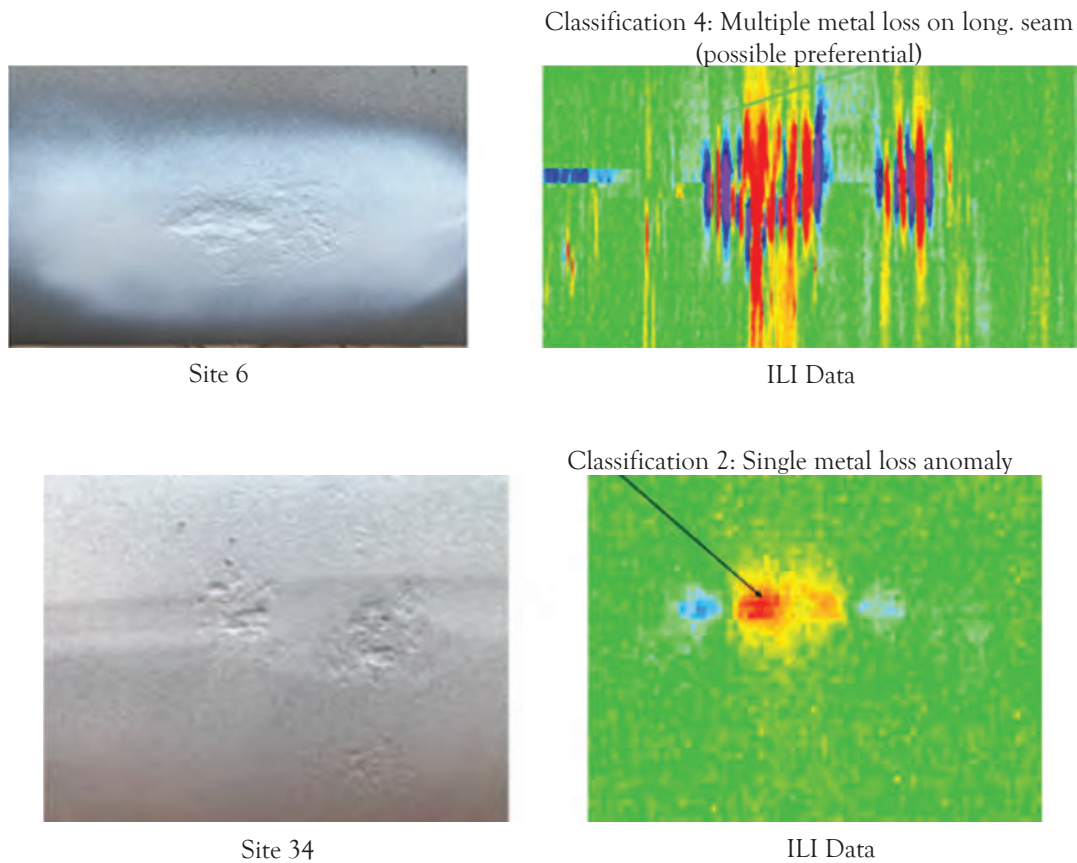
A classification matrix was established to categorise the detected features, see Table 1. The like-and-similar analysis was performed independently by two analysts. Site 6 (approximate 2020 odometer 114.471 m) received a matrix classification of 4 from both analysts. Site 34 (2020 odometer 1157.453 m) received a matrix classification of 2 from both analysts. Features with similar characteristics to Site 6 and Site 34 were further prioritised. A comparison between in-the-ditch findings and ILI data can be seen in Figure 11.

Figure 11. Comparison of the visual appearance and ILI data for Site 6 and Site 34.

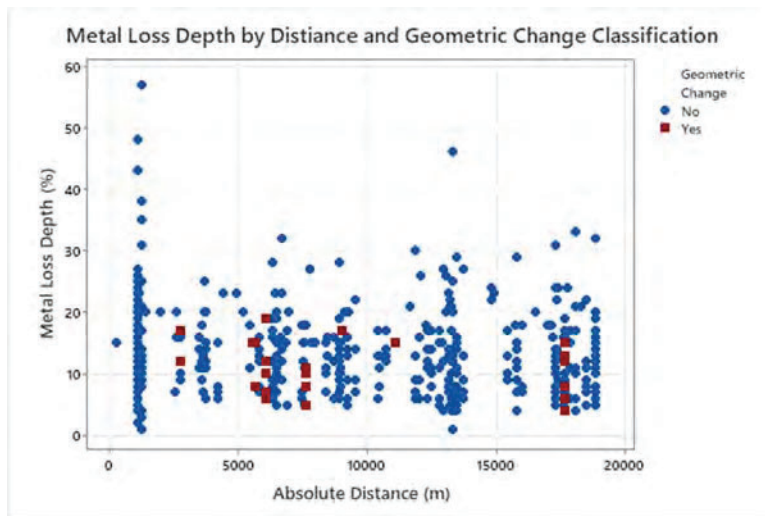
Figure 12. Distribution of metal loss geometric change classification.

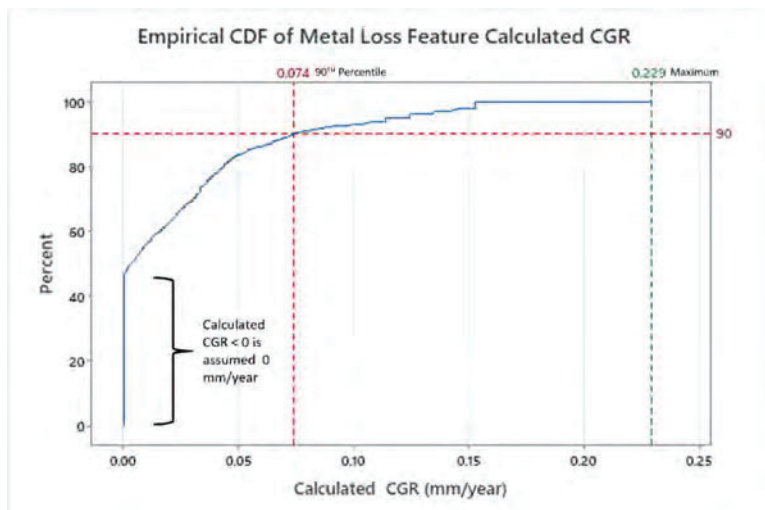
Figure 13. Empirical CDF of calculated metal loss features CGRs.

The highest CGR determined was 0.229 mm/year. Geometric change was identified in the corresponding pipe joint, with metal loss ranging from 4 % to 15 % that was not detected in the 2015 ILI. Approximately 90% of the selected CGRs are less than or equal to 0.074 mm/year, with the average selected CGR being 0.025 mm/year.

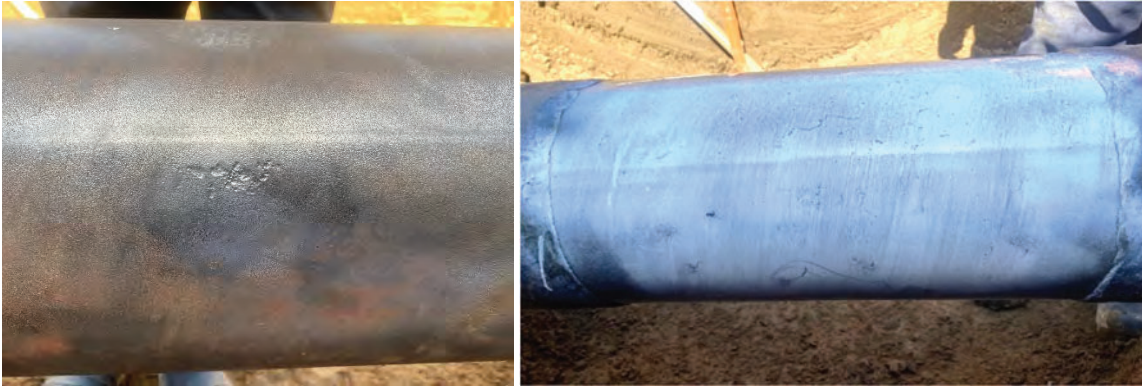
| Absolute Distance (m) | December 2020 ILI Features and Remaining Life Assessment | | | | | Direct Inspection - October 2023 | | |
|---|--|---|---|---|---|---|---|---|
| 8349.816 | 5.56 | 7 | 32 | 0.1449 | 4.9 | 8 | NR | None |

Figure 14. Corrosion feature at 8349.816 m.

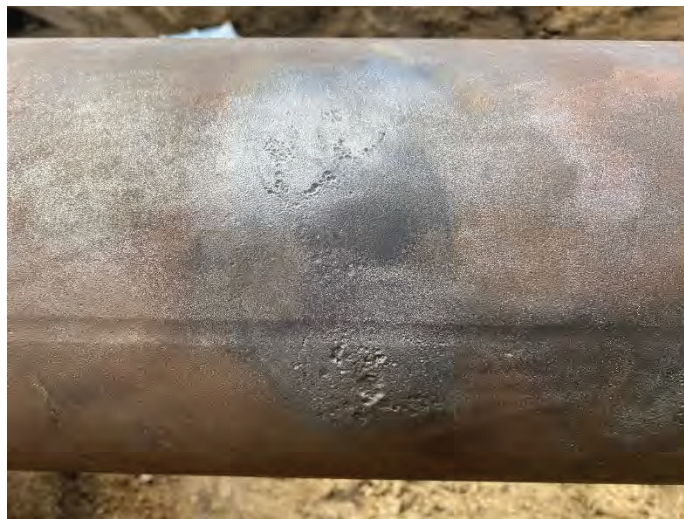
| Absolute Distance (m) | December 2020 ILI Features and Remaining Life Assessment | | | | | Direct Inspection - October 2023 | | |
|---|--|---|---|---|---|---|---|---|
| 9248.145 | 5.56 | 12 | 47 | 0.1049 | 3.9 | 17 | 36 | None |

Figure 15. Corrosion feature at 9248.145 m.

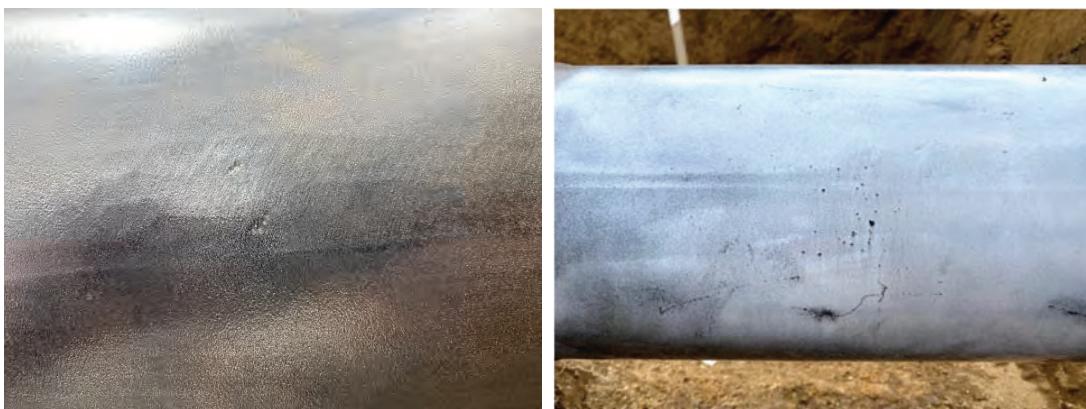
| Absolute Distance (m) | December 2020 ILI Features and Remaining Life Assessment | | | | | Direct Inspection - October 2023 | | |
|---|--|---|---|---|---|---|---|---|
| 15182.347 | 5.56 | 9 | 63 | 0.0931 | 5.5 | 5 | 5 | None |

Figure 16. Corrosion Feature at 15182.347 m. Longer length reported by ILI appears to be due to the corrosion defect being, mostly, ground out during construction.
