# A Case Study of a Natural Gas Pipeline Failure Due to CP-Related Hydrogen-Assisted Cracking

Pablo Cazenave, Ming Gao, Katina Jimenez and Ravi Krishnamurthy  
Blade Energy Partners

## Pipeline Pigging and Integrity Management Conference

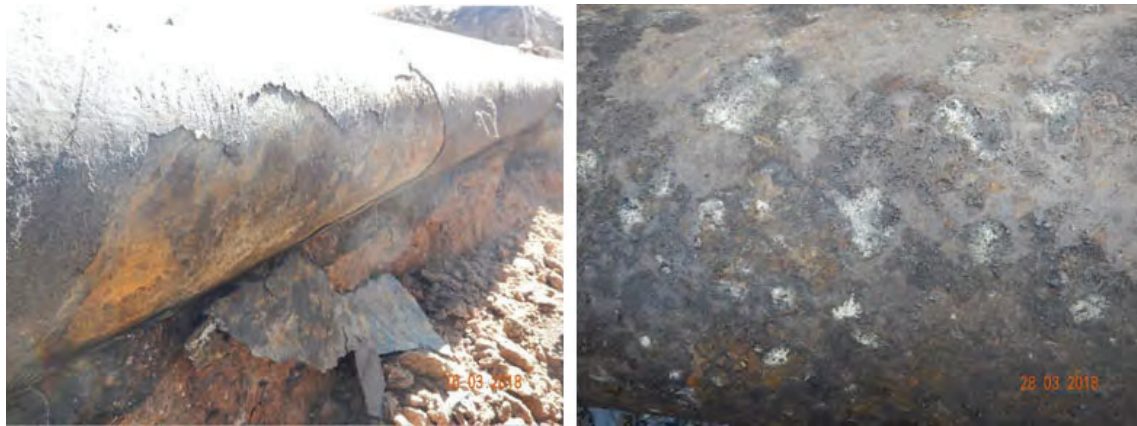
The in-ditch photographic documentation revealed similar coating characteristics across the investigated locations: it is brittle and poorly adhered, there was no significant corrosion, suggesting that it has provided a degree of protection against corrosion, and the interface between the coating and the metallic pipe surface contains contaminants such as soil, whitish, and reddish deposits, see Figure 1.

**Figure 1:** Coating condition and whitish deposits found in excavations

The combined findings from the coating evaluation and in-ditch photographic documentation show that the coating has aged and probably does not cause the shielding of the cathodic protection. The absence of significant corrosion and the whitish residues indicate that the pipe has been cathodically protected against corrosion.

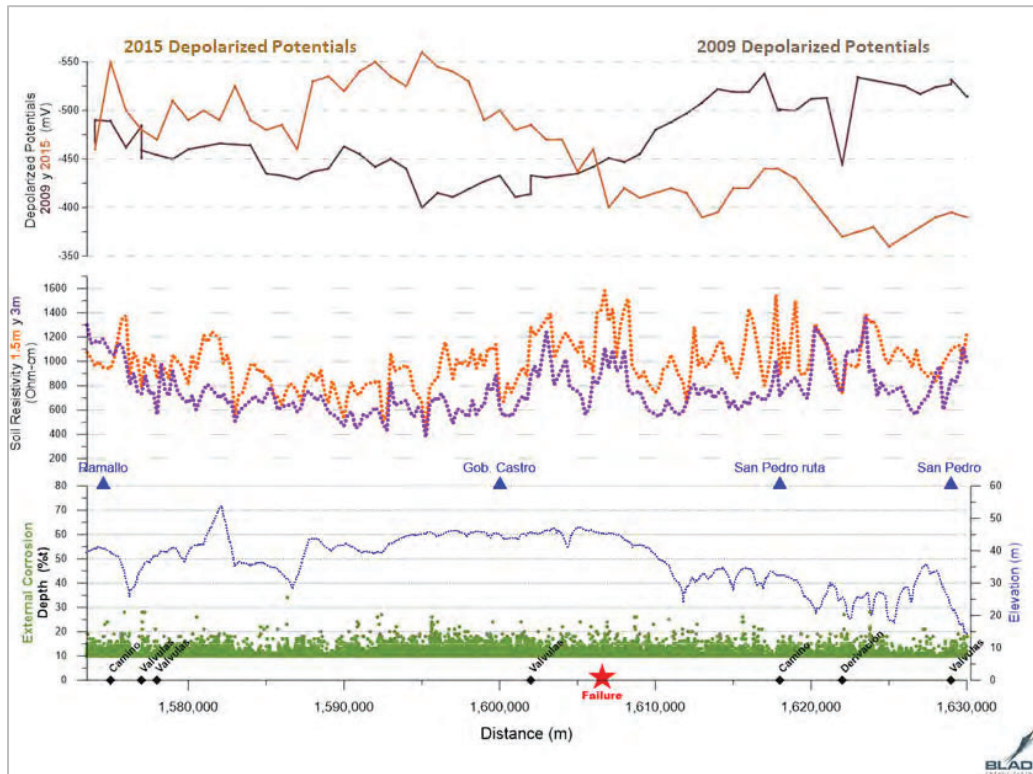
**Figure 2** shows the ON, OFF (IR-free) surveys and depolarized potentials in the section around the rupture carried out in 2009 and 2015. These data are aligned and aggregated with the soil resistivity, elevation, and depth of external corrosion surveyed by the 2013 ILI (MFL). It is observed that the depolarized potentials vary between -550 and -350 mV CSE and that the 2015 depolarized potential records show a change in the most positive direction in the rupture area.

Figure 2: CP potentials in the area of the rupture

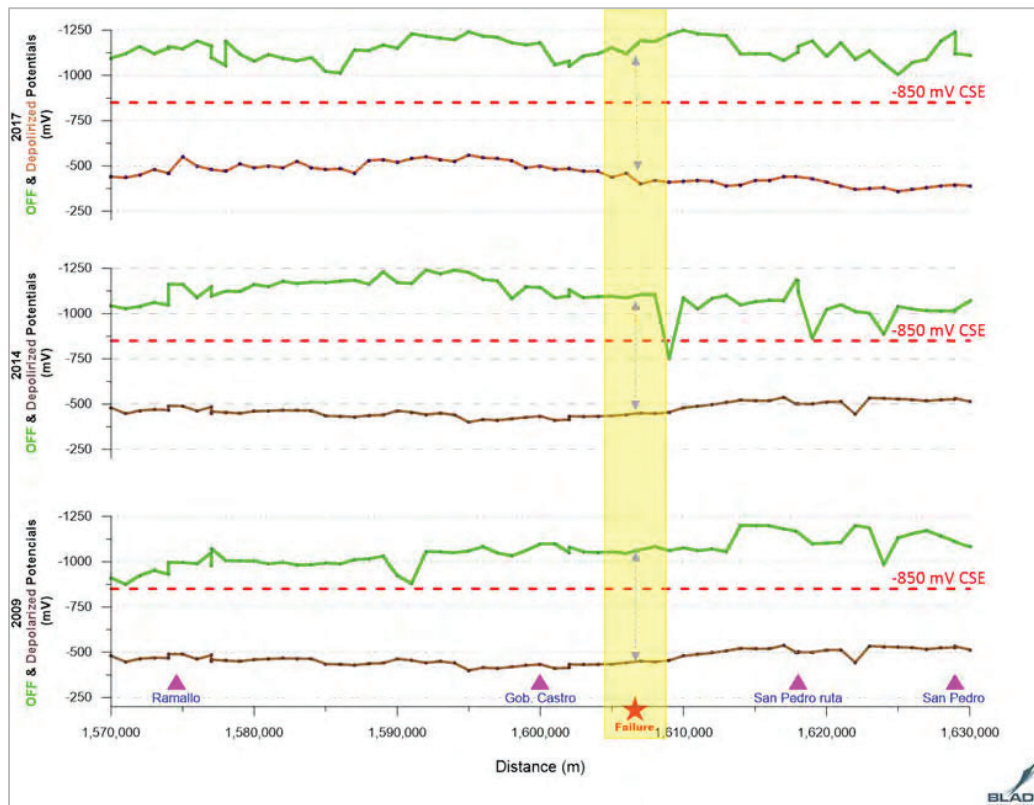
Regarding the cathodic P/S potential levels of the section, they comply with current NACE<sup>2</sup> and ISO<sup>3</sup> practices and recommendations. The OFF pipe-to-soil potentials have been kept very close to the recommended limit of -1200 mV CSE, and the polarization of this pipe section tends to increase over time (see Figure 3). In the zone adjacent to the rupture, when comparing OFF and depolarized potentials, the level of polarization in the area adjacent to the rupture increased.

**Figure 3:** Historic OFF and depolarized potentials near the rupture area

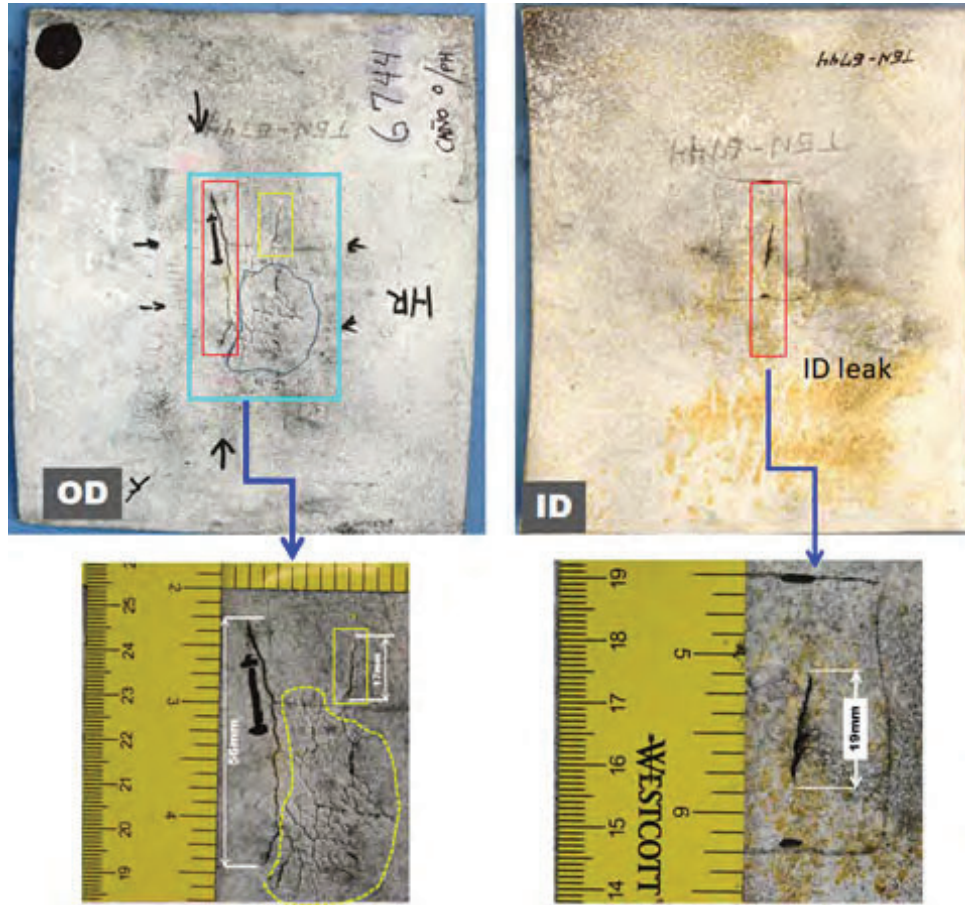
In addition, in the areas where the leaks occurred, none of the cracks are linked to external corrosion. Instead, the panels exhibit a complex pattern of multiple circumferential and spiderweb cracks (see Figure 4), some penetrating through the wall and causing leaks.

**Figure 4:** Example of circumferential and spiderweb cracking in the leaking areas

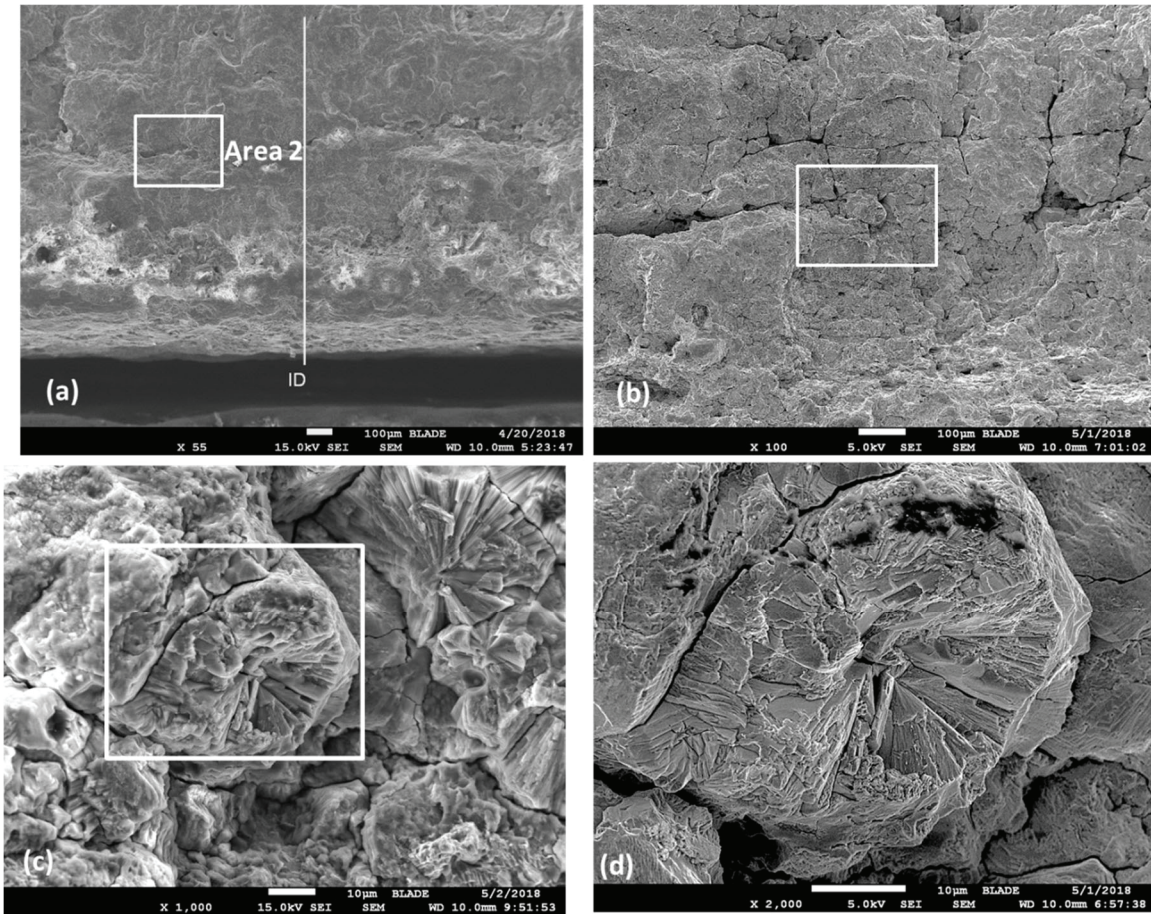
The samples containing the rupture's origin were cleaned to remove the superficial corrosion deposits and scales, and the fracture surface of the origin near the crack tip was then examined. Figure 5 shows the fracture surface morphology of the origin near the crack tip at various magnifications. At higher magnifications, as shown in Figure 5c and d, the appearance of the fracture surface is featured with cleavage facets, typical of cracking produced by hydrogen embrittlement with high hydrogen fugacity.

**Figure 5:** Fracture surface morphology near the crack tip at various magnifications

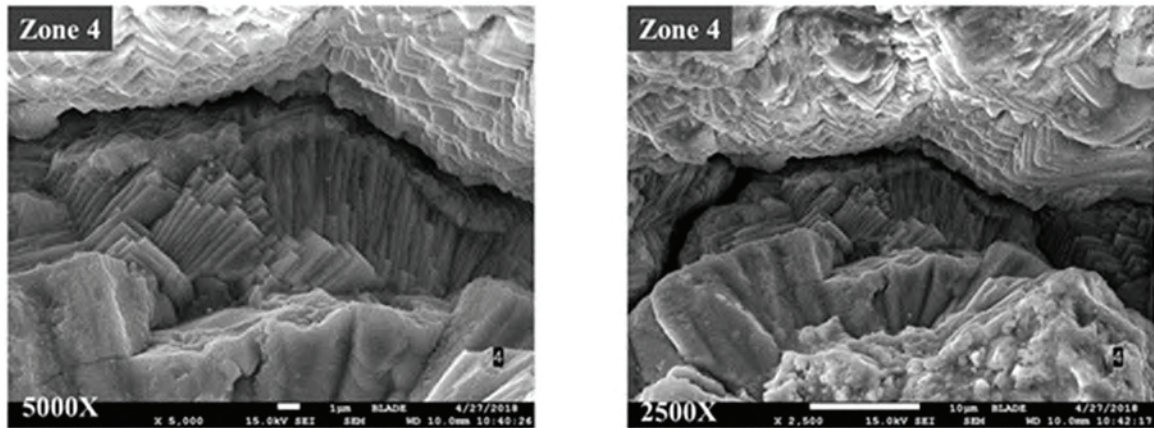
This type of cleavage facets cannot be produced by corrosion; they are also inconsistent with those produced by high pH SCC, near-neutral pH SCC, or fatigue. It is noted that these cleavage facets were generally observed near and along the crack-tip region where the fracture surface was most recently formed with little corrosion under high cathodic potential conditions. Figure 6 shows the cleavage facets observed along the crack region.

Figure 6: Cleavage facets along the crack tip region – 2500X and 5000X

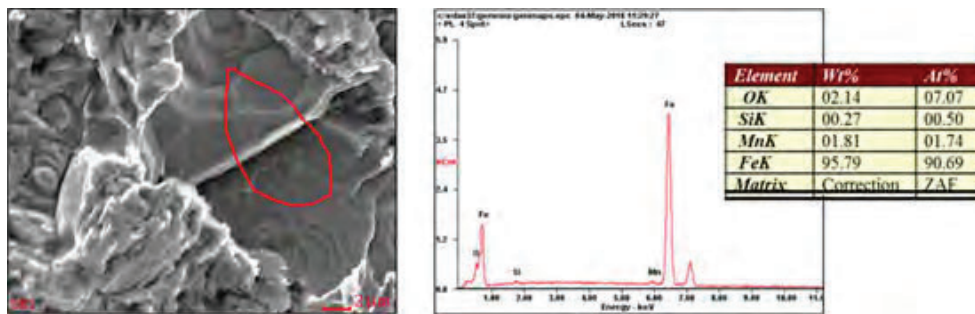
Further EDS analysis of the cleavage facets shows the facets free of oxide scale, as demonstrated by a high peak of iron and very low oxygen peak, and with some minor Mn and Si peaks that are part of the composition of X52. Similar EDS results are obtained from other cleavage facets, commonly showing higher iron (Fe) and nil oxygen (O) peaks. The findings confirm that the newly formed fracture surfaces have minor corrosion, as shown in Figure 7.

Figure 7: EDS spectrums

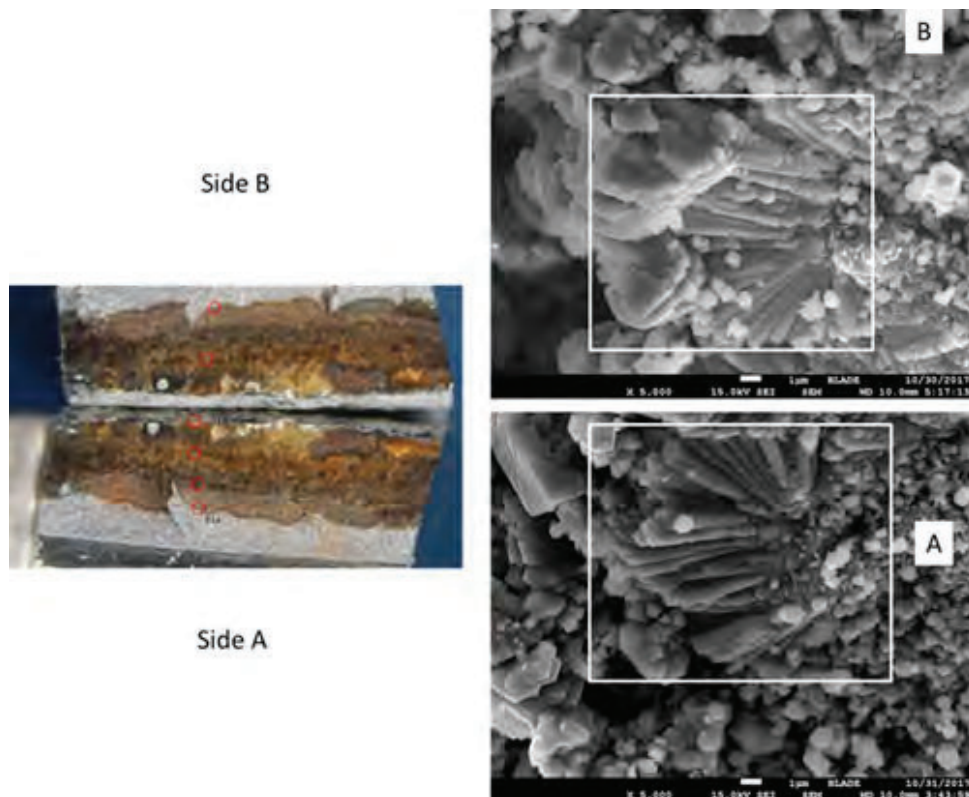
Similar Cleavage Facets were observed in a refined products pipeline system studied<sup>8</sup> by the authors in North America. Figure 8 shows the mirrored cleavage facets on the mated surfaces of circumferential cracks in the referred pipeline. As corrosion cannot produce mirrored cleavage facets because it is an independent event on each side of the fracture surface, these cleavage facets can only be made by hydrogen cracking<sup>9,10,11</sup>.

**Figure 8:** Mirrored cleavage facets of mated surfaces - Hydrogen-induced cracking observed in a pipeline in the USA

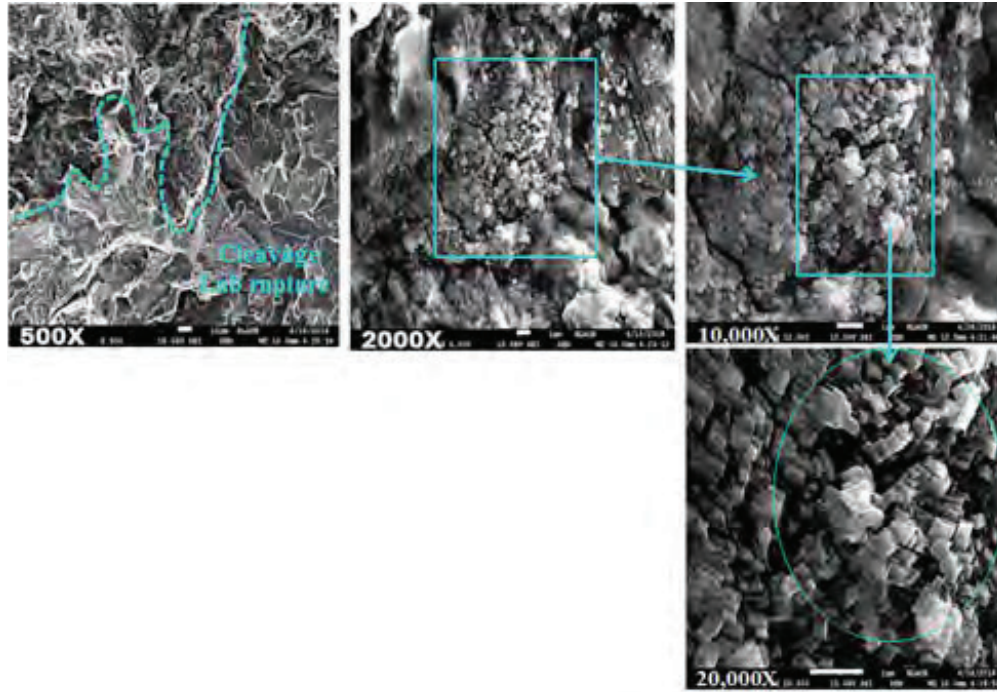
Cracks in the colonies near the rupture origin were also broken open and examined in SEM for fractography. Figure 9 below shows the fracture morphology at the tip. The view at higher magnifications of the areas outlined with blue boxes reveals the presence of microcrystals.

Figure 9: Morphology micro-crystals on the fracture surfaces at 500X, 2000X, 10000X and 20000X

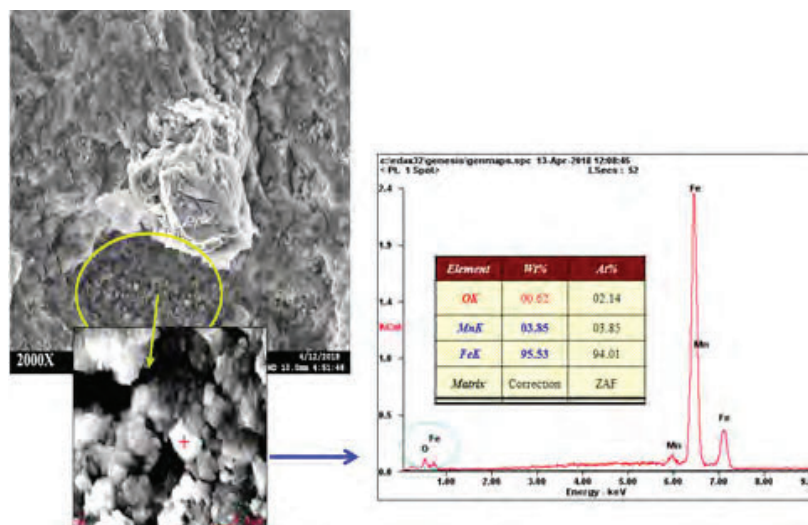
The EDS spectrum of the microcrystals in Figure 10, in a location close to the crack-tip, shows a large iron (Fe) peak and a small oxygen (O) peak, suggesting the microcrystals are ferrite without oxide scales. This type of microcrystal of ferrite was also observed in the previously mentioned study of cracking in the pipeline in the US. The EDS analysis performed during that investigation showed that these micro-crystals were pure ferrite crystals, consistent with the present study.

Figure 10: SEM/EDS analyses for a location close to crack-tip

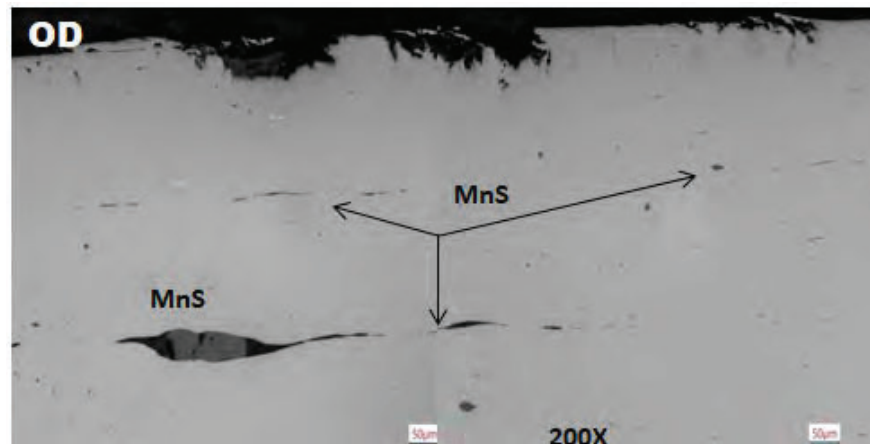
The accumulation of hydrogen molecules in those trapping sites that resulted in the interface cracking is well documented in the literature<sup>12,13,14</sup>, and Figure 11 and Figure 12 show the respective optical microscope examination of polished and etched cross-sections of a sample close to the ruptured area, showing microcracks that are associated to manganese sulfide (MnS) inclusions.

Figure 11: Microcracks associated with inclusions near the ruptured crack

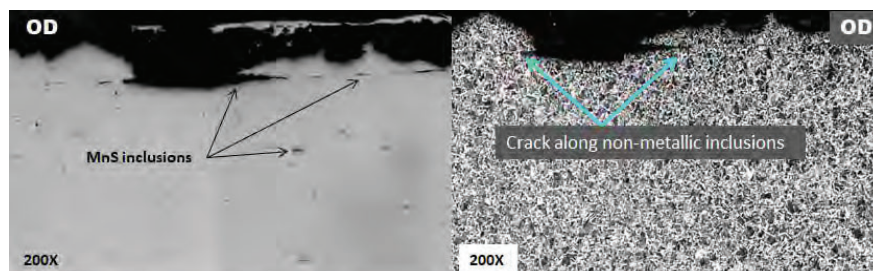
Figure 12: Etched longitudinal cross-section of base metal

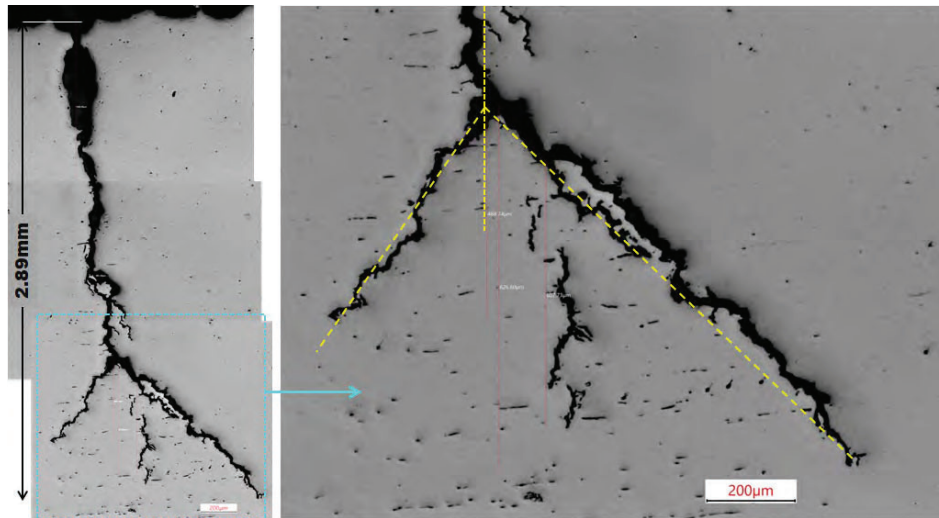
Furthermore, Figure 13 and Figure 14 show details of the evaluation with an optical microscope of a polished cross-section adjacent to the main crack, where numerous microcracks associated with the inclusions of MnS are observed.

The figures show optical micrographs of the polished cross-section of axial cracks, where branching features are visible along the main crack path. Multiple crack ramifications and micro-cracks associated with the close inclusions are observed at increasing magnification, consistent with the hydrogen-induced cracking mechanism.

Figure 13: High concentration of microcracks in inclusions near the ruptured crack

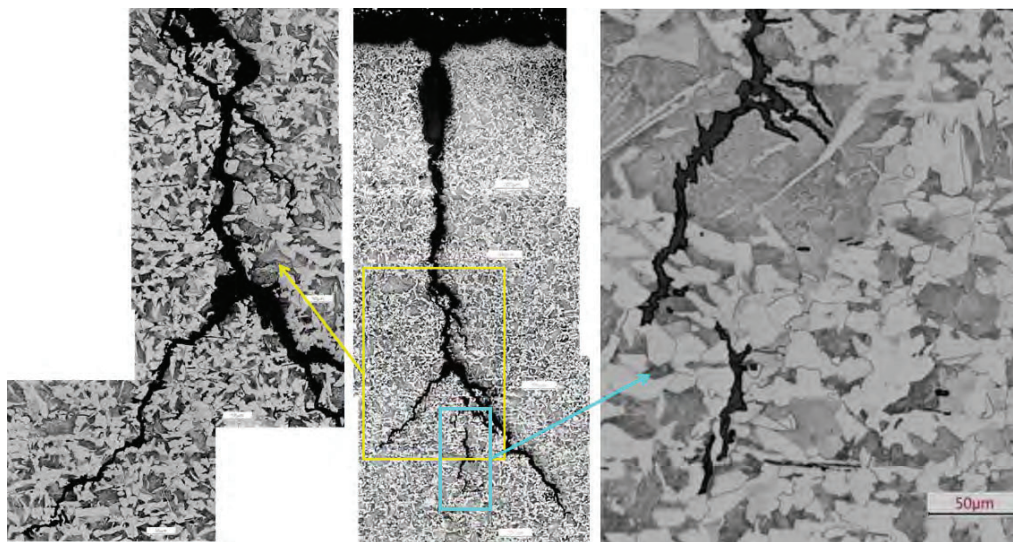
Figure 14: Details of the cracks (etched)
