Leveraging Destructive Testing to Enhance Detection and Identification of Complex Cracking in LF-ERW; Case Study Phase II

Christopher Newton¹, Jordi Aymerich², Sayan Pipatpan², Tannia Haro²,
Santiago Urrea², Alex Hensley²,
¹Phillips 66 LLC, ²NDT Global

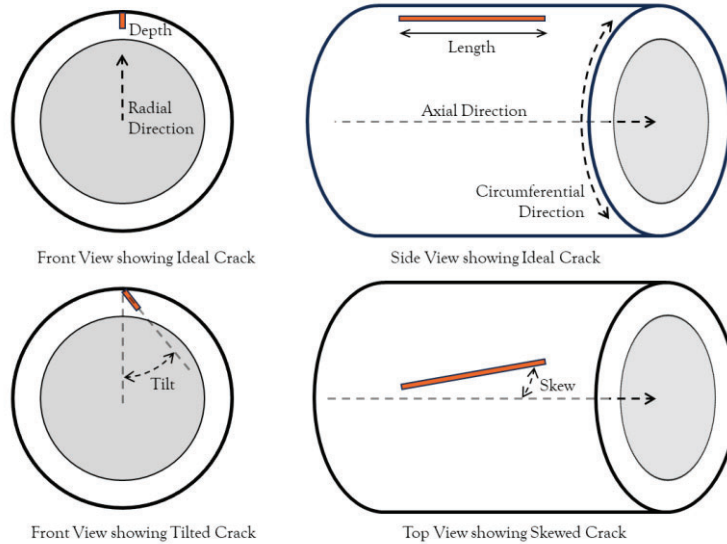
Figure 1. Crack definitions and terms. Schematic of tilted and skewed ideal cracks.

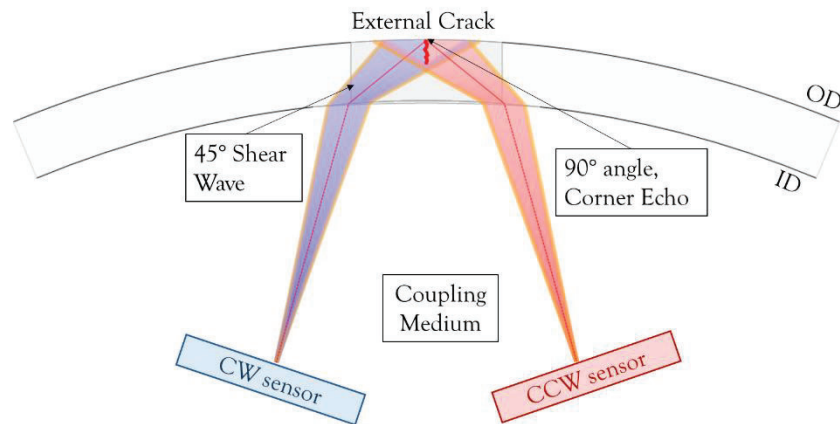
Figure 2. Schematic at scale of clockwise and counterclockwise UT sensors interacting with an ideal crack. Wall thickness equals to 0.188". Sensor diameter equals to 0.590".

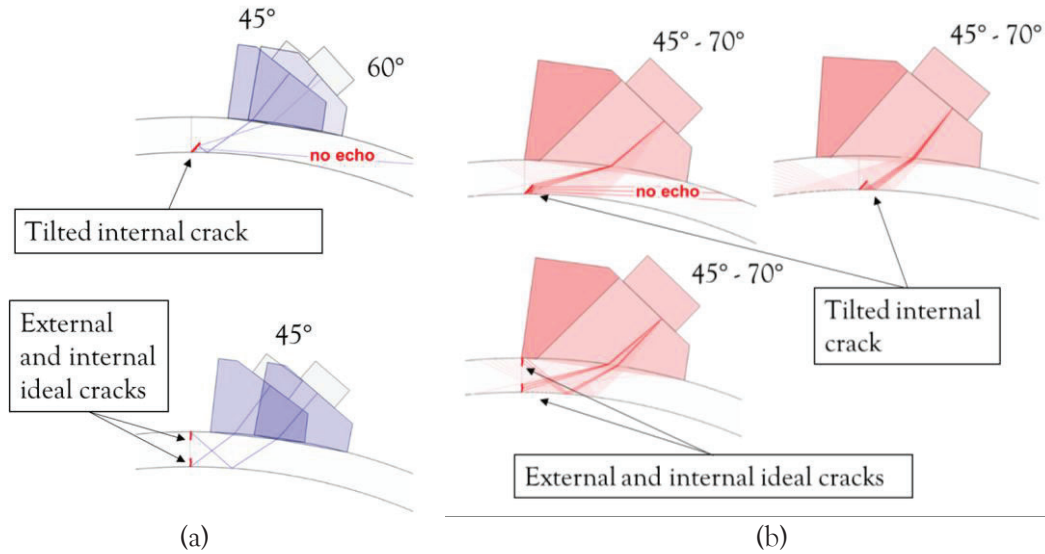
Figure 3. Sound paths for UT (a) and PAUT (b) for tilted cracks (top) and radial, surface-connected cracks (bottom).

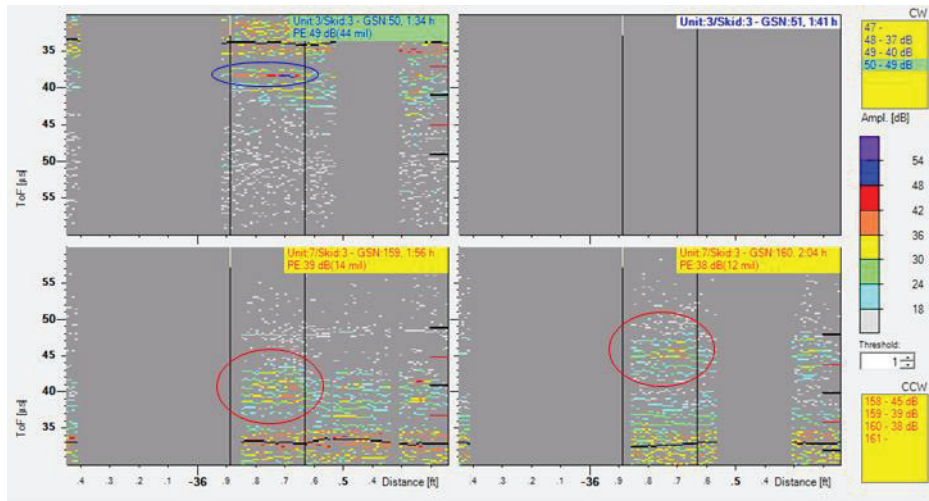
Figure 4. B-Scan data for a verified hook crack following the first signal pattern identified. Upper scans correspond to CW sensors and bottom scans to CCW sensors.

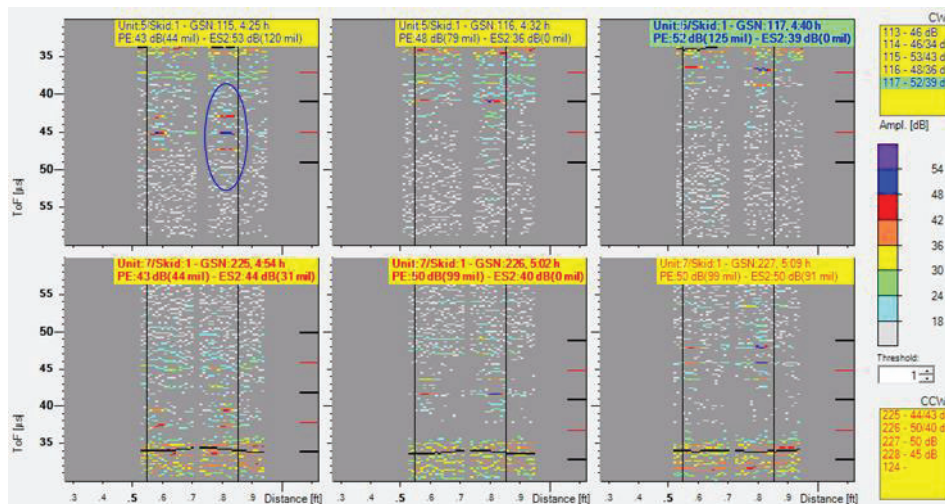
Figure 5. B-Scan data for a verified hook crack following the second signal pattern identified. Upper scans correspond to CW sensors and bottom scans to CCW sensors.

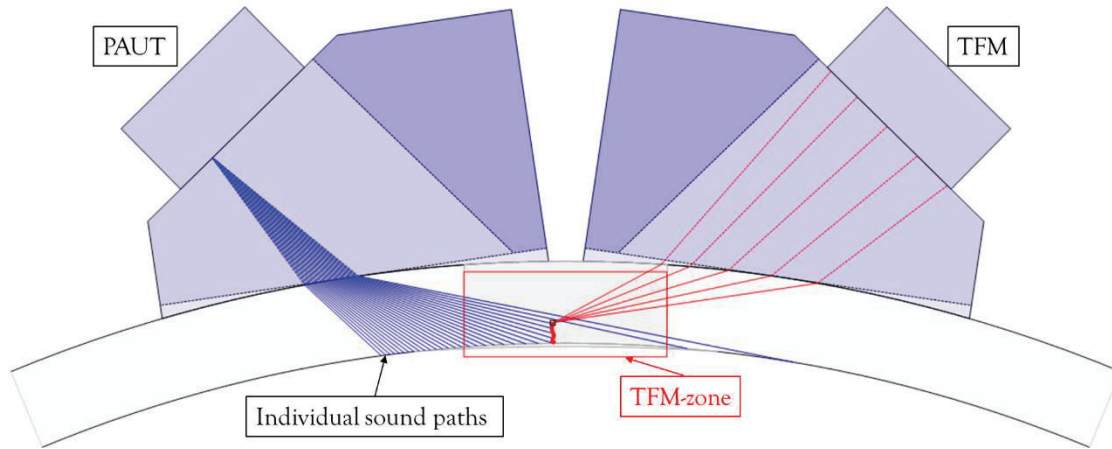
Figure 6. Scheme of PAUT and TFM techniques.

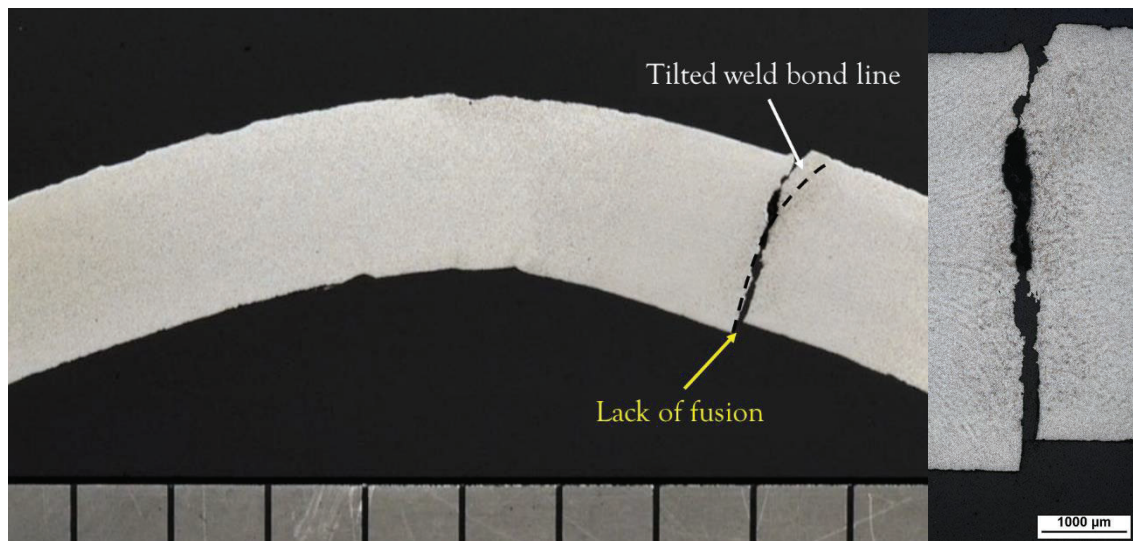
Figure 7. Full-thickness macro and micro photograph of the transverse metallographic for one of the destructive tested anomalies identified as LOF. Scale divisions are 1/10 inch.

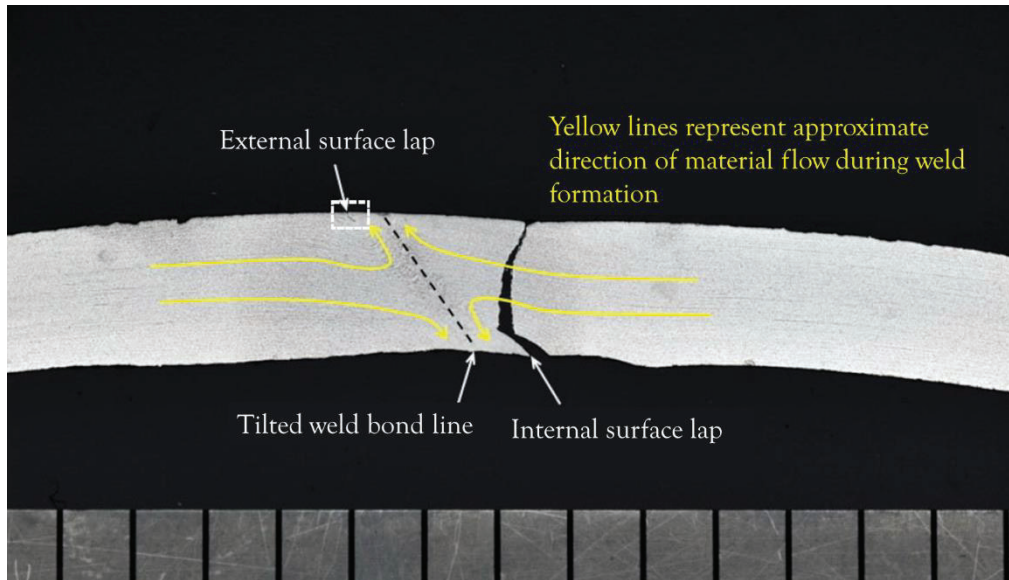
Figure 8. Macro photograph of the transverse metallographic for an anomaly identified as surface lap. Scale divisions are 1/10 inch.

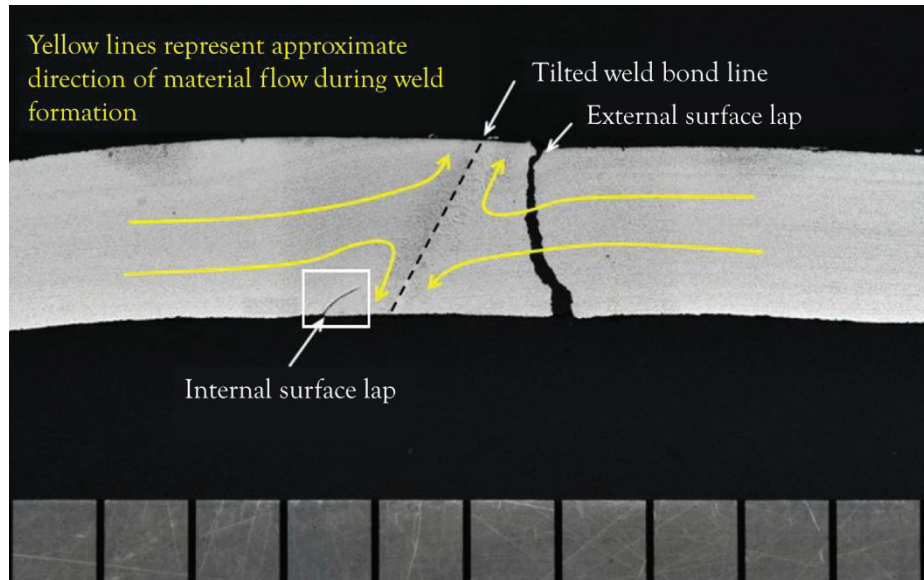
Figure 9. Macro photograph of the transverse metallographic for an anomaly identified as surface lap. Scale divisions are 1/10 inch.

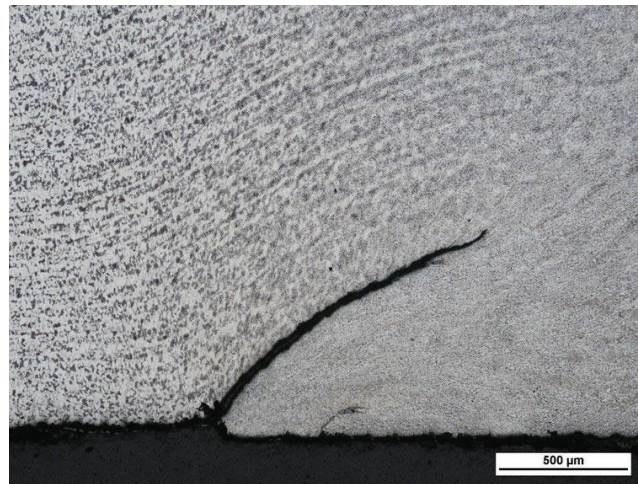
Figure 10. Detail of an internal surface lap

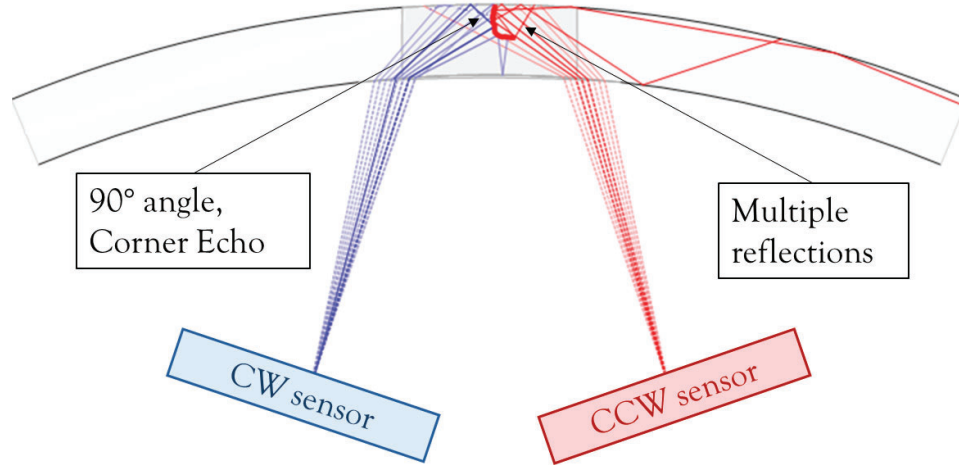
Figure 11. Scheme at scale of a 'hook crack' detected by clockwise and counterclockwise sensors. Colour lines simulate the sound beam, and the stronger ones indicate reflections from the flaw back to the sensors.

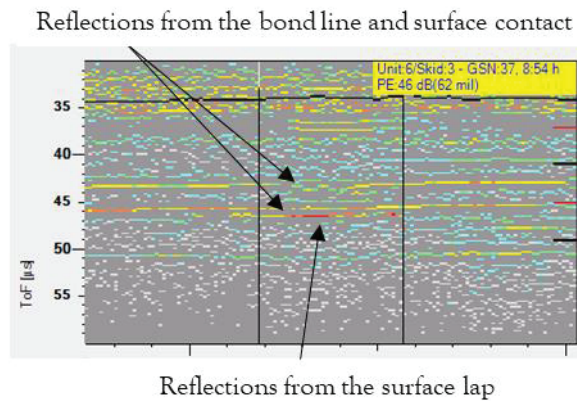
Figure 12. B-Scan ILI data for a CW sensor for a verified internal surface lap.

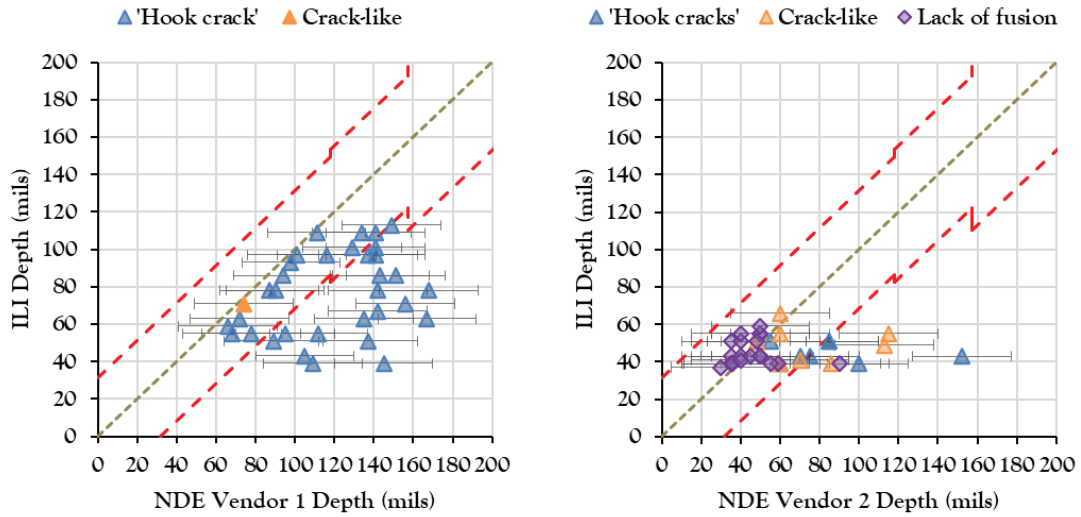
Figure 13. Unity plot for NDE Vendor 1 (left) and Vendor 2 (right) results compared to ILI results.

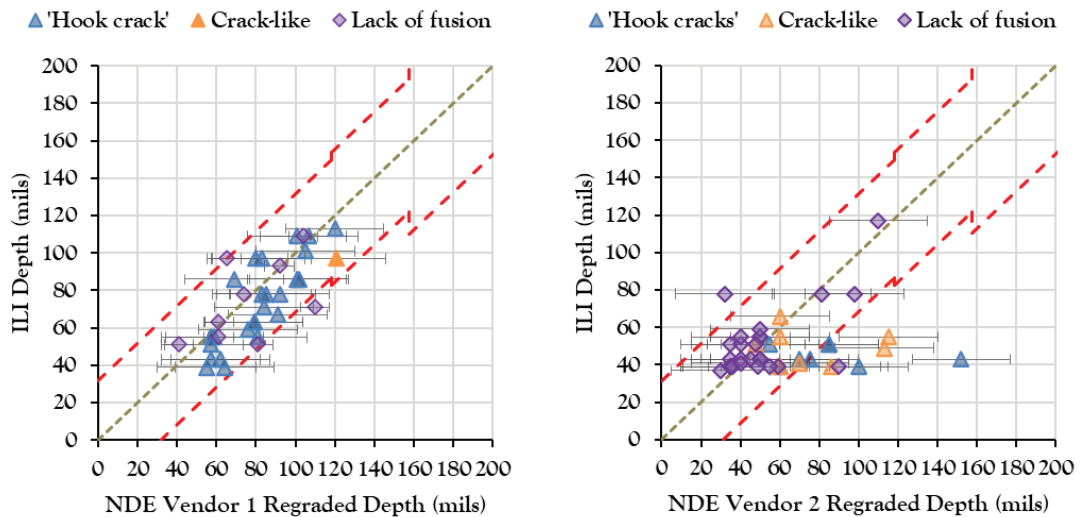
Figure 14. Unity plot for NDE Vendor 1 (left) and Vendor 2 (right) regraded results compared to ILI results.

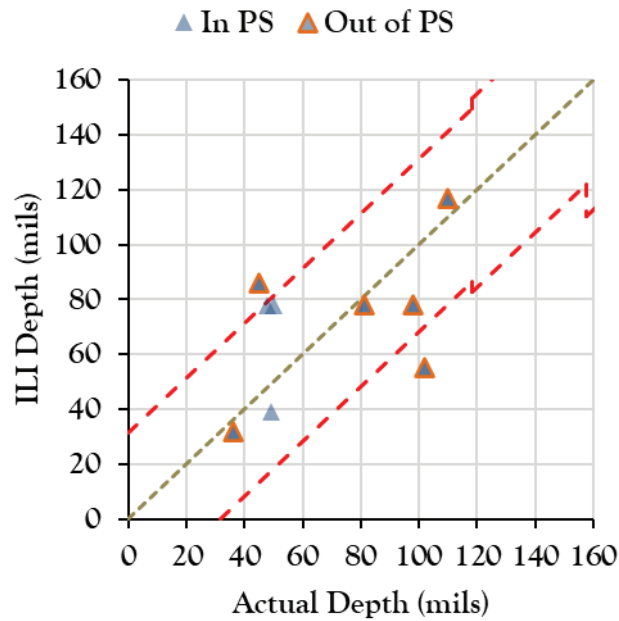
Figure 15. Unity plot for laboratory results compared to ILI results.

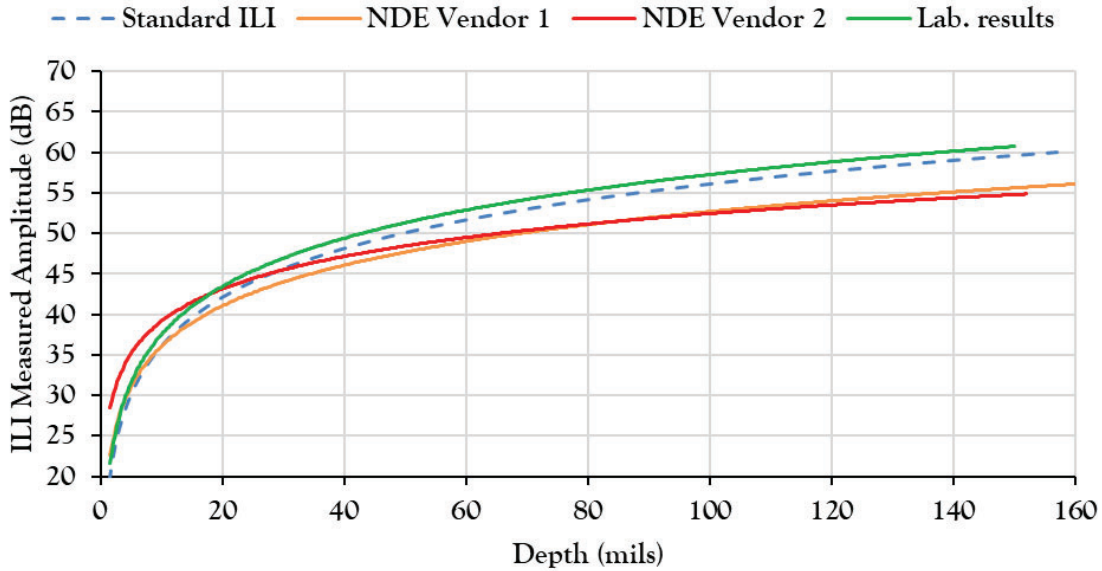
Figure 16. Different sizing curves based on the NDE results from Vendor 1 and 2, and the measured amplitudes for the ILI anomalies.
