# Crack Detection

Selective Seam Weld Corrosion and Narrow Axial Cracking

**ADVANCED INSPECTION SYSTEMS**

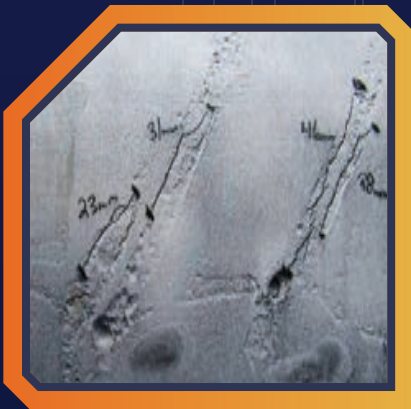
**SCC**  
(Stress Corrosion Cracking)

**Comes in 3 variations:**

- Circumferential Cracking
  - Axial Cracking
- Off-Axis Cracking

**EXTERNAL STRESS CORROSION CRACKING, IS CAUSED BY A COMBINATION OF FACTORS THAT INCLUDE, FAILED PIPE COATING, A CORROSIVE ENVIRONMENT AND STRESS (EITHER RESIDUAL OR APPLIED). THE PIPE-MATERIAL CAN ALSO INCREASE THE SUSCEPTIBILITY TO SCC.**

SCC, is a form of environment-assisted cracking. It is typically characterized by, appearing as small cracks that are individual from one another, abutting in an array or colony, on the external surface of the pipe. Overtime, these individual cracks may coalesce, forming one larger crack that can lead to pipeline leakage, or even failure.

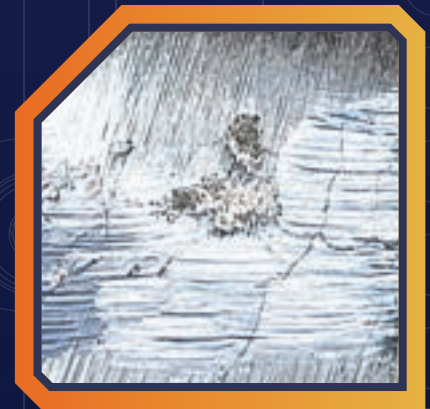
**Cracking In External Gouging**

**Comes in 3 variations:**

- Circumferential Cracking
  - Axial Cracking
- Off-Axis Cracking

- Detected And Sized Using Both Micron AMFL-MC<sup>SM</sup> & CMFL-LDF<sup>SM</sup> Technology

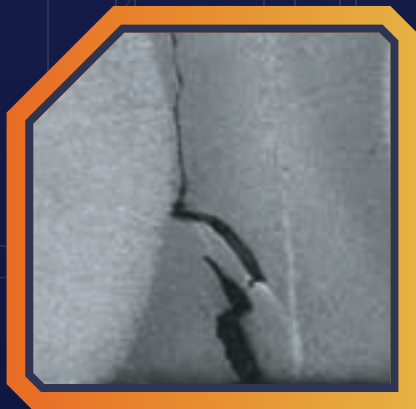
## Seam Flaws

### ERW & Flash Seam Weld Flaws:

- Misalignment of Long Seam Edges
- Under/Over Trim Identification
  - Hook Cracks
  - Lack of Fusion

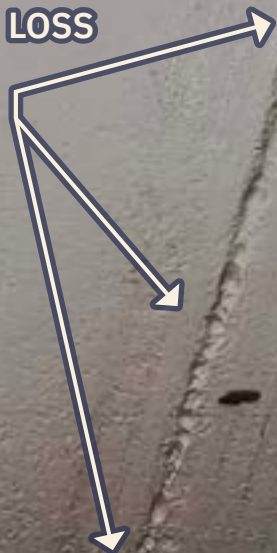
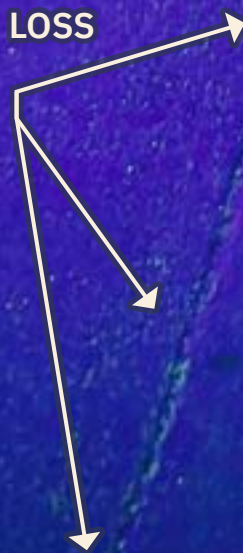
# OFF-AXIS SCC IN SPIRAL METAL LOSS

OFF-AXIS SCC IN  
SPIRAL METAL LOSS

SPIRAL  
METAL  
LOSS

Fluorescent MPI Crack  
Inspection was performed

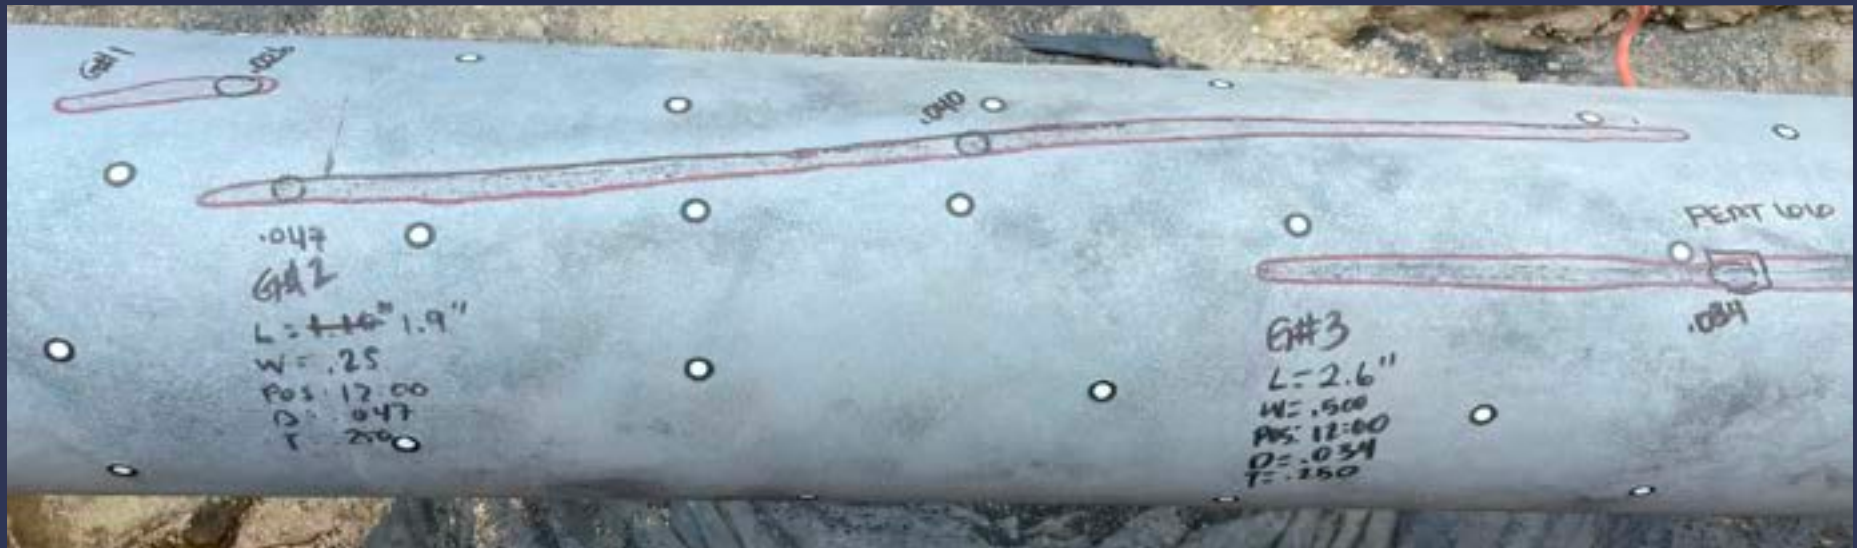
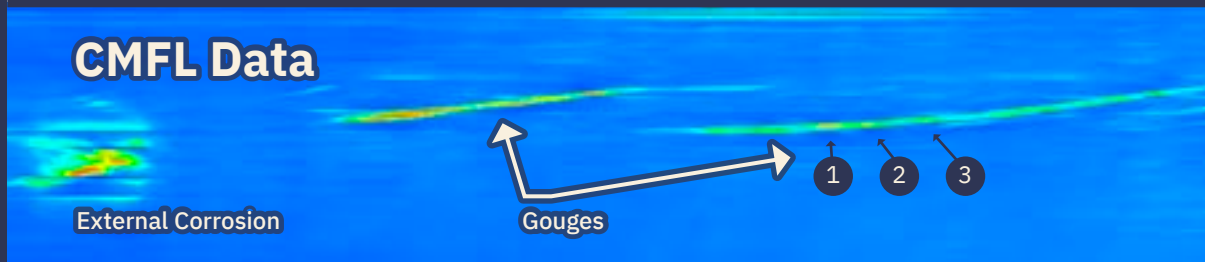
# CRACKING IN GOUGES

## Three Cracks

1, 2, 3 in Gouge Location

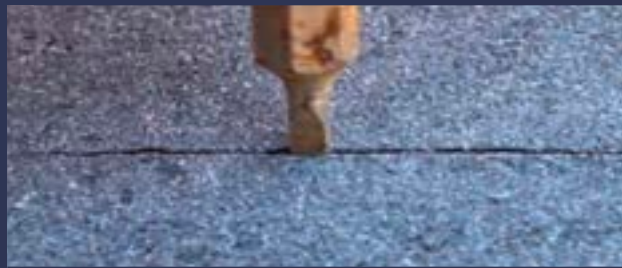
Item A

FLAWS IN THE ERW SEAM

Depth 42%, Length 1.47"

16" Diameter, WT 0.312"

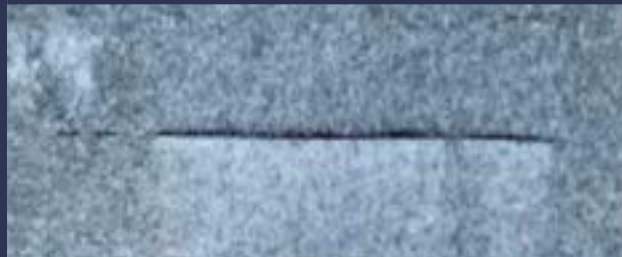
Item B

FLAWS IN THE ERW SEAM

Depth 30%, Length 1.08"

16" Diameter, WT 0.312"

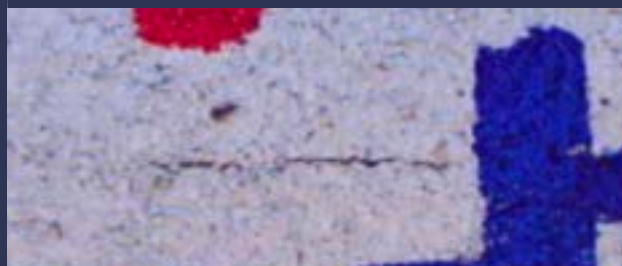
Item C

FLAWS IN THE ERW SEAM

Depth 32%, Length 1.05"

16" Diameter, WT 0.250"

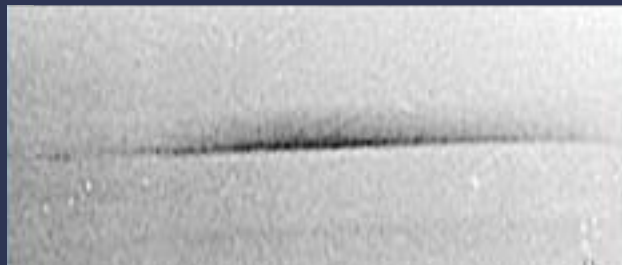
## ERW SEAM FLAW

**CMFL B-Scan  
Showing Detection  
with Six Sensors**

**ERW Hook Crack ID**  
Connected Depth: 38%  
Length: 2.2" (56mm)
