Longitudinal Insonification

Circumferential Insonification

SONOTRON NDT

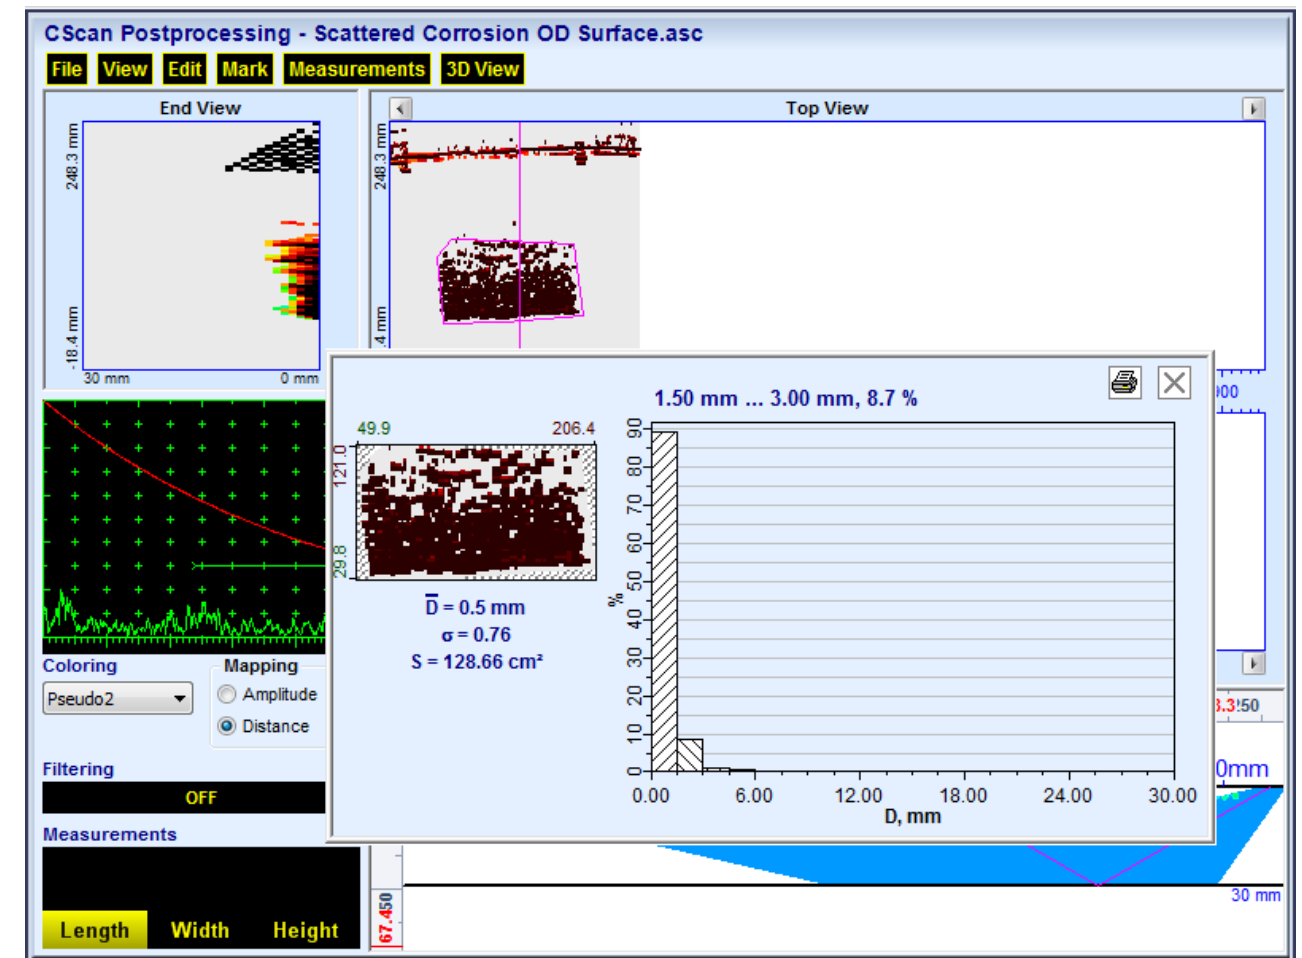
Typical C-Scan indication obtained through manipulating PA probe circumferentially: 30 mm WT riser – scattered corrosion on the OD surface under stiffener ring

At every position along the C-Scan the cross sectional data captured during the scanning may be stored into a separate file and evaluated as it is shown above

The integrated degree of corrosion damage of the selected area may be evaluated statistically using *POLYGON* function applied to distance C-Scan (Top View)

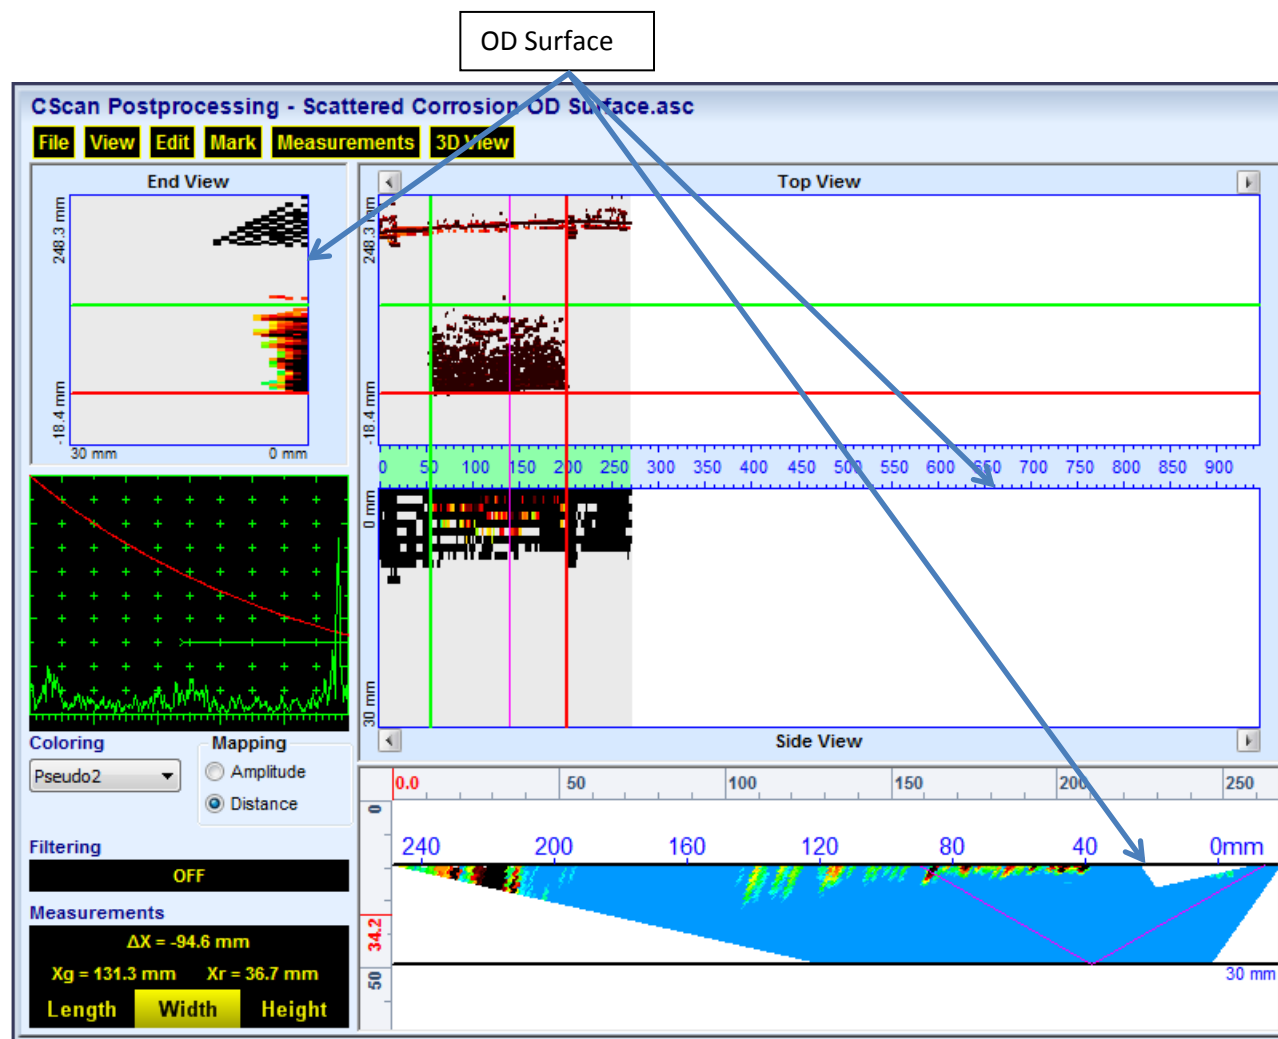
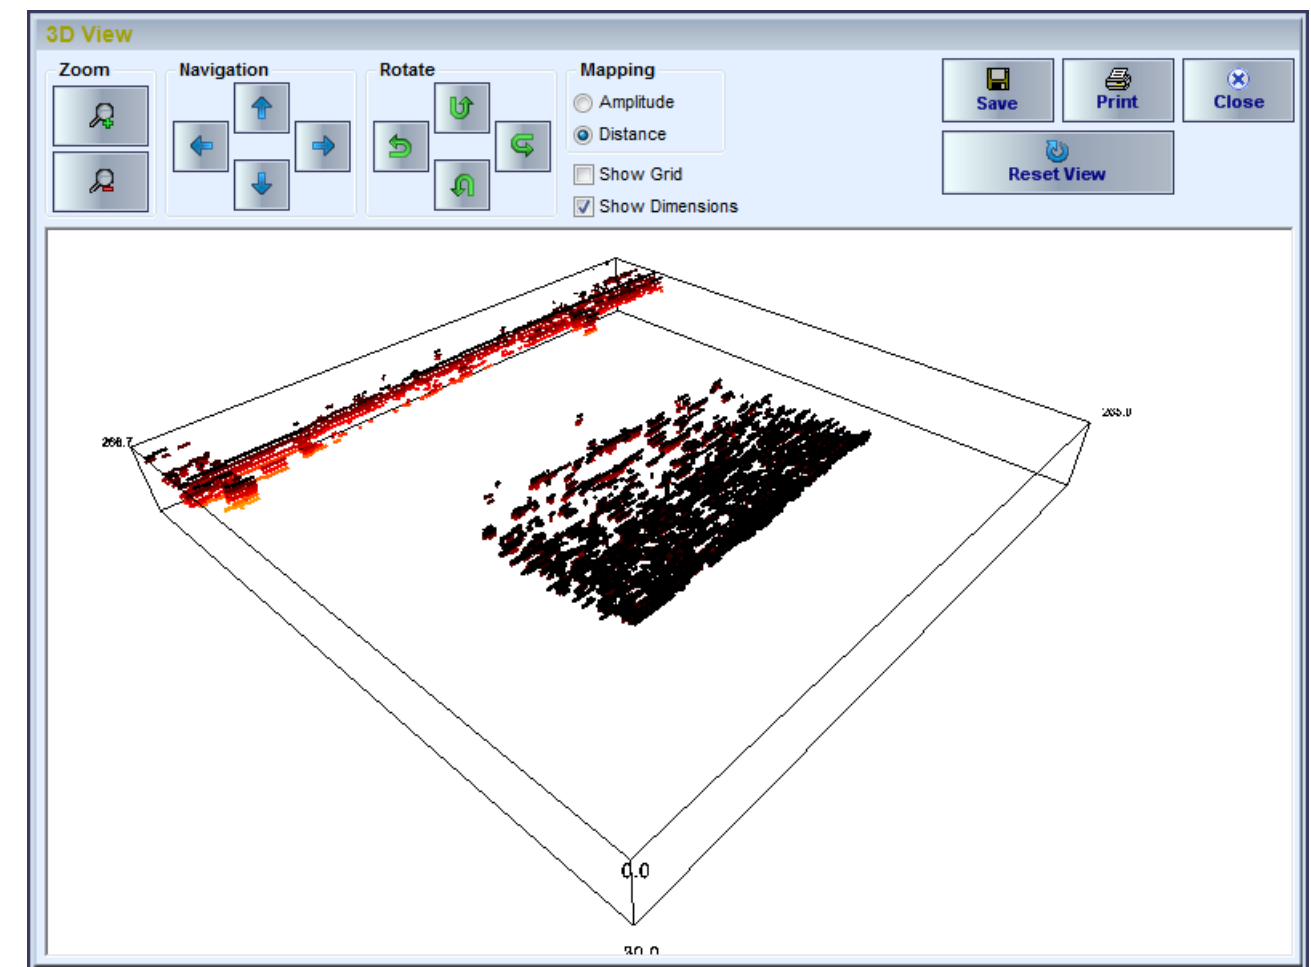
Typical C-Scan indication obtained through manipulating PA probe circumferentially: 30 mm WT riser – scattered corrosion on the OD surface under stiffener ring

The length and width of the damage area may be evaluated through boxing with the appropriate cursors

3D-presentation provides better understanding for the non-UT personnel

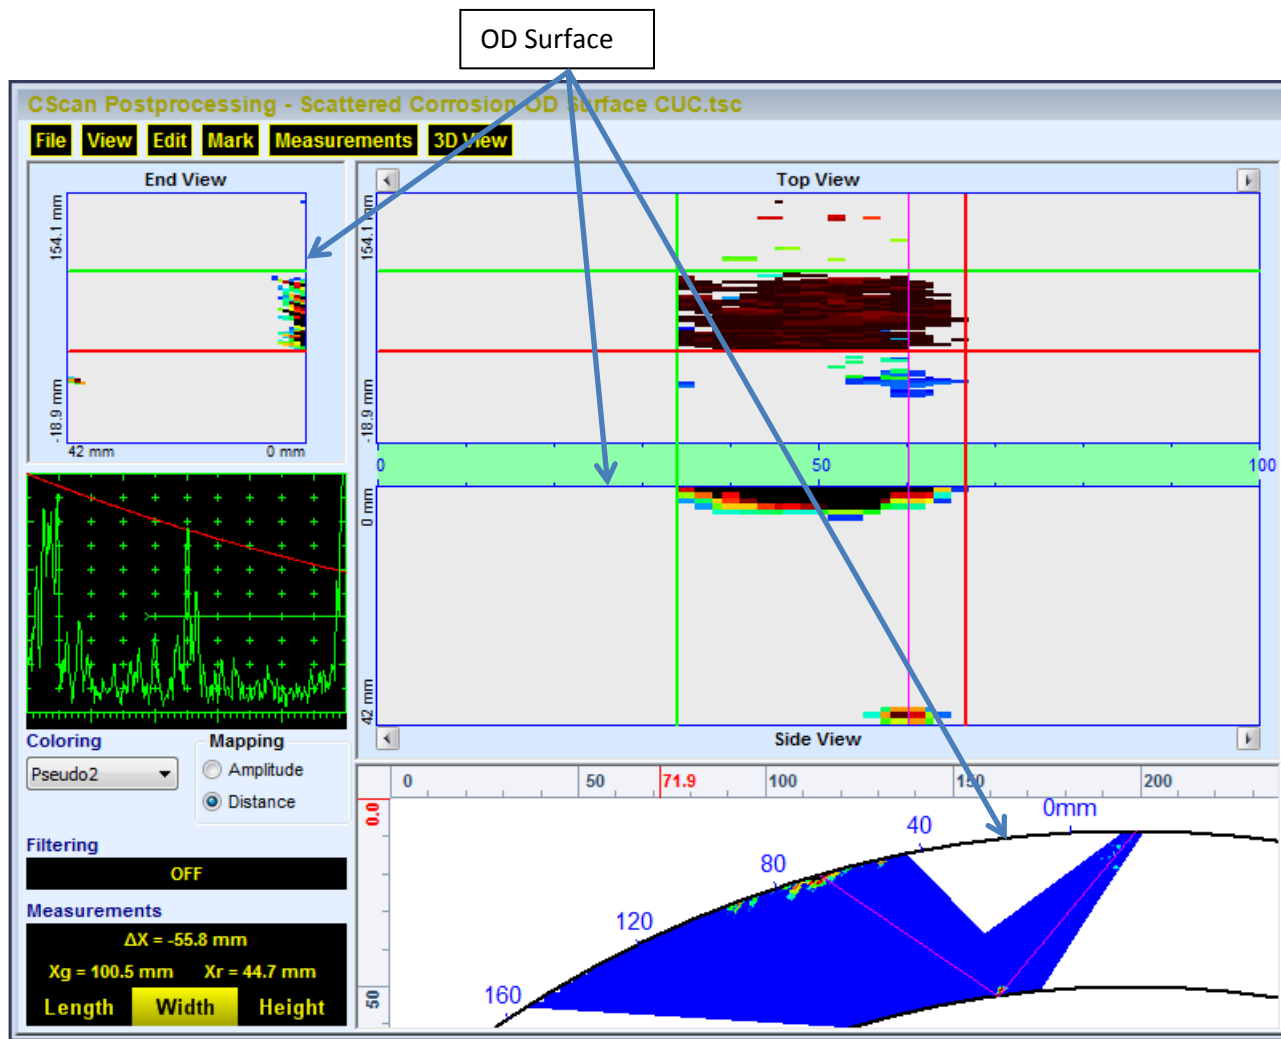
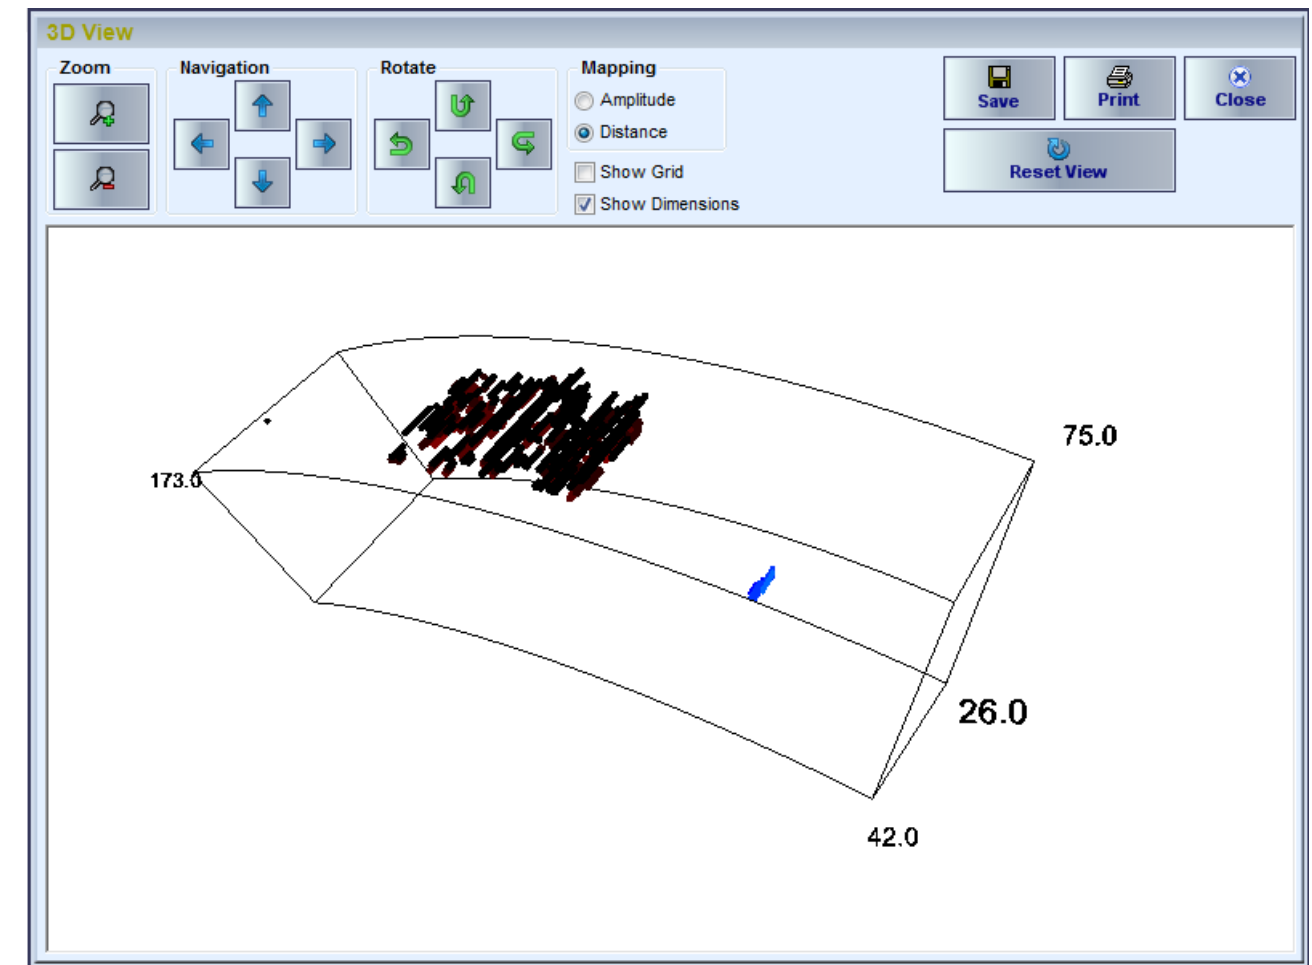
Typical C-Scan indication obtained through manipulating PA probe along the pipe: 42 mm WT pipe – scattered corrosion on the OD surface above the support

The length and width of the damage area may be evaluated through boxing with the appropriate cursors

3D-presentaton provides better understanding for the non-UT personnel
