# SETTING NEW STANDARDS FOR PINHOLE METAL LOSS DETECTION.

CASE STUDY: MFL PINHOLE DETECTION

## ENTEGRA® CHARACTERIZES A RANGE OF PINHOLE AND OTHER ANOMALIES FOR GERMAN OPERATOR.

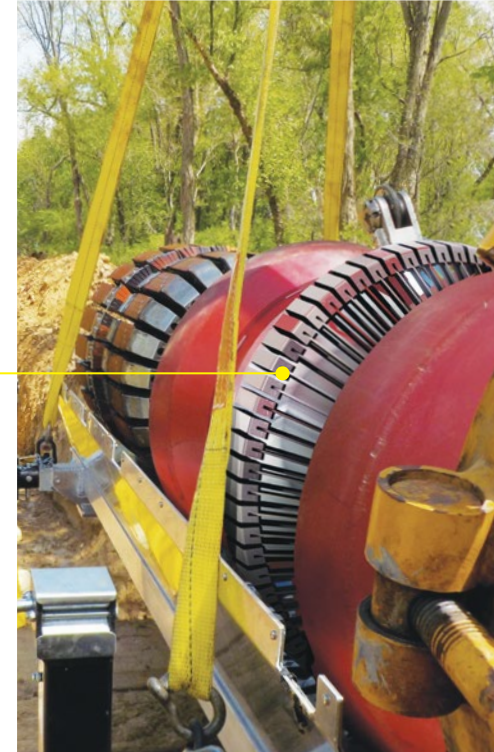
UHR MFL/CAL/IMU Tool

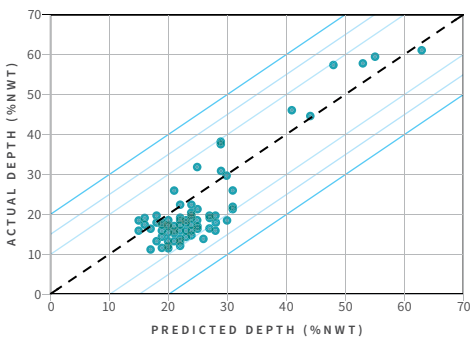
UNITY GRAPHS: Internal Pinhole Defect on 6" DNS150 Pipe Cut-outs

Extensive pull testing on a series of machined defects confirms ENTEGRA's ability to detect and characterize a pinhole metal loss feature as small as 3mm x 3mm. This was substantiated with field correlation which compared hundreds of internal and external pinhole anomalies with actual field observations. This field correlation testing is considered to be the most reliable and stringent in the industry based on API 1163 qualification standards.

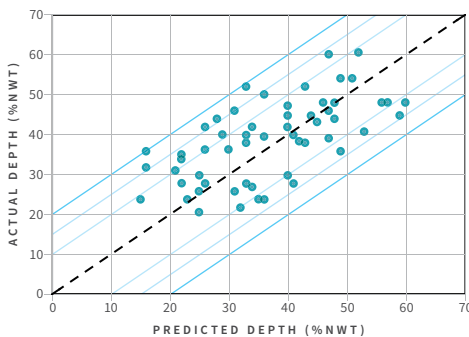
Internal Pinhole Defect on 16" DNS400 Pipe Cut-outs
