CORROSION PROTECTION | CMI METHOD

# EVALUATION OF THE CORROSION PROTECTION OF BURIED PIPELINES: THE USE OF CURRENT MAGNETOMETRY INSPECTION (CMI)

Mark Glinka, Dr. Markus Büchler, Dominique Luisier and Florian Linder

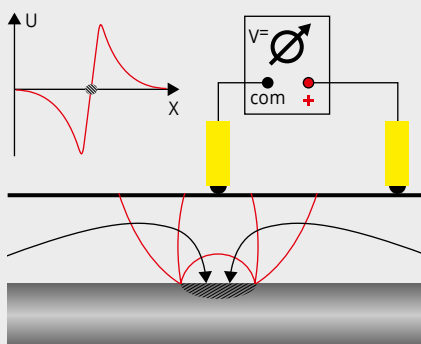
**Figure 1:** Schematic measuring principle of DCVG, where the CP rectifier is used as the current source.

The schematic measurement setup is shown in **Figure 1**. These voltage gradient-based methods have significant drawbacks. The most important is that an electrolytic contact of the electrodes to the soil is required. Additionally, other buried metallic structures as earthing systems or other pipelines influence the measured voltage gradient, leading to erroneous results. In a typical urban environment with asphalt surfaces and a significant number of buried metallic structures, conducting these measurements based on voltage gradients and interpreting the data is challenging. Furthermore, increasingly dry conditions make voltage gradient measurements difficult or even impossible. The need for electrolyte contact is overcome by the method of Current Attenuation Measurement (CAM). This method is based on measuring the electromagnetic field generated by the AC current fed into the pipeline by the signal generator. The schematic setup is shown in **Figure 2**. The measured electromagnetic field is proportional to the current in the pipeline and therefore allows for an assessment of the current distribution along the pipeline. Defects

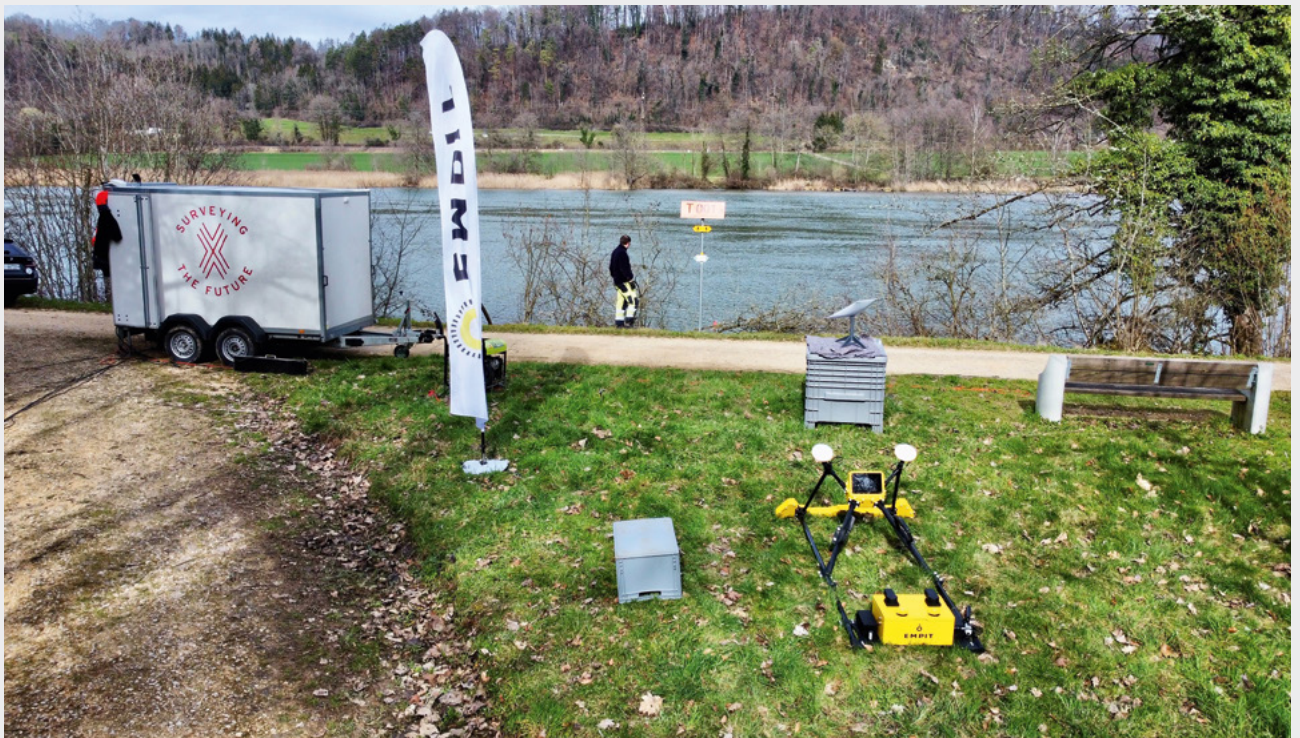
**Figure 4:** Measurement setup for the CMI. The trailer on the left contains the signal generator. The sensor arrays are integrated into the portable detector (yellow), and above the detector is the Starlink antenna, which sends the large amount of data directly to the cloud for immediate processing.

In order to evaluate the reliability of both DCVG and CMI, measurements were carried out on a section of the Transigas AG pipeline (**Figure 4**) using both methods. This pipeline section, built in 1973, runs from the southern bank of the Rhine River to the Wallbach station, with a length of about 1,433 m. The pipeline has a nominal diameter of 36" (914.4 mm) and a wall thickness of 12.7 mm. The corrosion protection consists of a bituminous coating with a thickness of about 5.5 mm.

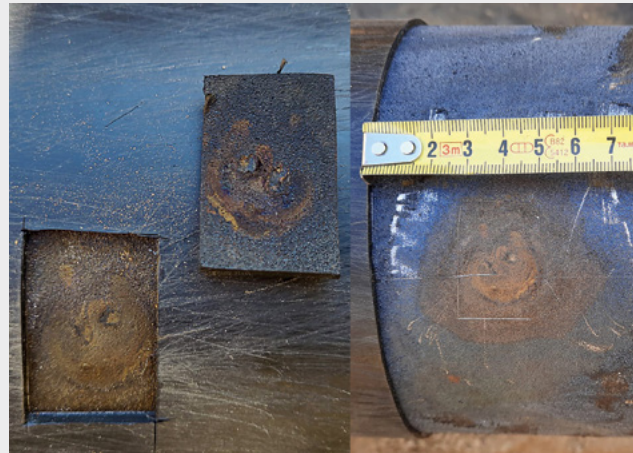
**Figure 6:** Defects identified with CMI. Left: Excised 3LPE coating. Right: Close-up of the defect with the disbonded area.

It was found that the CMI indicated the presence of two distinct coating defects, each with size of about  $0.1 \text{ cm}^2$  (Figure 6, left). After removing the coating, it became clear that there was a large-scale disbondment of the coating with a surface of about  $12 \text{ cm}^2$ . Based on the available information the minor metal loss associated with the local corrosion effects, the voluminous corrosion products, and the disbondment of the coating are associated with AC corrosion. The visual appearance of the corrosion site is consistent with the typical effects described in [6], [7], [1] and DVGW GW 28 B1 [8] in the case of a pipeline exposed to AC interference.

The corrosion effects at smallest coating defects, the formation of voluminous corrosion products, the large-scale disbondment of the coating, and limited corrosion are characteristic for AC corrosion.

The occurrence of AC corrosion shown in Figure 6 clearly indicates that the pipeline section under investigation could be at risk due to AC interference. It has been reported [6] that more negative  $E_{\text{on}}$  potentials can accelerate the corrosion process. Therefore, from the perspective of pipeline integrity, it is ideal to perform high-resolution coating defect detection without further accelerating alternating current corrosion and coating disbondment at more negative  $E_{\text{on}}$ .

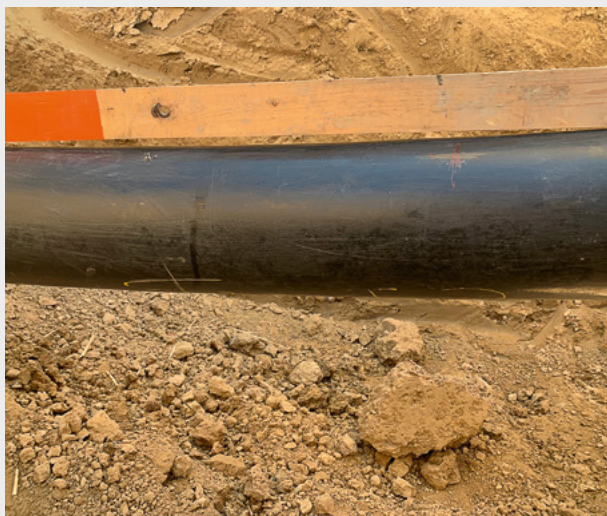
**Figure 7:** Pipe bend in the vicinity of the defect (at the red cross).

The excavation shown in Figure 6 was not only undertaken due to the detected coating defect. Rather, CMI identified a pipe bend that should not be present at that location according to the pipe book. During the excavation, this pipe deformation was indeed confirmed, as can be seen in **Figure 7**.

The slight deformation of the pipe in Figure 7 clearly demonstrates the high measurement resolution in terms of pipeline positioning that can be achieved with CMI, due to the large number of sensor arrays and the high lateral measurement resolution of 1 cm along the pipeline. These measurements illustrate that CMI significantly surpasses the capabilities of DCVG and provides additional important information regarding pipeline integrity assessment. The accurate capture of the pipeline's exact position and the determination of changes in position and geometry over the years are just some of the key advantages of CMI.

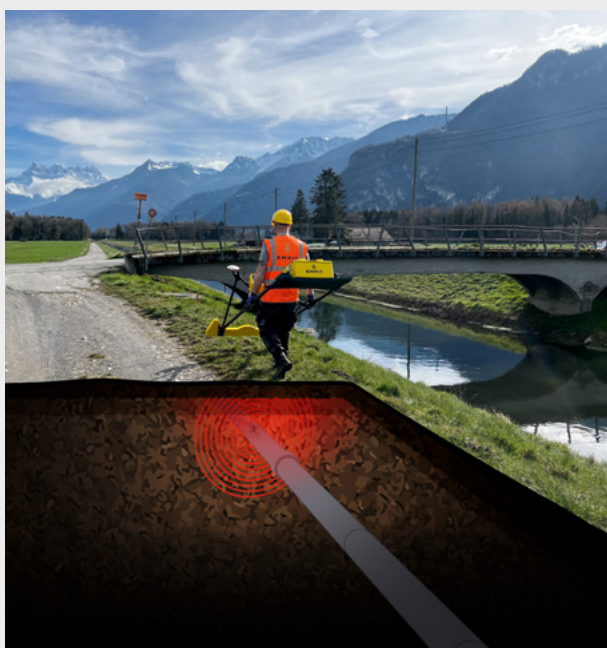
**Figure 8:** Hand-held CMI detector in use. The red circular lines around the pipe illustrate the magnetic field generated by the signal generator.

The method which is shown in use in **Figure 8**, in combination with appropriate numerical simulation, allows for the quantification of the current passing into the soil through the defect and the calculation of the pipe to soil potential. This immediately allows for calculating the spread resistance of the identified coating defects for the various applied frequencies, providing crucial insights into the corrosion-relevant conditions at each defect. Notably, these methods enable a further evaluation of the large number
