TSC Subsea ART vPush | PPIM 2023 Innovation Award Submission

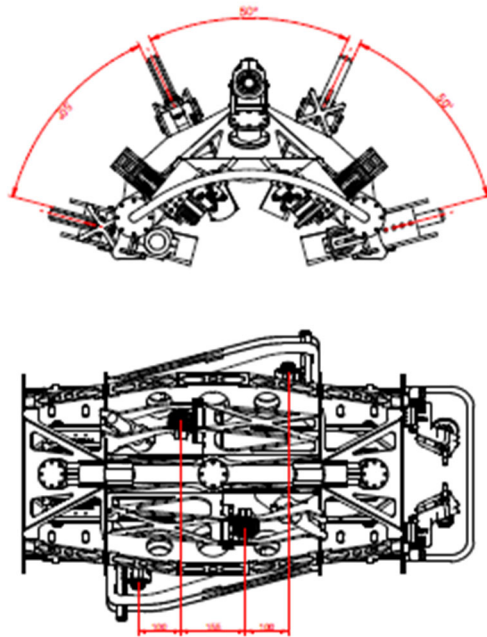
In response, TSC Subsea developed the ART vPush. Deployed by ROV, the ART vPush is pushed along the top of the subsea pipeline quickly obtaining data from 4 sensors in real-time, providing hydrate detection as quickly as the ROV can travel the span of the pipeline.

Unlike existing technologies, the ART vPush only needs access to the top half of the pipe, greatly reducing or eliminating the need for dredging.

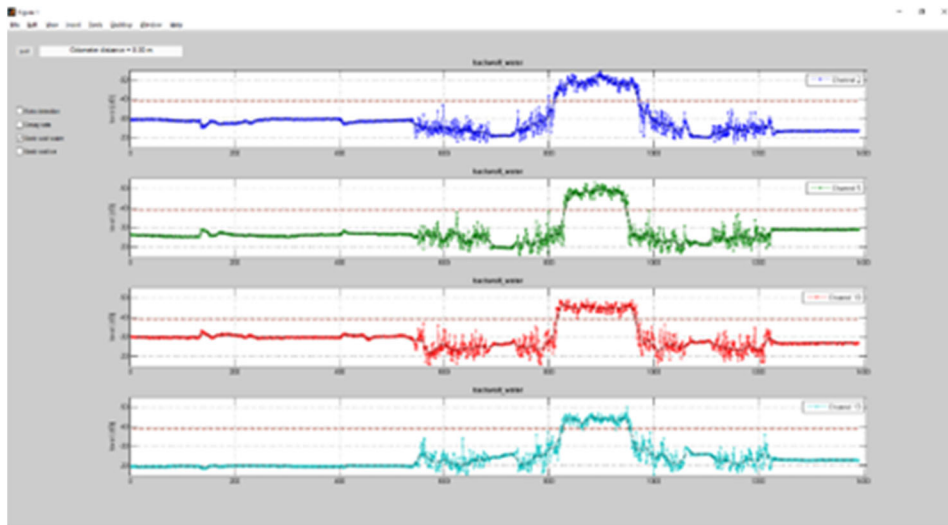
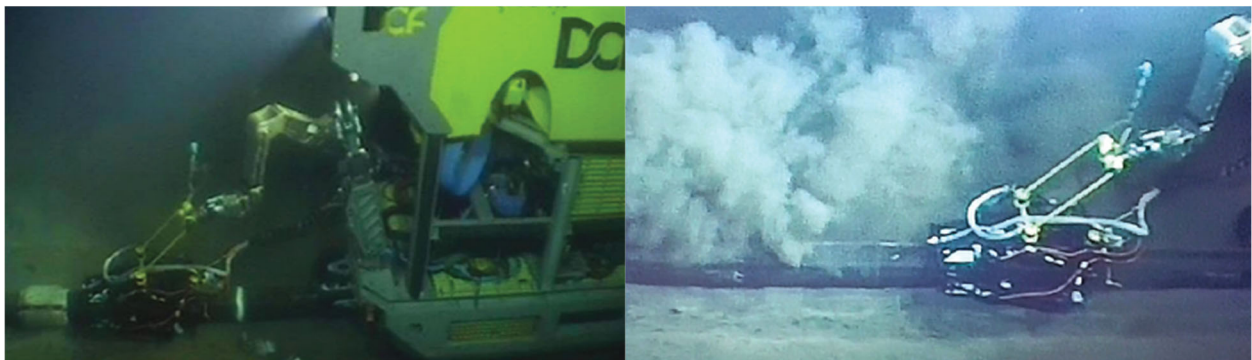
The ART vPush was mobilized to West Africa and scanned a 12 km pipeline in only 33 hours, locating a 250 m plug to exact measurements. Once the plug was found, the operator then deployed TSC Subsea's ARTEMIS® tool in several locations to completely characterize
