Interim Results of the PetroSleeve (Steel Compression Reinforcement Sleeve; Repair F) from the JIP Evaluation of Repair Technologies for Circumferential Cracks on Pipelines

Robert J. Smyth' P. Eng.
PetroSleeve Incorporated

Proceedings of the 2025 Pipeline Pigging and Integrity Management Conference.

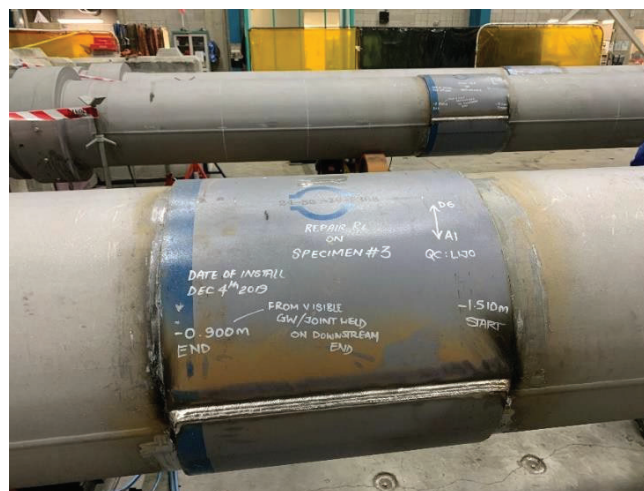
Below is a photograph of the Repair F on pipe specimens.

Figure 1. Repair F

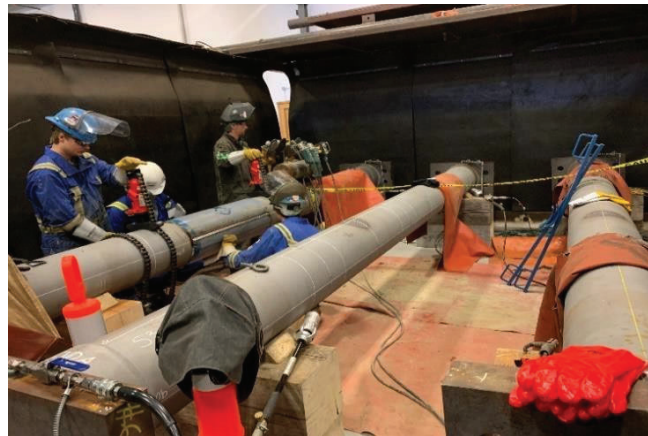
Figure 8. Installing Repair F

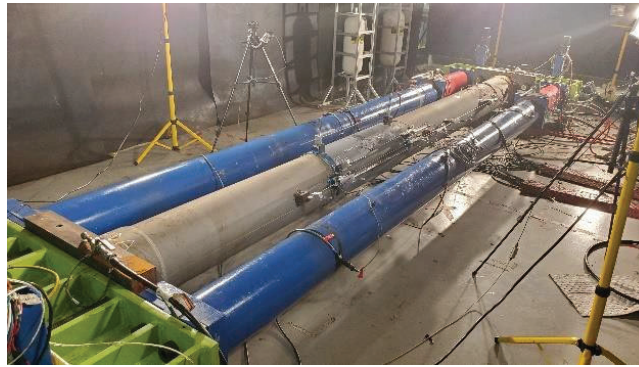
Figure 9. During Phase 3 Tensioning

Figure 9 illustrates the test setup. The vessel was pressurized to 25% SMYS, (514 psi, 3,541 kPa). At that point, depending on readings, the internal pressure was increased to 72% SMYS (1482 psi (10,210 Kpa) and tension applied to failure. This involved increasing tension until the base pipe entered the plastic range and the crack opened.

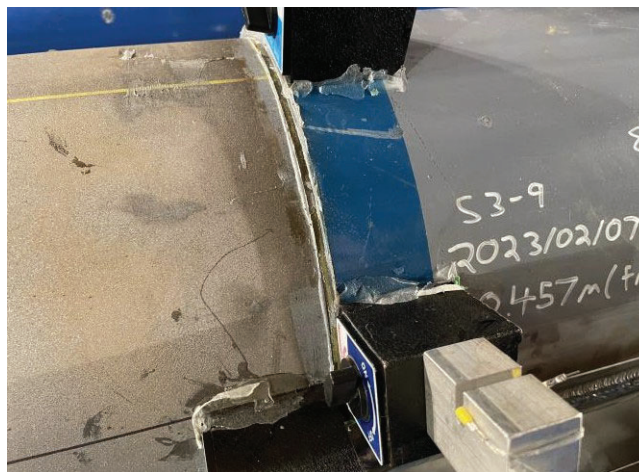
The crack opened when the tension was 560 Kip (560,000 lb-force). At that tension level, the parent pipe was in the elastic range.

Figure 10. At the failure point where crack opened

As can be seen in Figure 10, the steel under the sleeve had entered the plastic region. This extension of the steel under the sleeve was illustrated by noticing that the epoxy, that had extruded from beneath the sleeve during installation, had moved away from the sleeve edge. At the time when the crack opened, water was seen dripping out from between the sleeve and pipe. The pressure had dropped to zero. The pipe had stretched 2.8% while the steel under the sleeve had stretched 1.6%. In referring to Figure 14, when the crack opened, the tension was at 560 kip. This tension level was sufficient to put the pipe into the plastic range.

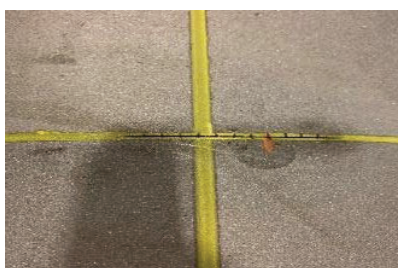
Figure 13. Illustrating Specimen 4-1A 80% Crack

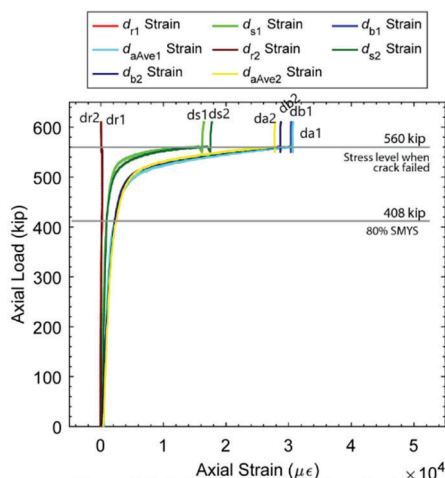
Figure 14 (4)

Phases 1, 2 & 3 have been completed, with Vendor A (Repair F) participating in Phase 4. Figure 14 illustrates strain vs. loading during a Phase 3 test.

Figure 4.5 Axial Test (Tension Loading)
Axial Load vs. Axial Strain

At the point where the steel had reached 80% SMYS, at the 408 Kip level, (Figure 14), the crack had not opened.
