Tethered Robotics for Unpiggable Pipelines: the Development and Field Deployment of TRITON

Paul Chittenden
TSC Subsea

Proceedings of the 2025 Pipeline Pigging and Integrity Management Conference.

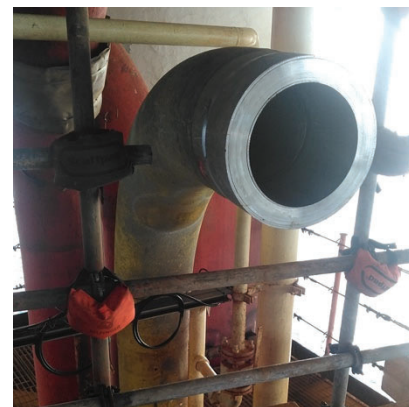
Figure 1 Offshore riser

bp faced a significant challenge with a 14-inch (365 mm) duplex riser on one of their offshore platforms in the North Sea. Initially installed as a spare, the riser had remained unused.

The duplex riser's unique design presented considerable challenges for conventional inspection methods. With a single entry and exit point, it measured 328 ft (100 m) in length with a wall thickness of 1.9 in (48.8 mm) and included recessed welds every 32 ft (10m) as well as three complex 90-degree bends with a radius of 3D. An external inspection was deemed infeasible due to geometric and environmental constraints, while the internal inspection was further complicated by the riser being partially flooded with anti-corrosion fluid, which was maintained at elevated temperatures.

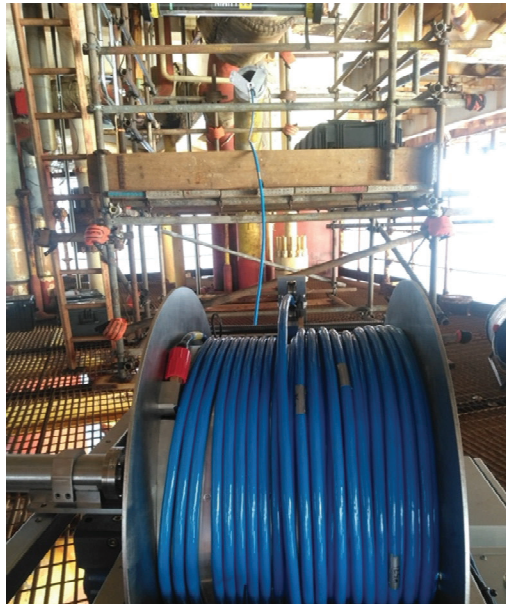
Figure 3 Umbilical management and winch system

The final solution featured a robotic crawler equipped with high-resolution cameras for navigation and visual inspections. An additional module contained the ACFM array and SPA probes, followed by a technology bottle containing the electronic circuitry. A custom winch system was used to handle the system's weight and ensure a fail-safe in case of crawler immobility.

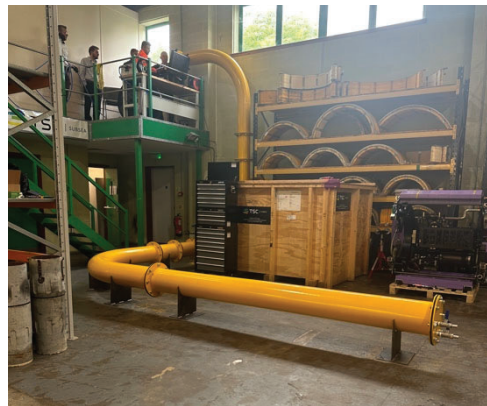
Figure 7 Full-size mock-up of the riser used to demonstrate TRITON's navigation

Prior to deployment, a rigorous Factory Acceptance Test (FAT) was conducted to validate TRITON's capabilities. A full-scale mockup of the riser, complete with recessed welds and complex bends, was fabricated. Additionally, bp provided a duplex test sample containing hidden defects to evaluate the detection accuracy of the NDT technologies.

1. Detection Validation: Both ACFM and SPA successfully detected and sized all engineered defects within bp's strict engineering tolerances.
2. Navigation Testing: TRITON demonstrated seamless mobility through the riser's bends and transitions. Trials were conducted in dry and flooded pipe conditions to simulate on-site conditions. The system's integrated high-resolution cameras ensured controlled navigation, even under low-visibility conditions in the flooded environment.

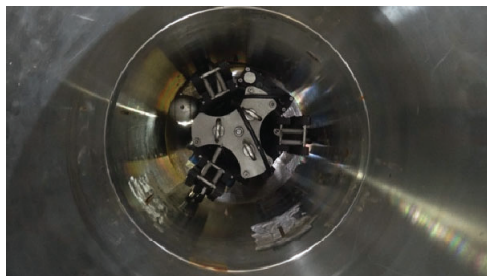
Figure 8 TRITON undergoing ACFM detection capabilities assessment.

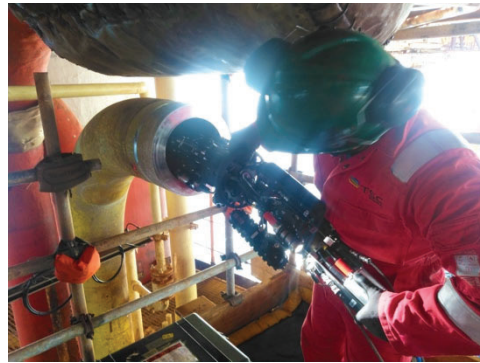
Figure 9 Offshore operation showing TRITON entering the riser.

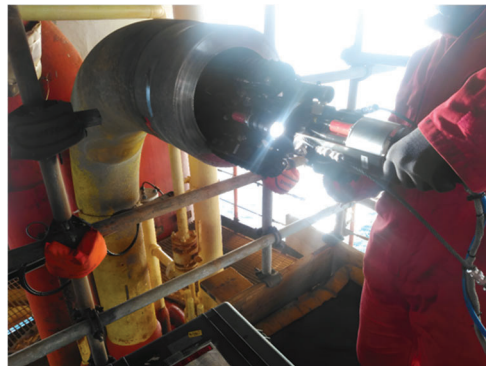
Figure 10 TRITON exiting the riser

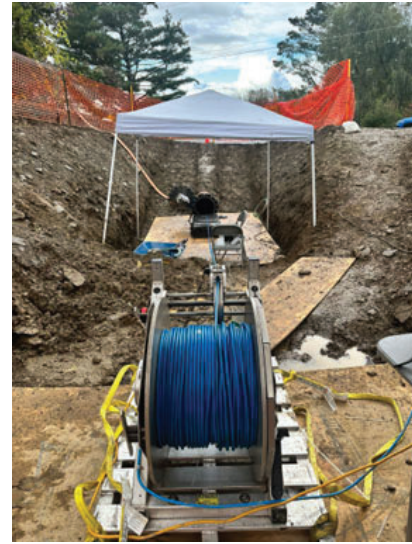
Figure 11 Onshore tethered pipeline inspection

For this inspection, the robotic tethered solution was instrumented with high-definition visual and laser scanning technologies to provide a high-quality visual inspection of the inspection locations. Laser scanning was to be used to determine pipe ovality and follow up on any locations where visual inspection anomalies were found.

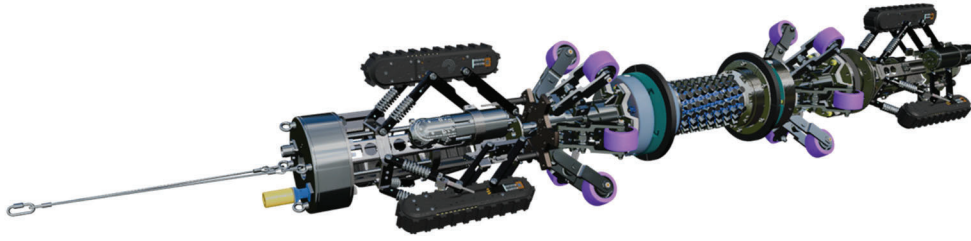
Figure 15 Dual TRITON crawler with ART Scan module

A tethered solution allowed for significant weight reduction by removing the need for ART Scan's battery assemblies since the system would be powered through the cable. However, the pull calculations, which take into account the system's weight, the tether's friction coefficient, and the pull weight when traversing the riser, clearly showed that a single Triton would not have the pull force to traverse the entire pipeline. Because of this, a dual Triton configuration was chosen.

The ART Scan module was mounted onto TRITON's adaptable chassis, designed with a modular configuration to accommodate the tool's size and weight without compromising mobility. For the ART Scan module, a wheeled configuration was chosen in order to reduce friction.
