Integrity Management of Axial Stress Corrosion Cracking and Selective Seam Weld Corrosion

Proceedings of the 2025 Pipeline Pigging and Integrity Management Conference.

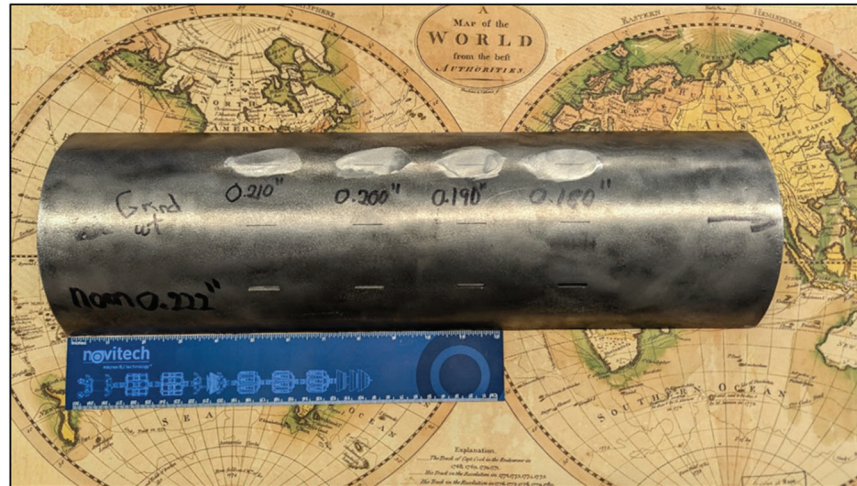
Figure 2. NPS 6 test pipe notch layout

An NPS 6, grade X42, 19.7" (0.5m) long, 0.222" (5.64mm) WT carbon steel pipe shell, was used for the testing (see Figure 2 and 3). Three rows of four straight axially oriented notches were machined into the pipe wall at varying depths to simulate in-field anomalies. Each row of notches was manufactured with depth verified using ultrasonic digital thickness gauge with a 7.5 MHz Dual crystal transducer and a digital depth gauge. The measurements showed approximately 23%, 40%, 70% and 90% WT depth (see Table 1). Each notch was 0.78" (20mm) long. Row 1 consisted of EDM notches where roughly 6-16% of the pipe surface was removed (by grinding) to simulate surface corrosion, while Row 2 consisted of the same EDM notches without surface grinding. Both Rows 1 and 2 notches had measured widths of 0.016-0.017" (0.4-0.43mm). Row 3 features were machined using a 3mm square end mill at the same specified depth and length as the EDM notches.

The experimental test was conducted by moving the assembly across each row of notches while their signal response was recorded. Summary of the results are as follows:

1. The most notable behaviour in the signals occurred at the location of the 23% WT depth notch. The signal response from the notch was reduced compared to the full field, while maintaining a strong and observable response from the deeper features despite amplitudes being diminished. This observation held true for both the EDM notches and wider machined notches and results were repeatable throughout multiple sample tests.

2. Due to reduced pipe wall saturation, the response of the surface grinding on Row 1 features was not captured on both signal channels in line with the notch and away from the notch. This validated the hypothesis that the simulated surface corrosion is ignored while deeper features are still being captured.

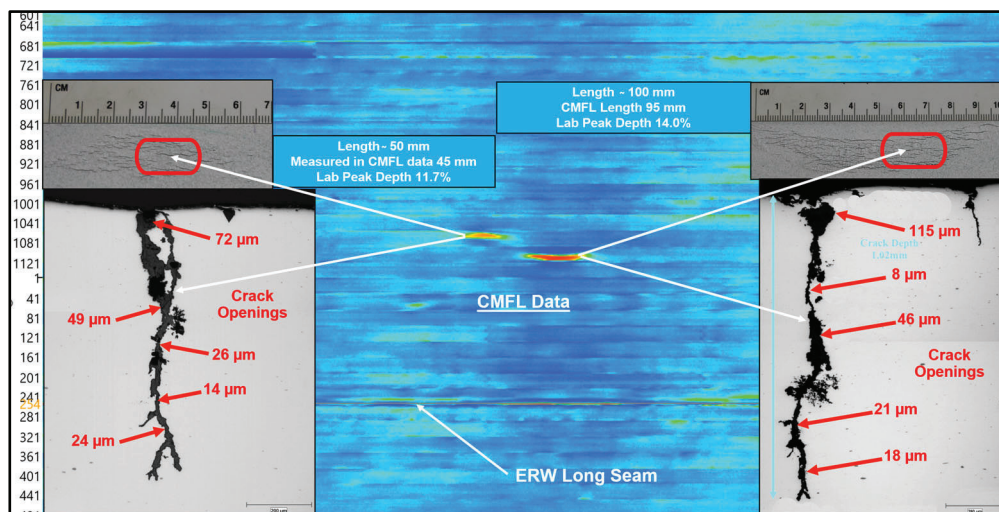
Figure 4. Result of NPS 16 pull tests of a pipe sample containing ASCC.

To demonstrate the potential of the new concepts, a pull test of an NPS 16 pipe sample containing ASCC features, provided by a pipeline operator (Figure 1) was conducted. Using the Novitech CMFL sensor, SCC features were successfully detected during the test. This finding had demonstrated the potential for discriminating axially oriented features and was used in the development of the multi-field CMFL module.
