Bi-Directional Tethered EMAT In-Line Inspections: A Case Study

Proceedings of the 2025 Pipeline Pigging and Integrity Management Conference.

NPS 10 Case Study

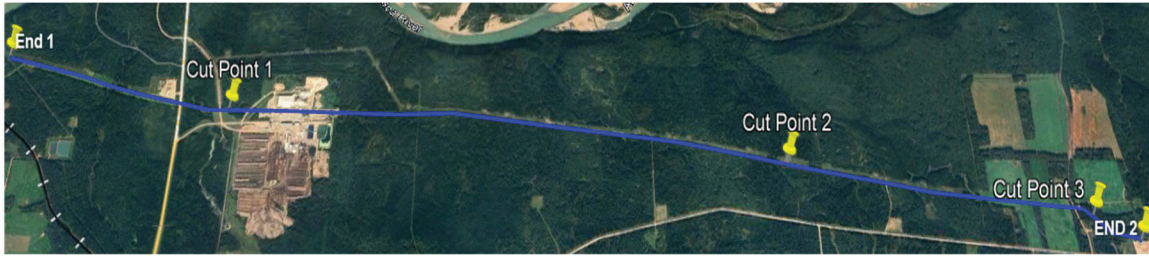
Figure 1. Pipeline Route and Cut Points.

Involving a total of three cut points, the longest distance between cut points was approximately 5.9 km. Due to the distances between the cut points and the limitations of the tethering equipment, a total of six inspection runs were performed between the three cut points. A meter station was excluded from the inspection plan due to the high number of bends and pipeline fittings in that station. Figure 1 illustrates the line route and cut points.

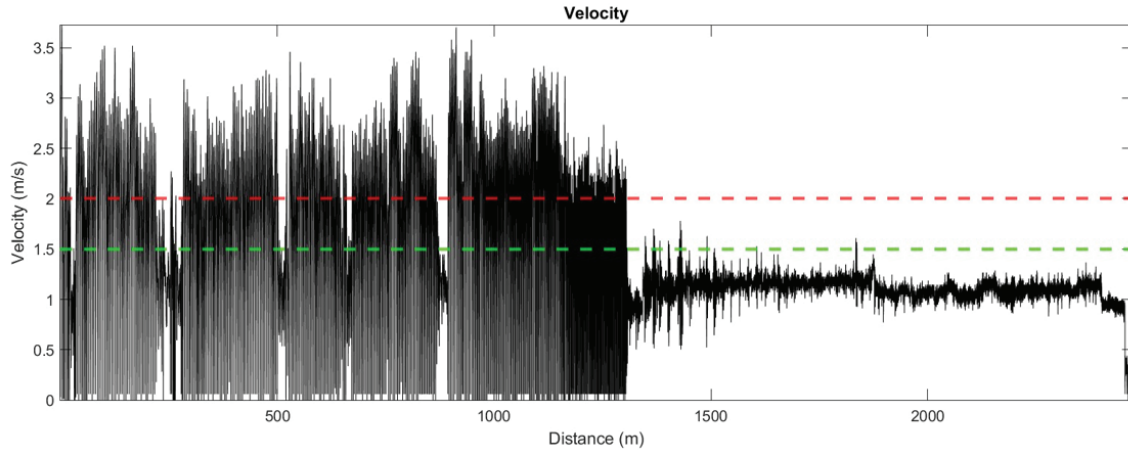
Figure 4. Velocity Excursion Example.

However, not all aspects of the project went as planned. Relatively significant velocity excursions were recorded by the ILI tool in four of the six inspections in both the away and toward excursions. Velocity excursions in the away direction while being propelled down the pipeline with compressed air and in the reverse orientation were not unexpected, but velocity excursions on the pull-back (or toward direction) were surprising considering the wireline speed was consistent for that portion of the inspection. Velocity excursions occurred in three of the four inspections at distances greater than approximately 1500 m from the wireline unit, while distances within 1500 m generally produced consistent velocity, within the specification. The one inspection with different results had the thinner 5/16-inch wireline unit. This inspection had similar results, but the excursions occurred at a distance greater than 750 m (versus 1500 m). These velocity excursions were also relatively short and distant (<1 m) but contained significant acceleration, which affected the tool's attitude during these acceleration periods. Figure 4 was taken directly from the Data Quality Report for one of the cut points with velocity excursions. The red dotted line indicates the maximum velocity of 2 m/s. Note that the chainage is shown with 0 m being the start of the pull-back.

The most significant issue in this project, from both an operational and data quality perspective, was the velocity excursions. The Quest Integrity team reviewed the characteristics of these excursions as well as the differences in relative distances where these velocity excursions between the 7/16-inch and 5/16-inch wireline rope. Based on the results of that review, it is theorized that the interplay between friction coefficients required to move the EMAT ILI tool as it navigates various pipeline features caused the wire rope to elongate excessively, leading to delays in the tool movement. This caused a weight-loading or “Yo-Yo” effect that was exaggerated by the differences in static and dynamic drag coefficients of the ILI tool. Below are discussion points on ways to reduce this effect.

As previously described, the distance travelled before the velocity excursions became significant and approximately doubled between the 5/16-inch and 7/16-inch wire ropes. During the investigation, the stretch coefficients of the 5/16-inch wire rope provided by the wireline operator were 1.2 ft/Kft/lbs or about double that of the 7/16-inch wire rope at 0.61 ft/Kft/lbs. The recommendation
