Quantifying the Impact of Coincidental Versus Preferential Seam Weld Corrosion

Michael Turnquist¹, Yanping Li², Yohann Miglis³

¹Quest Integrity, ²Enbridge, ³Kinder Morgan

Pipeline Pigging and Integrity Management Conference

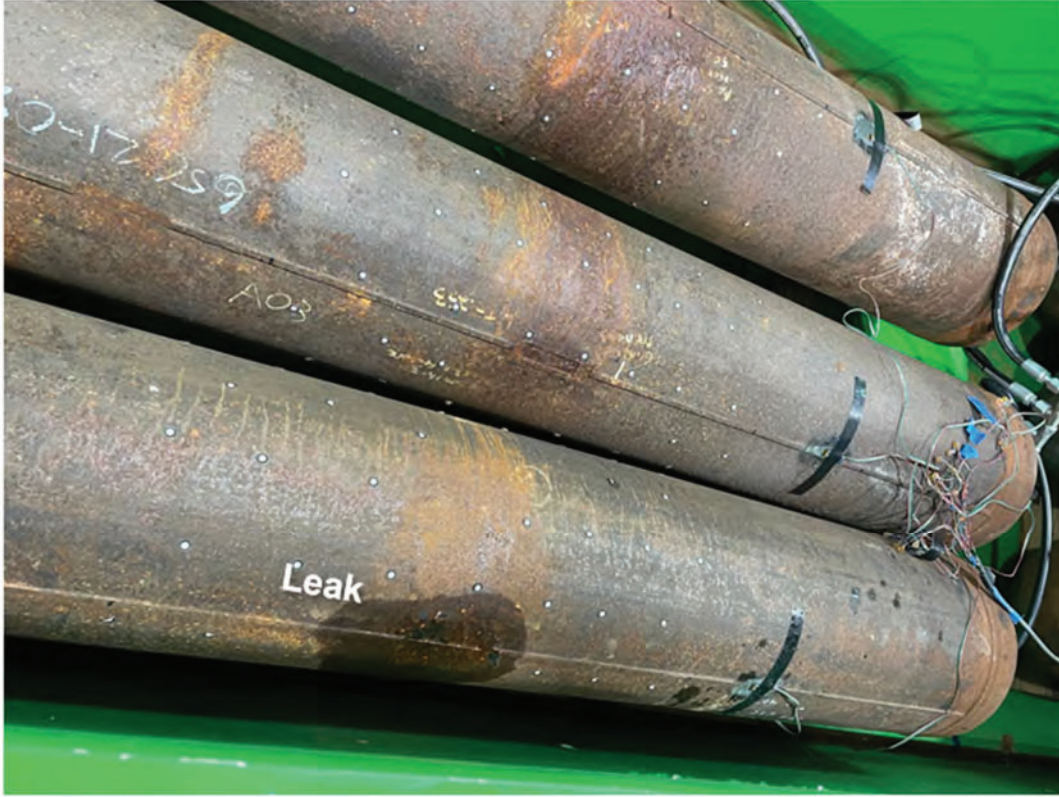
Figure 2. Leak observed in sample AO2 after 17,749 cycles.

Table 6 contains a summary of the full-scale testing results. Of the 16 samples subjected to fatigue testing, one leak was observed for sample AO2 after the completion of 17,749 cycles, as shown in **Figure 2**. No leaks or ruptures were observed for any of the other 15 samples.

Two of the 16 samples showed evidence of fatigue propagation: AO2 (which leaked during the fatigue testing) and DSAW2. Note, these samples contained the deepest and narrowest corrosion features, thereby introducing the highest potential for geometry-induced constraint.

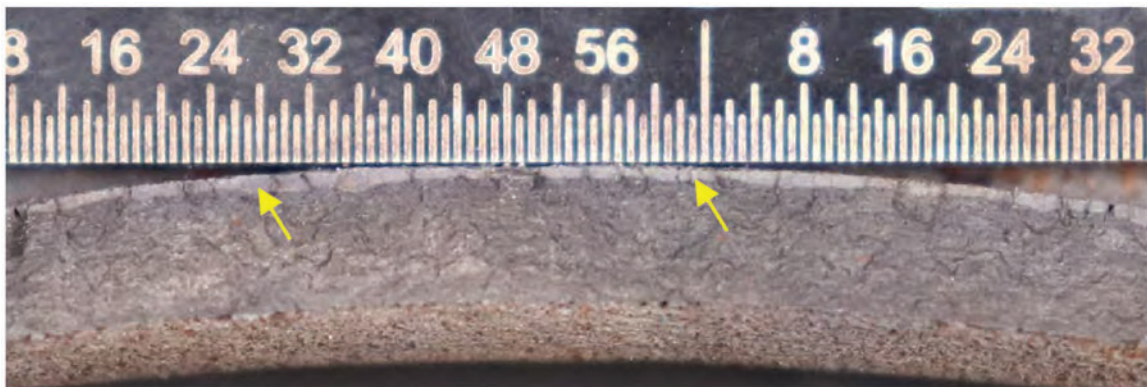
Figure 4. Fracture surface, sample DSAW2.

For sample AO2, ratchet marks were observed along the boundary between the notch and fracture, and propagation was observed through the remaining WT beneath the EDM notch, as shown in **Figure 3**. For sample DSAW2, ratchet marks were observed along the boundary between the notch and fracture, and propagation was observed for a depth up to 0.022 inch beneath the EDM notch, as shown in **Figure 4**.

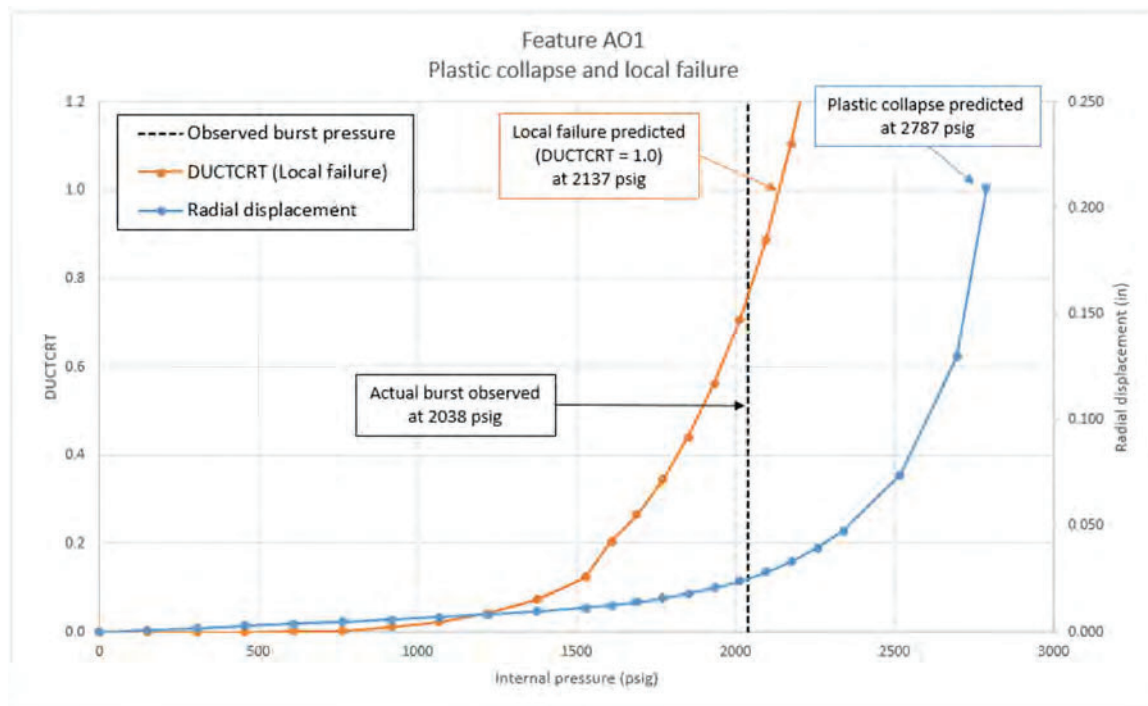
Figure 5. Evaluation of plastic collapse and local failure, sample AO1

Figure 5 exemplifies how plastic collapse and local failure were evaluated for sample AO1. For this sample, the DUCTCRT reached 1.0 prior to exhibiting plastic collapse behavior, indicating that local failure was the controlling failure mechanism. Local failure was predicted to occur (i.e., $DUCTCRT = 1.0$) at 2,137 psig. This predicted failure pressure exceeded the actual observed pressure (2,038 psig) by less than 5%, indicating the FEA model provided a reasonably consistent prediction compared to the actual observed results. **Figure 6** and **Figure 7** provide screenshots of the computed von Mises stress and equivalent plastic strain at a pressure approaching the predicted local failure pressure.
