Enhancing Pipeline Assessments: Answering the Challenge of Unpiggable Liquid Assets with Self-Propelled Solutions

Pipeline Pigging and Integrity Management Conference

Case study #1

Case Study #2

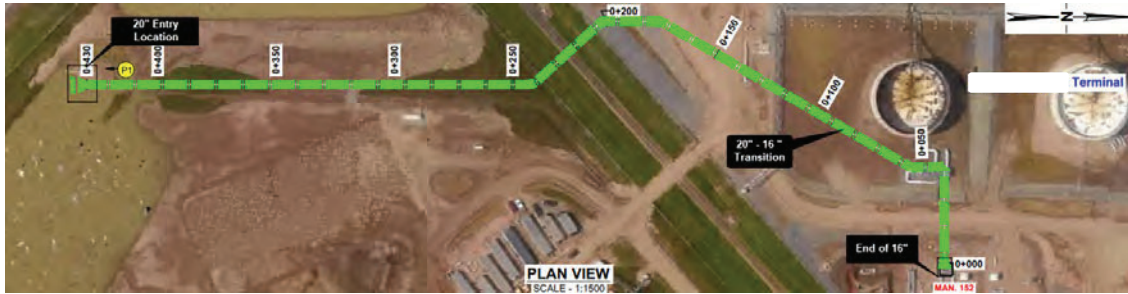
Figure 1. Pipeline Overview.

Imperial Oil's underground lateral line between the Regina fuel distribution terminal and 3rd party main pipeline operator is used to supply multiple storage tanks with distillate and gasoline product. This line has a dual diameter segment that runs within the 3rd party facility land and can be accessed from aboveground risers with tool launching and receiving infrastructure.

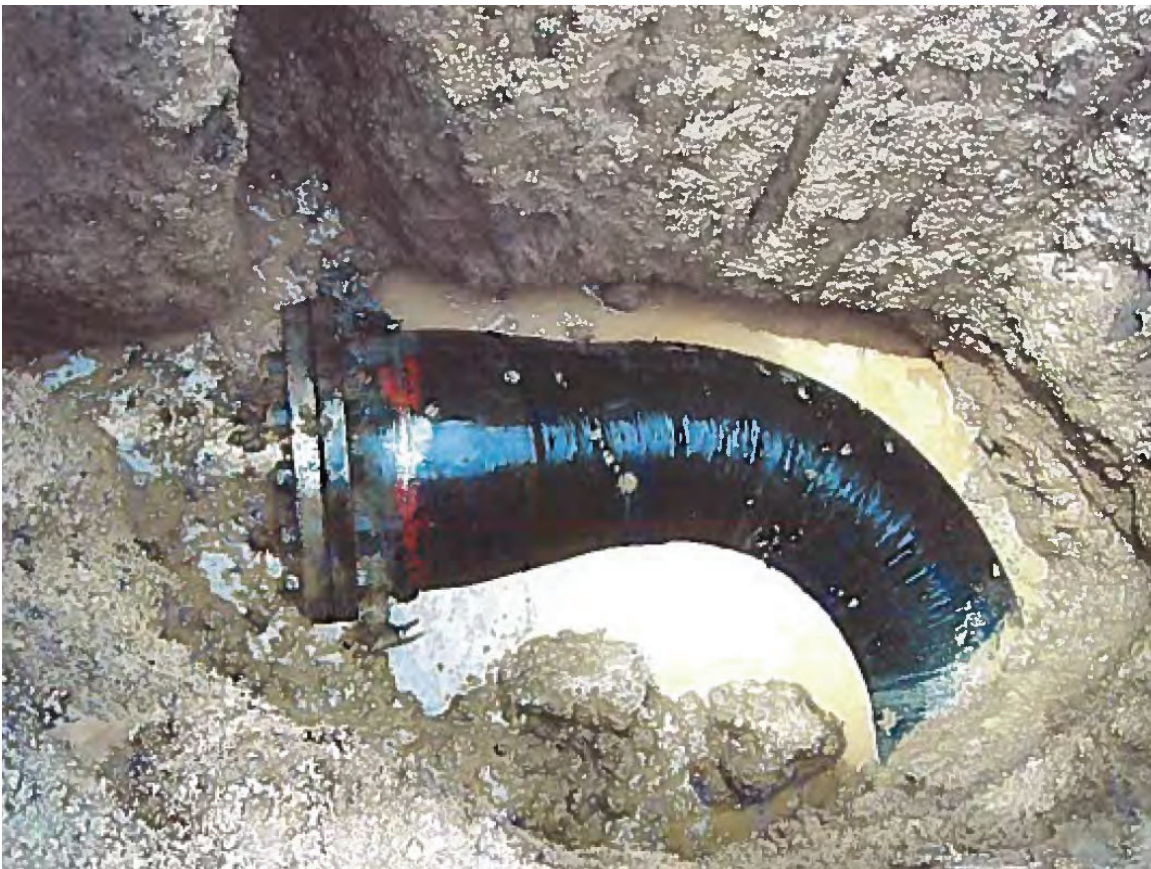
Figure 2. 16"/20" transition with affixed bend

1. Despite launcher and receiver capabilities, the line was not designed for conventional pigging
2. Operating in-service conditions did not allow for a conventional ILI tool inspection.
3. Limited space available to setup temporary pumping equipment for standard pigging operation on 16" end.
4. Staging of temporary equipment for conventional pigging (flowback tanks and pump) could pose risks to the environment.
5. 16"/20" transition located at bend (Figure 2).

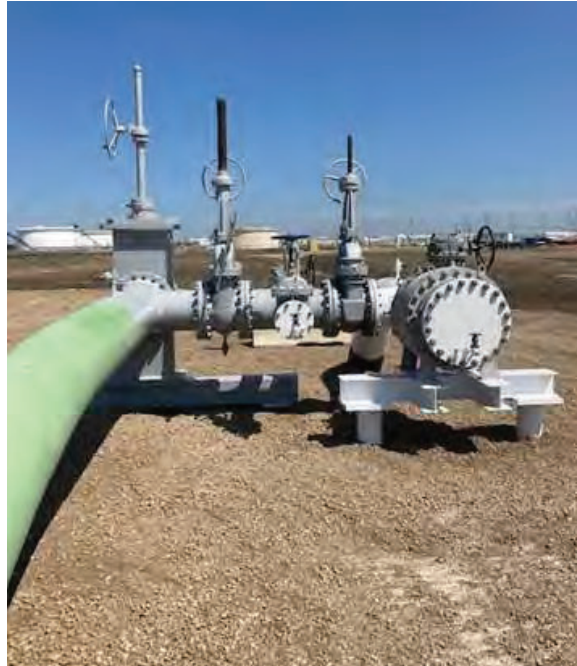
Figure 7. Topping valve and entrance point

To ensure the line was adequately prepared for inspection, various measures were reviewed and implemented. Notably, considering the absence of standard pigging facilities for introducing the tool train, a temporary launcher spool was connected to the topside valve, as depicted below. Specifically, a 20"/24" barrel with a length of ~22' (6.71m) was utilized from the previous campaign as the launcher spool for this purpose.

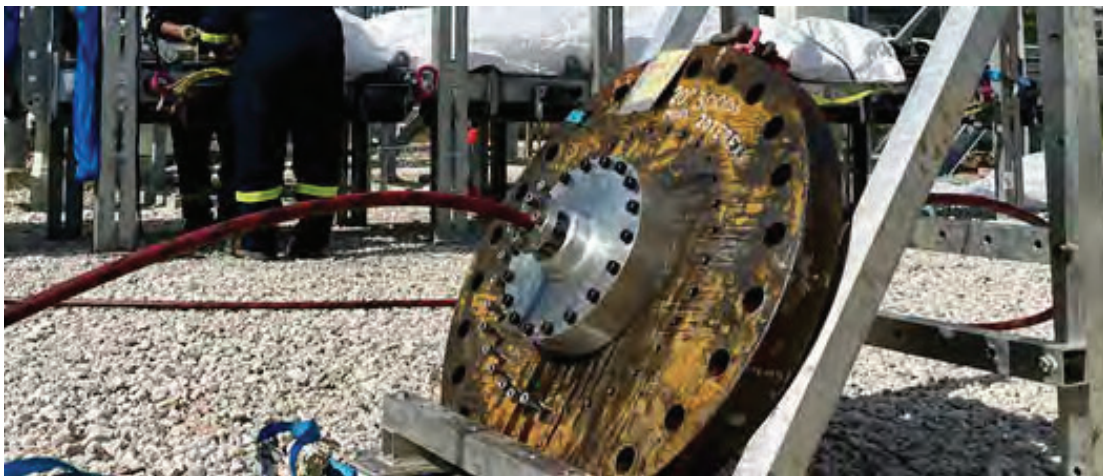
Figure 8. Stuffing box and flange assembly

The inspection is within a "closed system," where a stuffing box flange is affixed to the pipeline entry flange. This stuffing box flange, a modified ASME 16.5 - 24" - 150# flange, features a central aperture for the passage of the inspection tool and threaded flat-bottom holes for connecting the stuffing box. The installation of the stuffing box is facilitated by feeding the umbilical through the flange.

Upon feeding the umbilical through the stuffing box flange, the stuffing box can be securely installed. An adjustable sealing and a torqued gland are employed to create a seal around the umbilical, enhancing its sealing capabilities. While the stuffing box can achieve complete sealing during tool standstill when over tightened, this may not be optimal during inspection, as it could impede the forward movement of the tool train by holding back the umbilical. Thus, it is adjusted as required throughout the system to balance seal and friction on the umbilical.

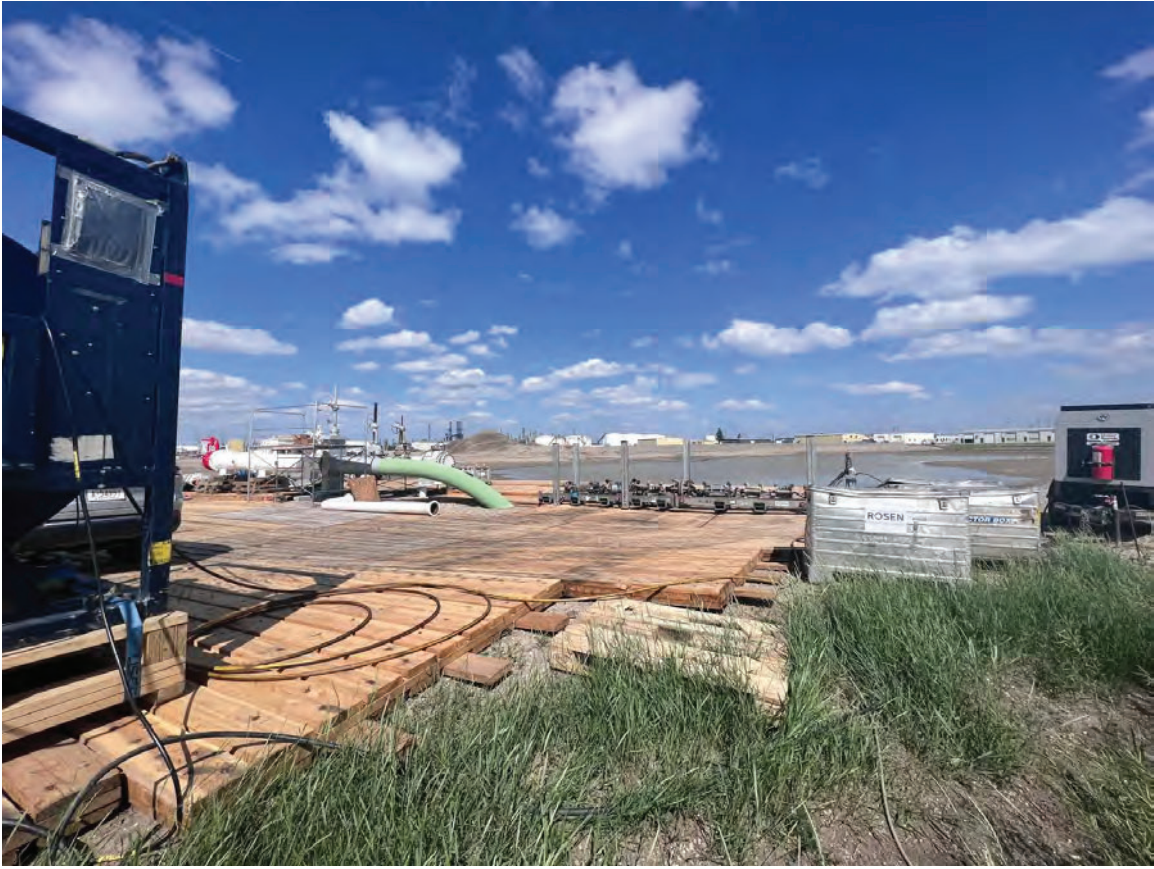
Figure 11. Site setup

The workstation was established adjacent to the winch to facilitate clear communication during inspection activities, while the generator was positioned just outside the working area.

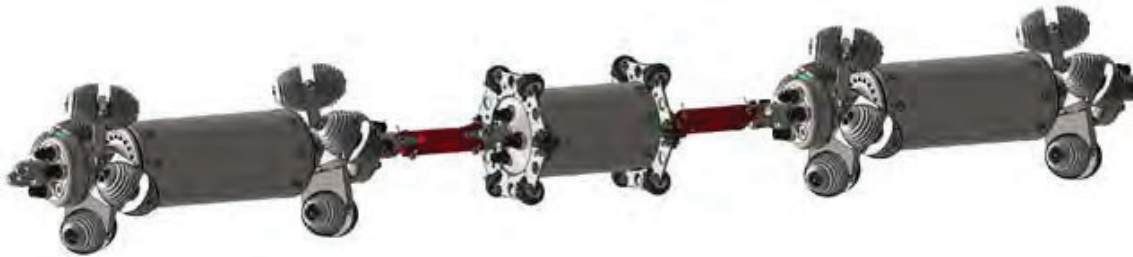
Figure 16. 10” Electro helix crawler system

For the inspection, ROSEN suggested the implementation of its self-propelled bi-directional ultrasonic testing (UT) solution. This technology aligns with the base tethered technology previously detailed in Case #1. ROSEN made additional modifications to enhance the solution. These included a dual propulsion system, which featured two crawler units in tandem. This created more power so that the tool could travel further into the pipeline and around all 18 bends. In lieu of the aforementioned tractor drive system, this particular setup utilized an electro helix crawler. The propulsion for the crawler is achieved by the rotation of both front and rear wheels in a radial manner. However, owing to the angled wheels, a helical movement is induced. The freely moving wheels are set at a positive angle in the direction of the desired tool movement. At the center of the crawler, two electric motors are positioned—one linked to the front wheel arms and the other to the rear wheel arms—to supply power to the drive wheel arms. Each arm is equipped with a spring-loading mechanism to ensure sufficient pressure on the wheel against the pipe wall, enabling effective traction.
