# Small-Diameter ILI Challenges in a Crude Oil Gathering System

Frank Micheli<sup>1</sup>, Kenneth Maxfield<sup>2</sup>, Phil Tisovec<sup>2</sup>

<sup>1</sup>Bridger Pipeline, <sup>2</sup>KMAX Inspection

## Pipeline Pigging and Integrity Management Conference

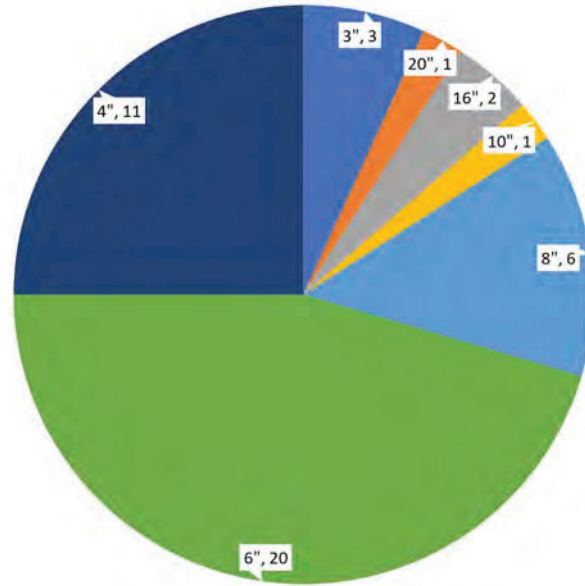
**Figure 1.** Line diameter and number of segments inspected by Bridger in 2023.

were first time inspections with an ILI tool. Figure 1 shows a chart with the segments grouped by diameter and the number of segments with that diameter. Note that over 75% of the segments are smaller diameter (3", 4" and 6") segments.

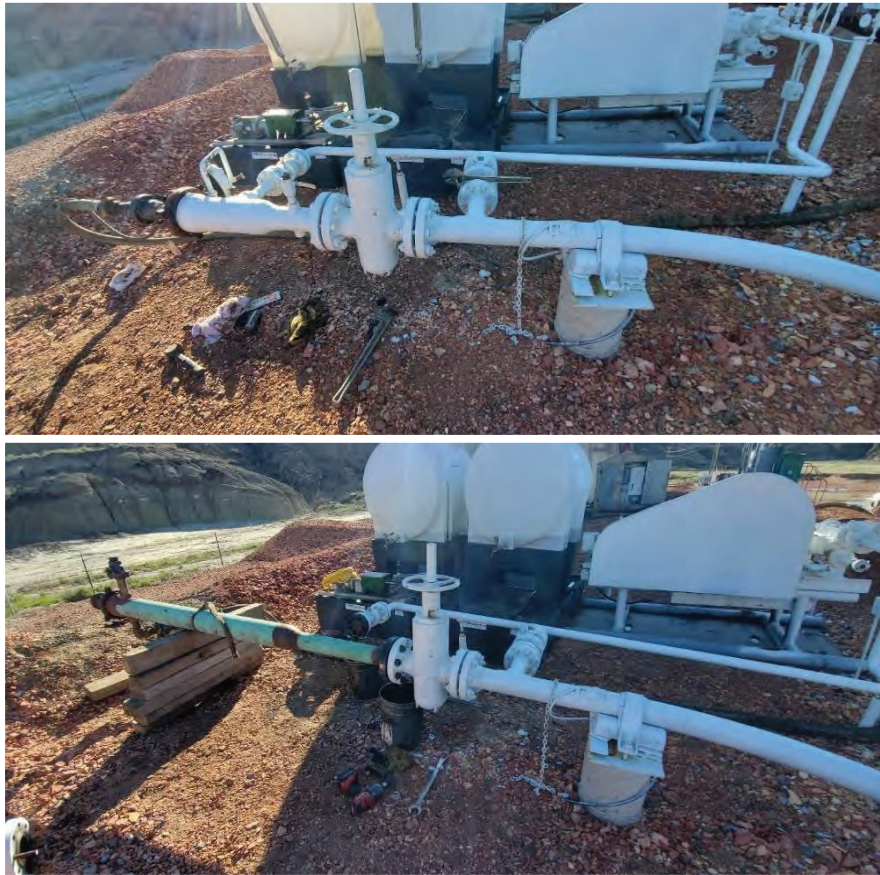
Figure 3. Trap before and after extension.

Running ILI tools in pipeline segments requires that launchers and receivers are long enough to accommodate ILI tools. Most of the Bridger system's lines do not have permanent traps with sufficient length for ILI tools. Temporary traps or extensions are installed on most of the segments

that are inspected with ILI tools. Figure 3 shows before and after installation of a temporary trap extension.

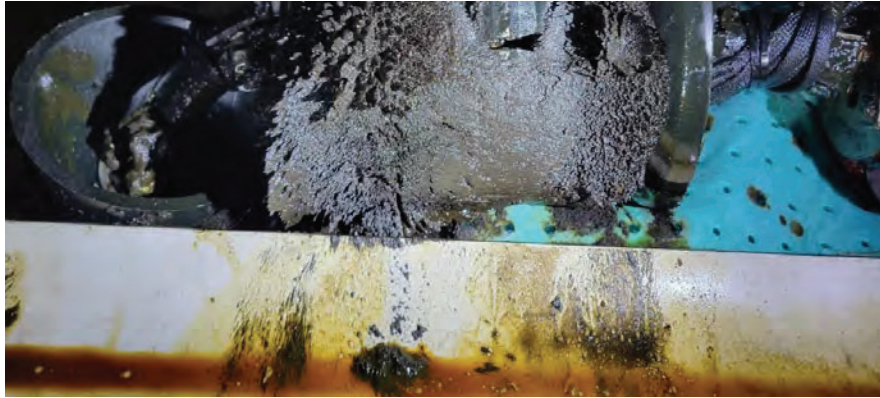
Figure 4. Ferrous debris on an MFL tool.

If the pipeline segment has not been previously inspected, there is risk that the pipeline segment can contain a large amount of ferrous debris. This ferrous debris could have been present in the pipeline since it was constructed or be a byproduct of internal corrosion present in the pipeline segment. Running a cleaning pig with a magnet can remove this ferrous debris. If there are large amounts of ferrous debris, multiple passes of a cleaning pig with a magnet could be required.

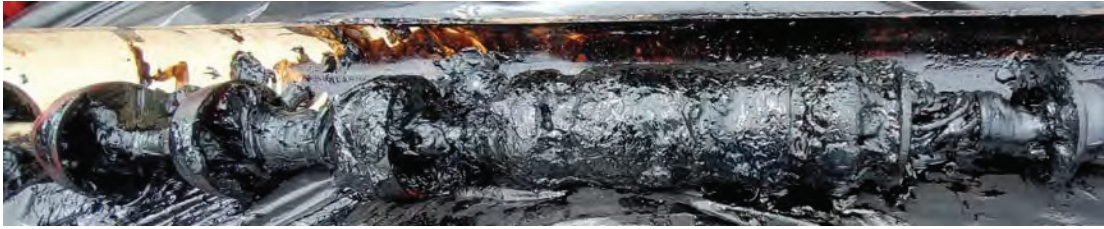
Figure 5. Paraffin wax packed into ILI tool. MFL and odometer data would likely be compromised.

Paraffin wax can create two main problems with MFL ILI: tool sensor response and odometer function. When MFL sensors do not ride directly on the pipe wall, the sensitivity to detect changes in the magnetic field caused by metal loss, especially for small metal loss features, decreases. The usually stable background magnetic field level detected by the sensor also changes as the distance from the pipe wall varies. This variation seen by the sensor can create errors in sizing metal loss anomalies. As a result, paraffin wax can cause the probability of detection to decrease and the sizing error of metal loss anomalies to increase. Additionally, paraffin can pack into and around the odometers which are responsible for recording overall line distance and, therefore critical to anomaly and feature locating.

Figure 5 Figure 6 show some of the paraffin wax issues that can be encountered when running ILI tools.

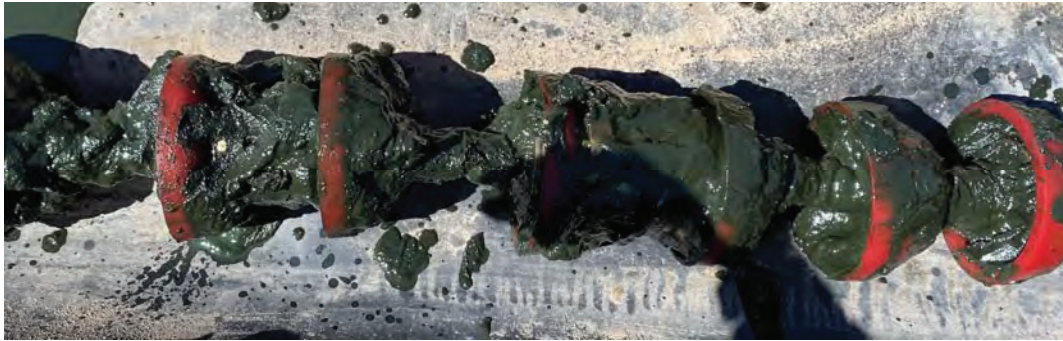
Figure 6. Paraffin wax on MFL tool.

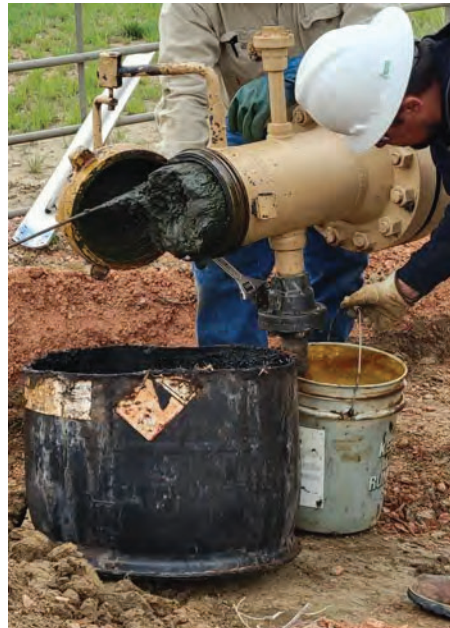
Figure 7. Paraffin wax “plug” in front of tool at receiver.

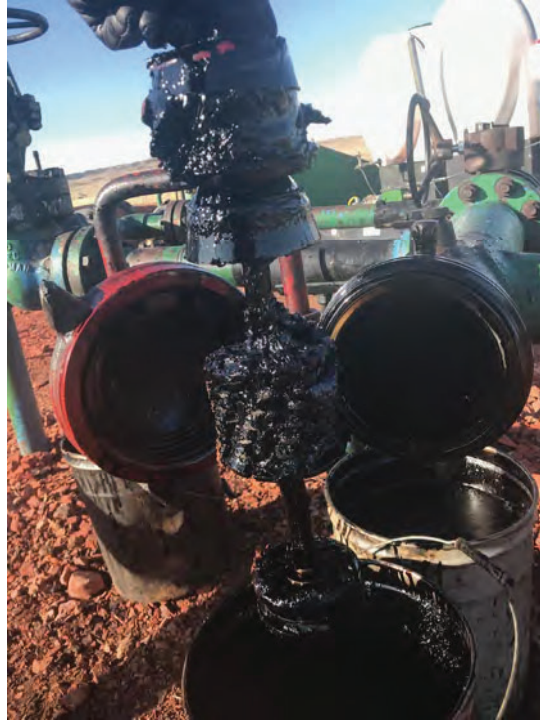
Figure 8. 4" combination gauge plate and cleaning pig, post run.

(caliper) tool could be run through the line to look for geometric features or restrictions that could cause issues with running an MFL tool through the line. Figure 8 shows a gauge plate pig configured in combination with a cleaning (brush) pig after running through the pipeline segment.

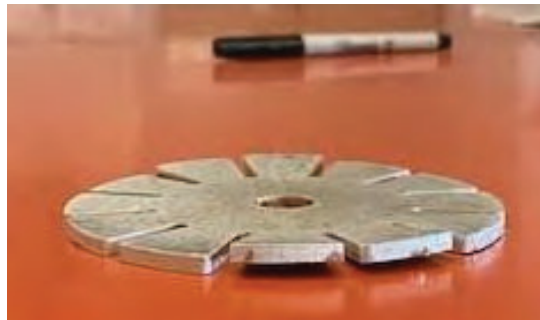
Figure 9. Gauge plate evaluation.

Figure 9 shows an example of a gauge pig plate post run with slight bends on two of the tabs indicating some type of intrusion or bore reduction.

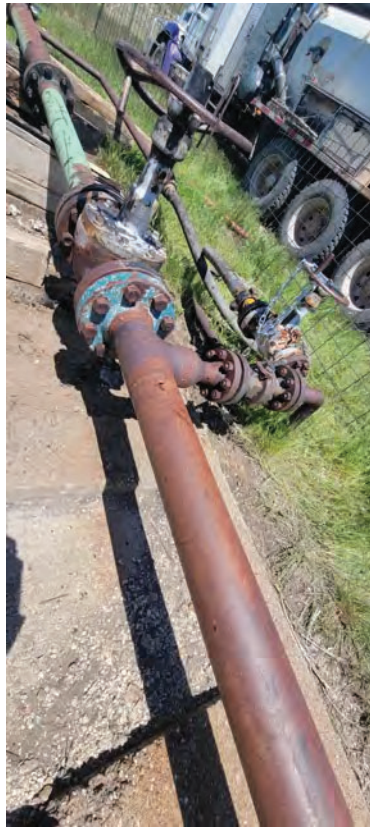
**Figure 10.** Using a pumper truck to help propel the tool.

Some of the segments inspected by Bridger do not have adequate pressure or flow to propel an ILI tool through the segment to be inspected. This is more prevalent in the small diameter lines that are fed by wells that have low output, or a low-pressure pump. In this situation, a pumper truck is used to bring in product and provide the necessary pressure and flow velocity to move the ILI tool through the pipeline segment. Figure 10 shows a pumper truck connected to the launch piping which provides adequate pressure and flow to run an ILI tool.

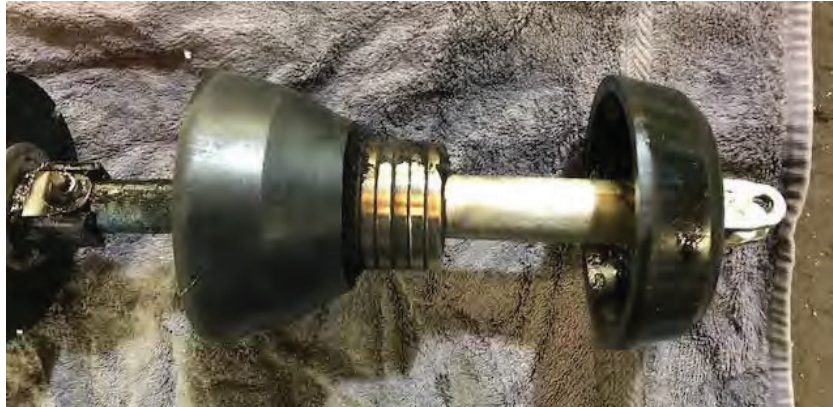
Figure 11. Drive section of the cleaning tool with magnets, post run.

The gauge/cleaning pig was launched and received in the pipeline segment with no apparent issues. Figure 11-Figure 13 show the condition of the gauge/cleaning pig after being run through the pipeline. The gauge plate had two tabs slightly bent as shown in Figure 14. After a discussion with KMAX Inspection, it was decided that although the gauge plate had bent tabs, that the bore of the pipe should be able to pass the KMAX Inspection MFL combo tool. It is common to see single bent tabs

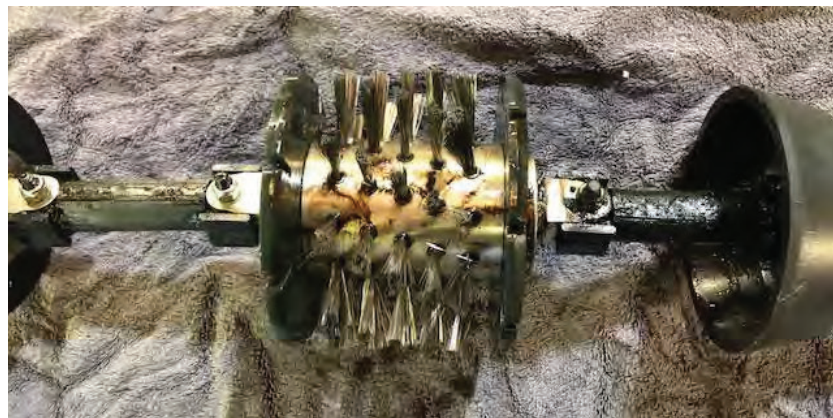
Figure 12. Brush section of the cleaning tool, post run.

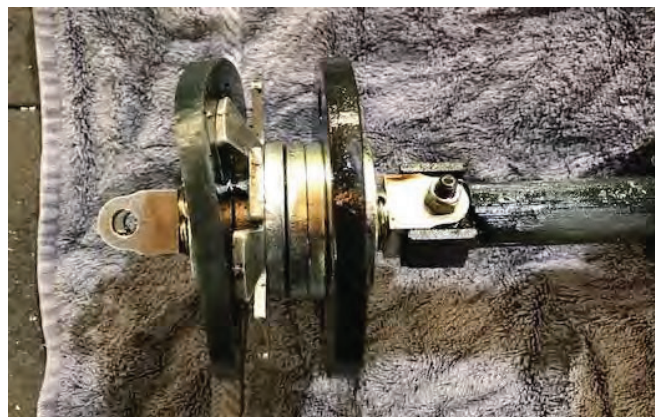
Figure 13. Gauge plate section of cleaning tool with bent tabs, post run.

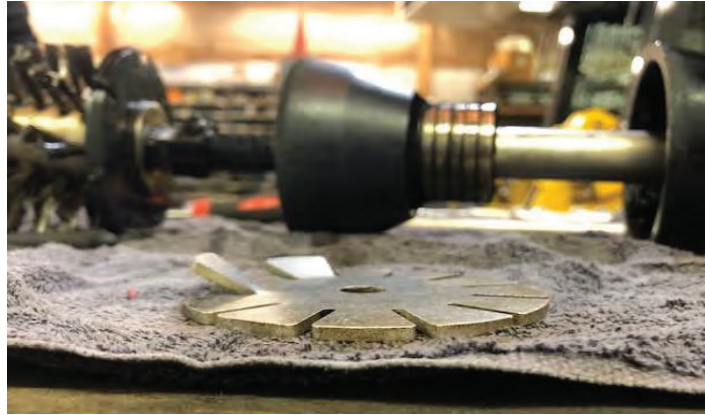
Figure 14. Cleaning tool's gauge plate showing bent tabs, post run.

caused by intrusions such as pig signallers (pig sigs) installed in the pipeline, even though the overall bore of the pipe is acceptable for ILI tool passage.

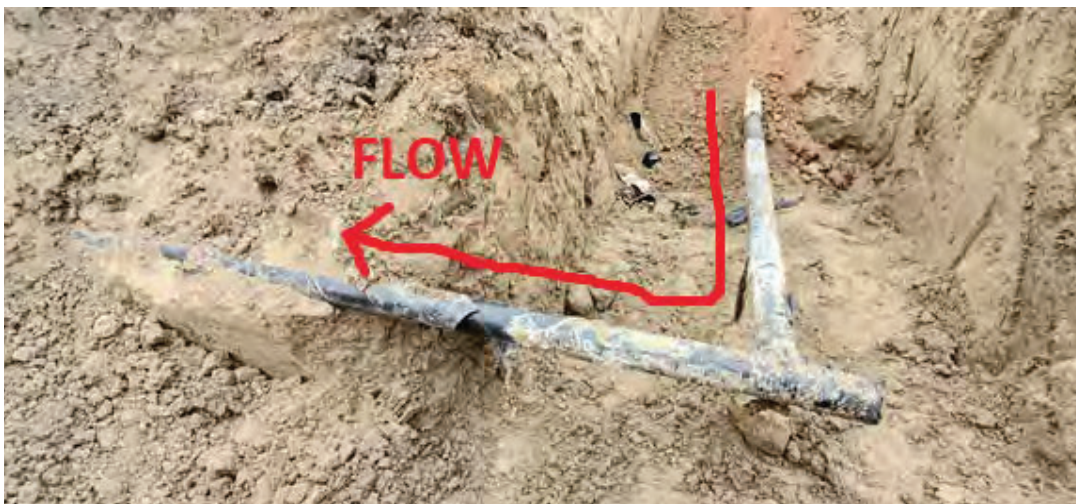
Figure 15. Location of stuck tool where a tee was used as a 90 degree elbow.

The pipeline was excavated at this location which is shown in Figure 15, and it was determined that a tee fitting was functioning as a 90 degree elbow. The ILI tool was of course not able to navigate through the tee from this direction and became lodged there. The line segment had to be drained and the ILI tool cut out from this location.

There are some lessons to be learned from this situation. At some point in time this pipeline was modified by either cutting the line and plugging the abandoned end of the tee or they simply used a tee where a 90 degree elbow was needed. The crew doing the modification should have been aware of general pipeline piggability and should have never substituted a tee as an elbow. Also of note, when running a gauge pig through a pipeline, the results are not always black and white. Various “shades of grey” exist where calculated risk might need to be made with running an ILI tool, running a geometry/deformation ILI tool or other approaches to further investigate ILI tool passage. If the

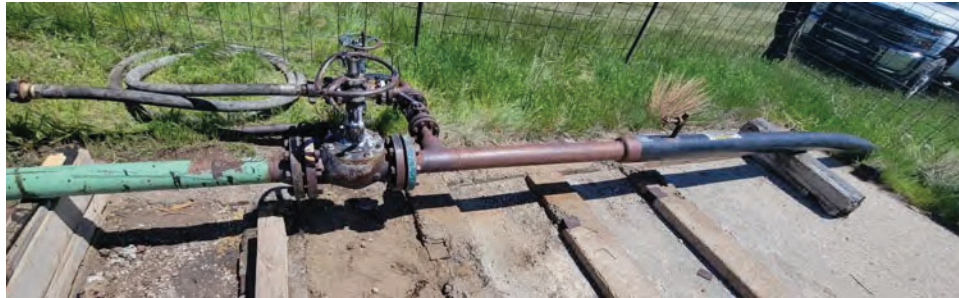
Figure 16. Receiver where the 4" pipe comes out of the abandoned 6" pipe.

Many years ago, a 1-mile, 6" pipeline segment was abandoned by Bridger. A new pipeline was needed to replace the abandoned line, so it was decided to use the 6" abandoned pipe as a housing for a new 4" pipeline. The 4" pipe was strung and pulled through the inside of the 6" pipe, meaning no excavation was used to install the new line. Figure 16 Figure 17 show where the new 4" line exits from inside the 6" line.

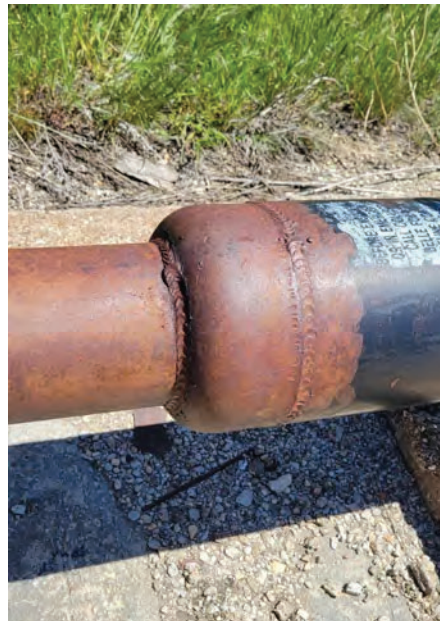
Figure 17. Closeup of where the 4" line emerges from inside the 6".

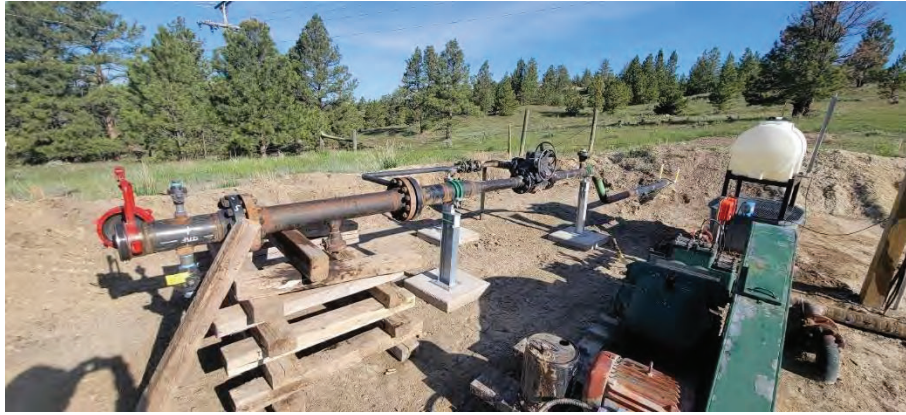
Figure 18. Launcher area, noting low spot as pipeline goes uphill after the launch.

Figure 18 shows the 4" launcher and the pipe entering the ground. Notice the pipeline goes up a hill right after the launcher. This configuration causes a low spot in the pipeline right where the piping enters the ground.

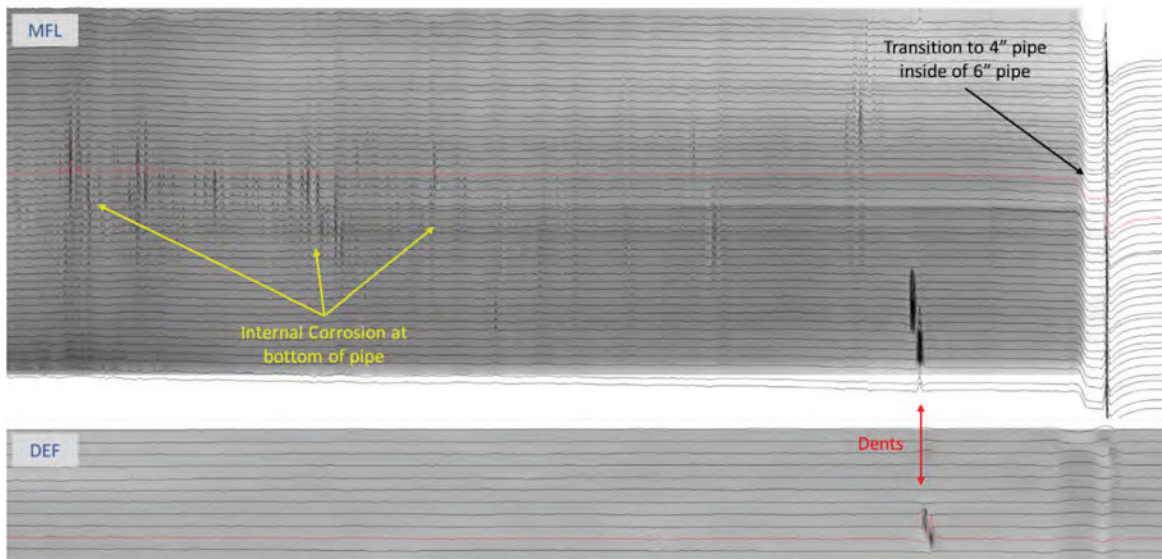
Figure 19. First 75 feet of the 4" pipe, noting internal corrosion, two dents and the transition to where the line goes inside the 6".

After a KMAX Inspection ILI tool was run and the data was analysed, it was discovered that some significant internal corrosion was occurring at this low spot in the pipeline. Figure 19 shows the ILI data at this low spot and the corresponding internal corrosion. At the right (downstream) side of the data, two dents and the begin of the outer 6" abandoned pipe can be seen.

- The total line inspected was 5,658 feet (1.07 miles) in length, with 5,578 feet of pipe inside of the abandoned 6" line.
- There were 124 metal loss anomalies/clusters detected with the deepest reported as 54% of wall loss.
- There were 20 dents detected ranging from 1.0% to 5.7% depth of OD. This could be considered a high number of dents for just over 1 mile of new pipe. It is assumed that the pipe was dented during the installation process of the 4" pipe being pulled into the 6" pipe.

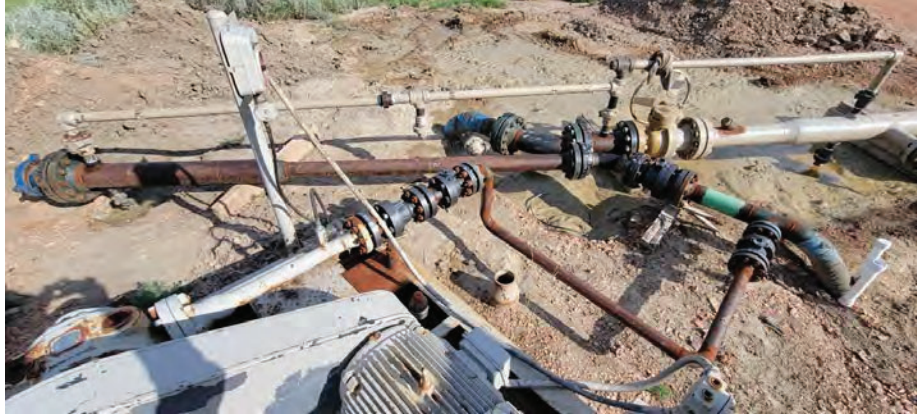
Figure 20. Installation of 4" receiver and 6" launcher at 4"/6" transition point of pipeline.

Bridger operates a 4"/6" dual diameter pipeline segment that had never been inspected with ILL before. The segment starts as a 4" line which then transitions into a 6" line. Because there are no commercially available 4"/6" dual-diameter MFL tools, it was decided to install temporary traps where the 4" pipe transitions to 6" pipe. Figure 20 and Figure 21 show how the temporary traps were installed.

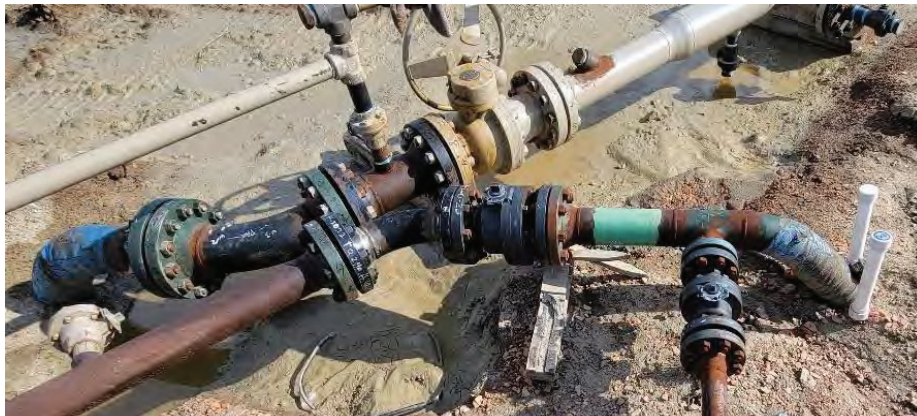
Figure 21. Closeup of 4" receiver and 6" launcher.

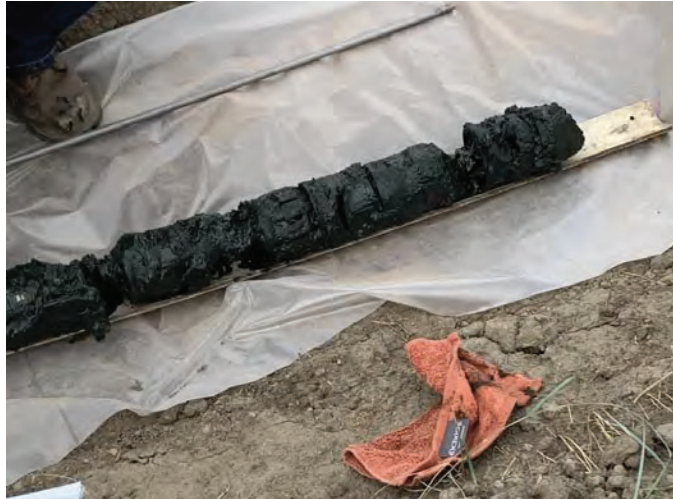
**Figure 22.** 4” tool after inspection of the 4” segment. Note the amount of paraffin attached to the tool sections.

Figure 22 shows a picture of the 4" tool after it was run through the 4" segment which was 3,325 feet in length. Notice the amount of paraffin wax on the tool. The paraffin wax did not affect the quality of the MFL data, but the odometer became stuck and distance data was compromised. KMAX Inspection was able to recreate the odometer information using other sensors on the tool, so the line did not have to be rerun due to the wax build up on the tool.
