Addressing Complex and Axially Aligned Corrosion with MFL Technologies and the Benefits of Triaxial Methods

Anthony Tindall, Steve Farnie
Baker Hughes

Pipeline Pigging and Integrity Management Conference

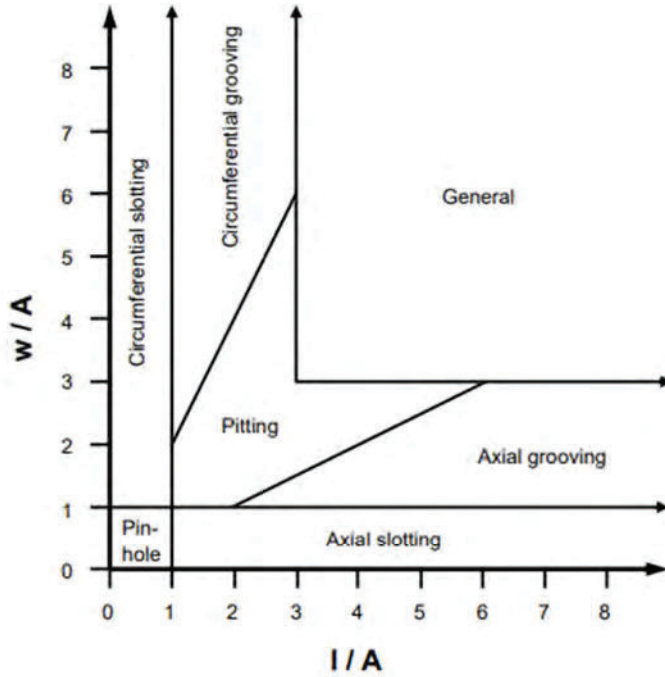
Figure 1: POF metal loss categories [1]

Corrosion within a pipeline occurs in varying shapes and sizes on the internal and external surfaces. For the last 25 years, the pipeline industry has relied upon the classification of defects based on their surface dimensions of length and width, as stipulated within the Pipeline Operators Forum specification in Figure 1.

The geometrical parameter A is linked to the NDE methods in the following manner:

- If $t < 10$ mm then $A = 10$ mm
- If $t \geq 10$ mm then $A = t$

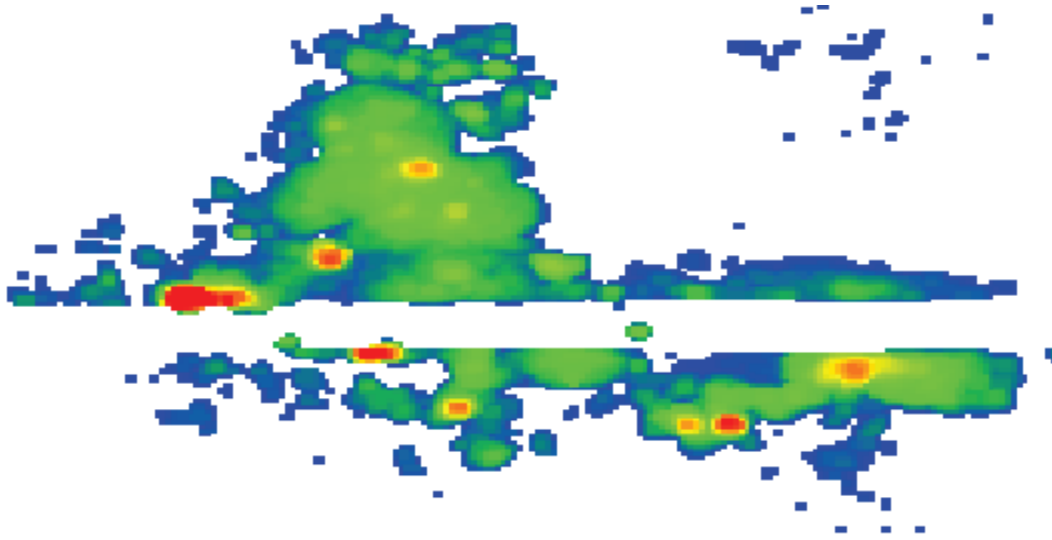
Figure 2: Laser scan containing axial slotting within complex corrosion adjacent to a seam weld

Axial aligned corrosion would fall within the “axial slotting” and “axial grooving” categories due to the relationship between length and width. The axial features within a pipeline can vary significantly from a simplified length and width category as described by POF e.g., axial slotting = defect which is bound by having a width less than 10mm and length greater than 10mm. It is rare to find an axial feature that is isolated as a singular corrosion formation does not follow these arbitrary boundaries laid out in the POF table. Corrosion patterns vary enormously and can often appear random in their creation as seen in the laser scan example in Figure 2.

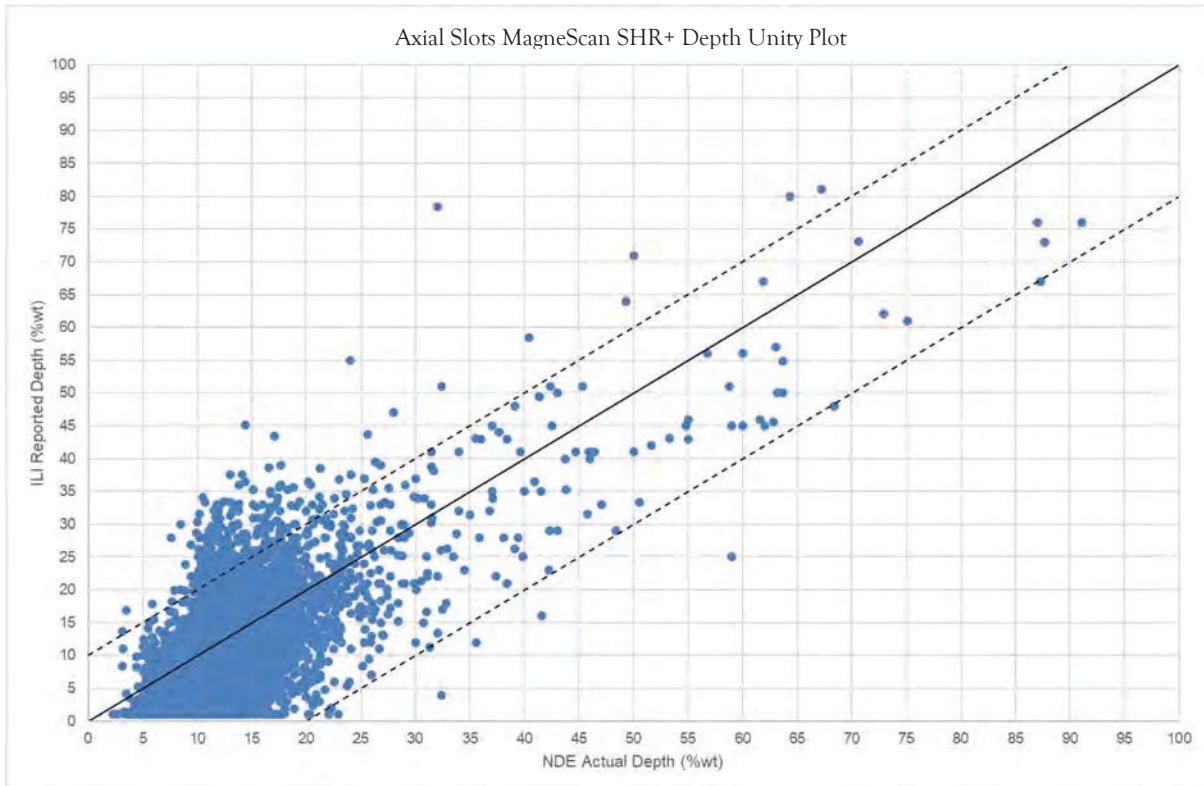
Figure 3: Baker Hughes sizing performance unity plot for axial slots

By utilising triaxial MFL data and combining the different signal measurements, Baker Hughes can resolve those axial slotting defects which are complex e.g., have additional interactions. Baker Hughes’ current performance example for MagneScan™ SHR+ (Super High Resolution Plus) can be seen in Figure 3 at 95% confidence level within the reporting specification.

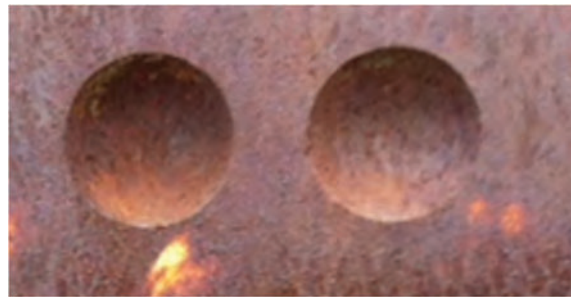
Figure 12a: Axially aligned pits

The theory of utilising multiple measurements from the triaxial sensors to identify complex corrosion morphology can be illustrated by considering and contrasting the signals recorded from three simple examples. In the first, Figure 12a, consider the interaction between two isolated axially aligned pits:

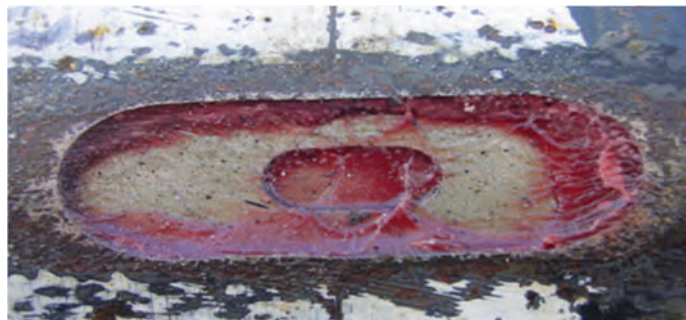
Figure 14a: Defect within defect

The third example shows a slightly more complex scenario of possible defect morphology - an axial slot with an additional axial slot within it. Figure 14a shows the defect shape as-machined - sometimes referred to as a “defect-within-defect”.

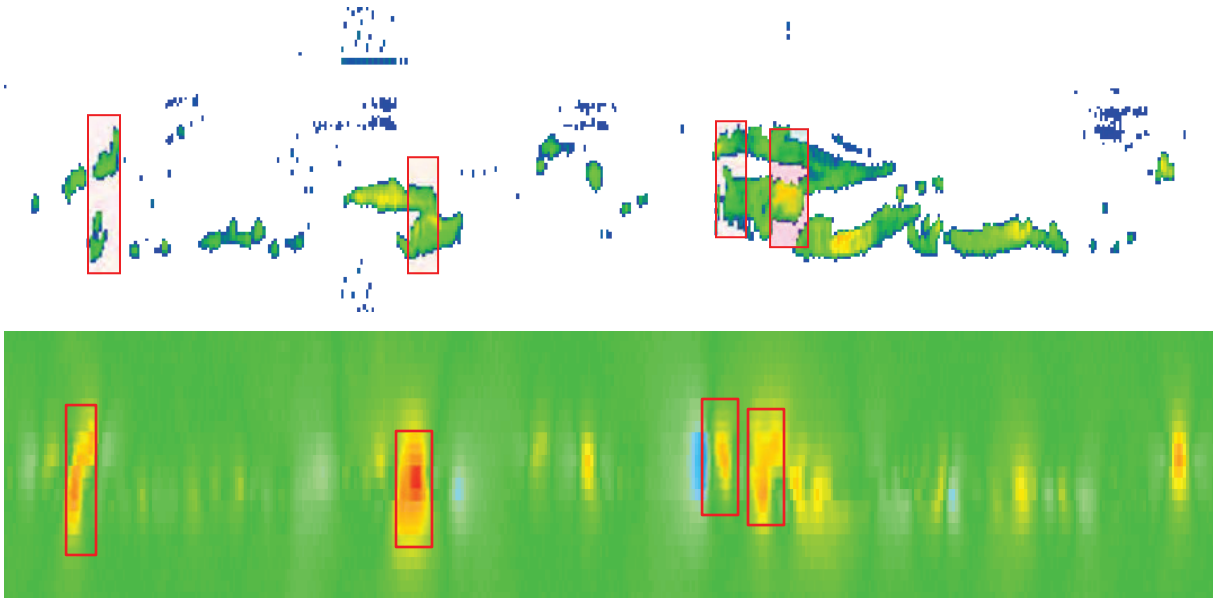
Figure 16: Axial aligned corrosion laser scan and axial component ILI signal

Figure 16 illustrates the same area juxtaposed with the axial component ILI signal data of an axial MFL inspection, shown in a false colour display. An examination of the largest amplitude areas, again shown in yellow and red and highlighted on the laser scan, show they are not necessarily the deepest sections but rather where the ILI signal is amplified due to the corrosion being wide or circumferentially interacting. This is to be expected as the circumferentially aligned corrosion deflects more magnetic flux for the same metal loss volume as explained in the previous sections. In contrast, the axially orientated areas do not stand out.

Utilising axial only, the axial MFL data does not help in identifying the most important aspects of the corrosion, although the trained analyst eye can already detect hints of the true nature of the features.

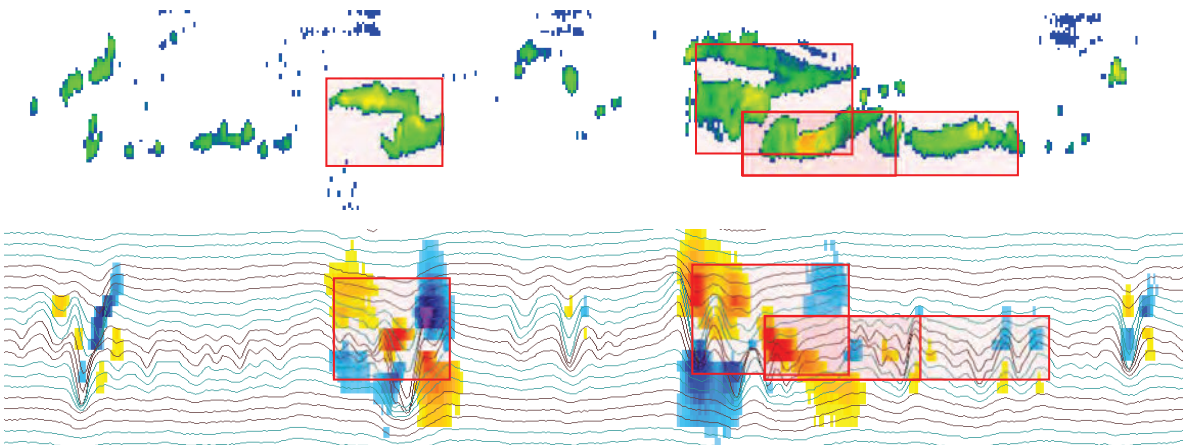
Figure 17: Axial aligned corrosion laser scan and axial component / transverse component overlay ILI signal

Figure 17 shows the same area, now with the transverse sensor ILI data. Rather than false colour, the ILI data is displayed in an “overlay” view where the simpler axial component signal is displayed in trace plot and with the transverse signal displayed in false colour.

The transverse quadripolar signal highlights the overall extents of the connected areas of corrosion. The second area is more complex as it consists of two areas with a common start point, but this is still evident as the signals in the trailing area clearly indicate only the end of a corrosion site. These can be contrasted with the self-contained signal of the isolated pit on the far right of the scan.

The quadripolar signals in the transverse visualisation indicate the areas of corrosion which can be considered connected or axial, and then assessed in more depth using the radial signal.

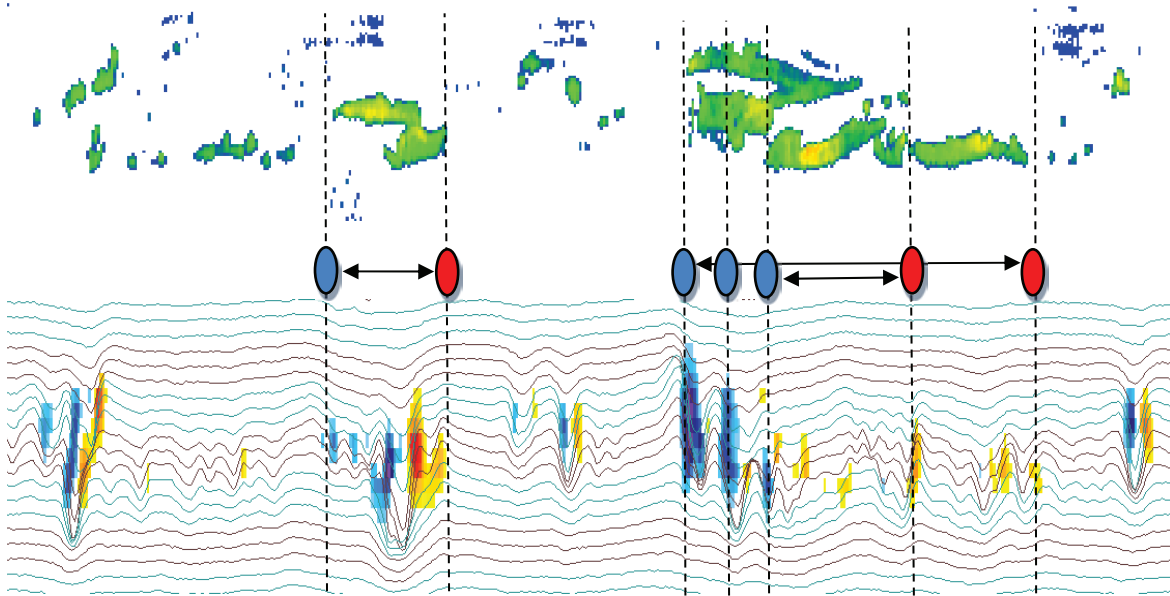
Figure 18 shows the same area, now with the radial sensor ILI data overlay. This allows the depth changes within axial areas to be visualised and quantified in more detail. The radial poles indicate magnetic flux leakage in the direction out and into the pipe wall, which can indicate respective increases and decreases in corrosion depth. The major start and end of the axial corrosion sites have been added to the diagram for clarity. In the Baker Hughes analysis software, the visualisation is adaptive to also display the finer details in the depth variations not visible below, and each aspect of the signal can be measured and utilised in the sizing process to quantify the depth variations in the corrosion.

Figure 18: Axial aligned corrosion laser scan and axial component / radial component overlay ILI signal. The red/blue ellipses indicate the predominant start/end of axial corrosion areas.

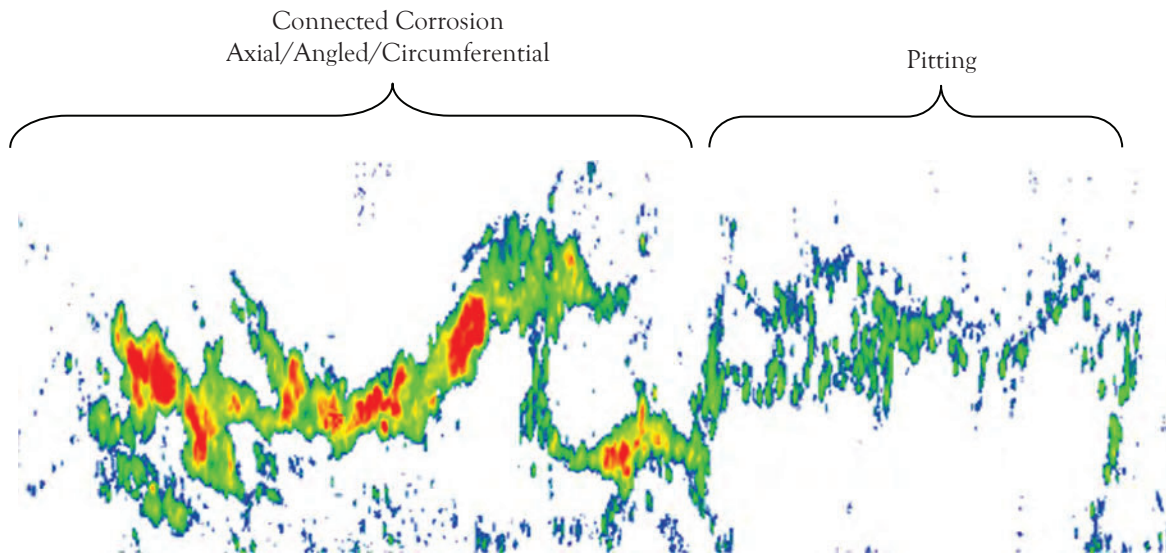
Figure 19: Connected complex corrosion laser scan

Some examples of the distinctions that must be identified for accurate categorisation and assessment are shown in the figures below. Figure 19 shows an area of corrosion which is certainly axial, but also has portions which are angled and circumferential in nature. It also shows areas of connected corrosion and dense pitting, which must be distinguished (using the principles shown in Figures 12c vs 13c) correctly for depth and pressure assessment.

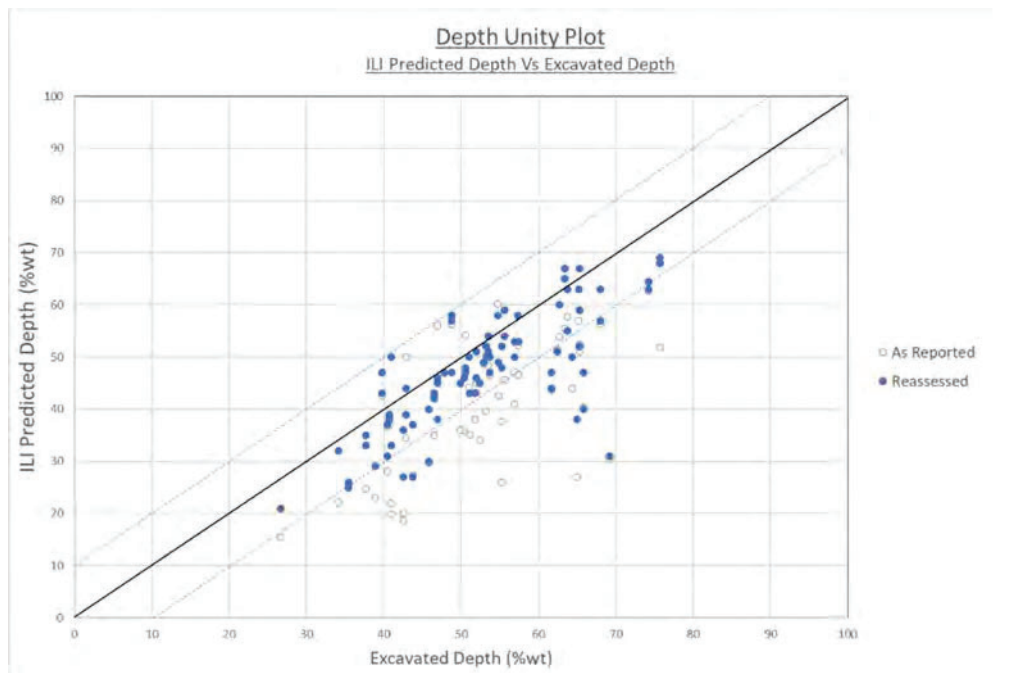
Figure 21: Depth performance unity plot

After applying the improved categorisation and analysis techniques, the depth performance could be improved significantly to 83% within $\pm 10\%$. Figure 21 shows a unity plot of both the original and new predictions.

Note that Figure 21 shows the depth performance for all sites in the study; some sites had multiple deeper sections for which the depth could be assessed independently.

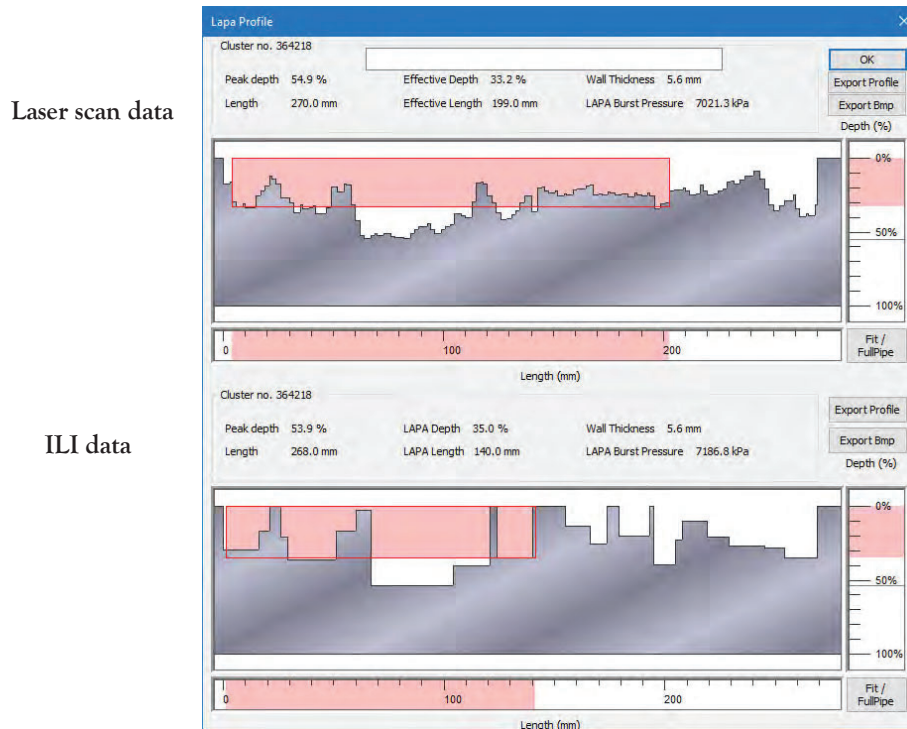
Figure 22: Depth profile and burst pressure comparison software visualisation

Peak depth under calling is certainly associated with non-conservative burst pressures but for larger areas it is often not the critical factor. In Figure 22 for example, the peak depth and overall depth profile are accurately predicted in the ILI data (on the lower profile), and the variation in burst pressure is driven by the absence of low level or “background” corrosion between the corrosion boxes detected by the ILI decreasing the effective length. The treatment of the “connecting” low level corrosion was often critical to accurate burst pressure prediction.

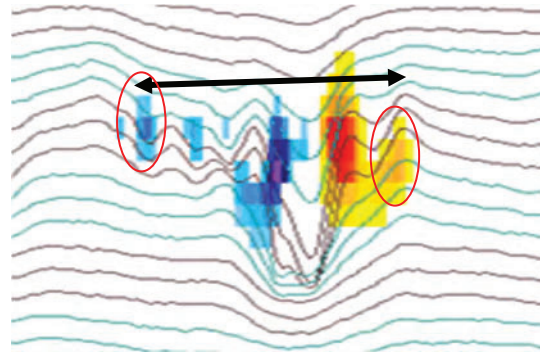
Figure 23: Background corrosion signal identifiers

Similar to the depth assessment, techniques were identified to recognise and address each of the root causes for under calling predicated pressures. In particular, updated techniques to measure or assess the extent, depth and impact of “background” corrosion were developed. In basic terms, the extent of this background is often associated with the “outside” poles of the ILI signal and may affect the depth sizing of any corrosion features contained within it. Figure 23 shows a subsection of the data shown in Figure 18, with the background corrosion poles identified, the arrow indicates the full extent of the corrosion.

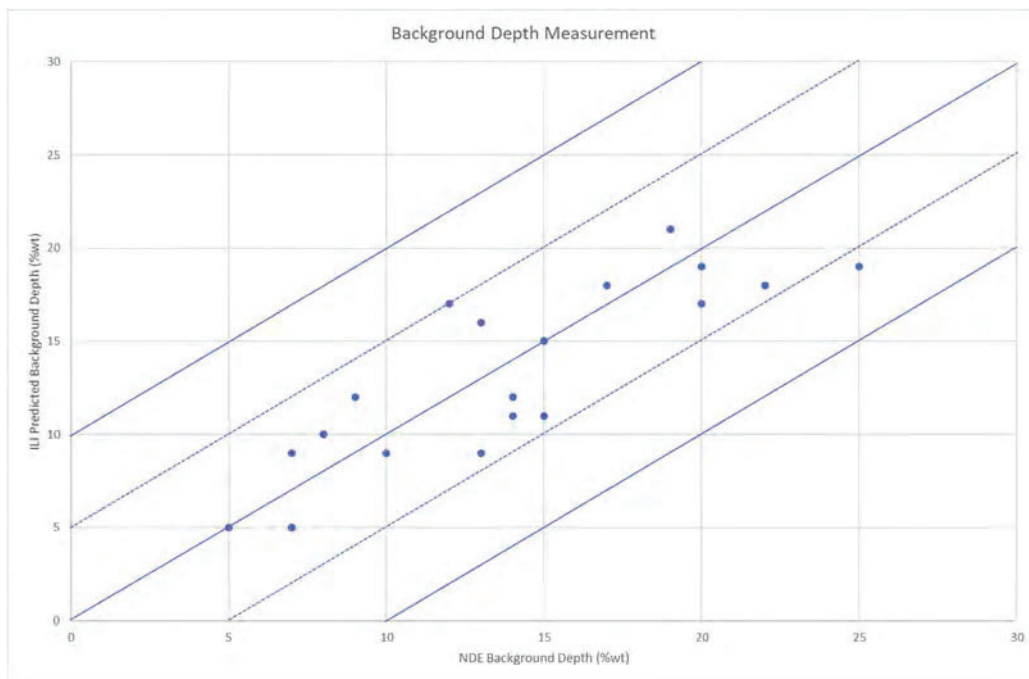
Figure 24: Background corrosion performance on selected sites

Following assessment of the background corrosion on selected sites, the performance against an NDE corrosion depth estimated from the laser scan profiles was performed, and it was found that the accuracy was within 5%wt for all but one feature (Figure 24). The high accuracy is partially explained in that depth of these areas is usually relatively low level compared to associated pitting, slots, or grooves. Despite the shallow depth, the length of the background corrosion can have a significant effect on the burst pressure, and so accuracy is important.

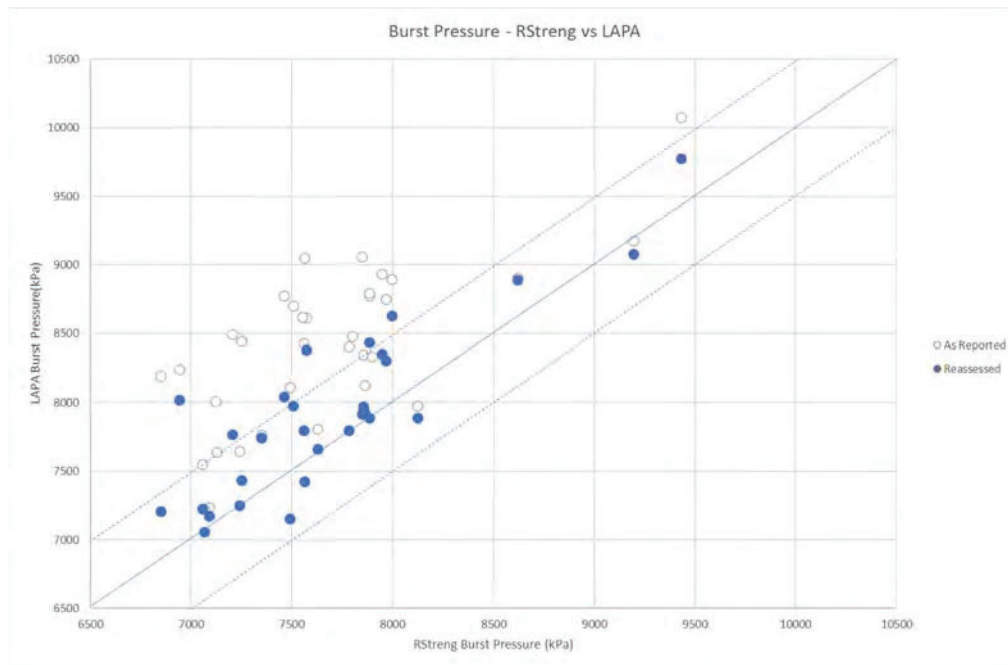
Figure 25: Burst pressure performance on selected sites

The results of the pressure assessment are shown in the unity plot in Figure 25. In general, the original burst pressures were non-conservative due the factors described above, with only 37% of the sites being within 500 kPa of the laser scan derived value. After re-assessment with the revised process, 77% of the sites were within 500 kPa.

Note the number of points assessed is lower than the total number of sites in the study as the small area of some sites meant the burst pressure was purely depth driven, and the data below in Figure 25 is focused on the more complex larger corrosion areas where the pressure outliers were more pronounced.
