Integrity Assessments of In-Line Isolation Tools: How to gain Assurance on New Technologies, Approval, Testing and Live Trials

Pipeline Pigging and Integrity Management Conference

Proceedings of the 2024 Pipeline Pigging and Integrity Management Conference.

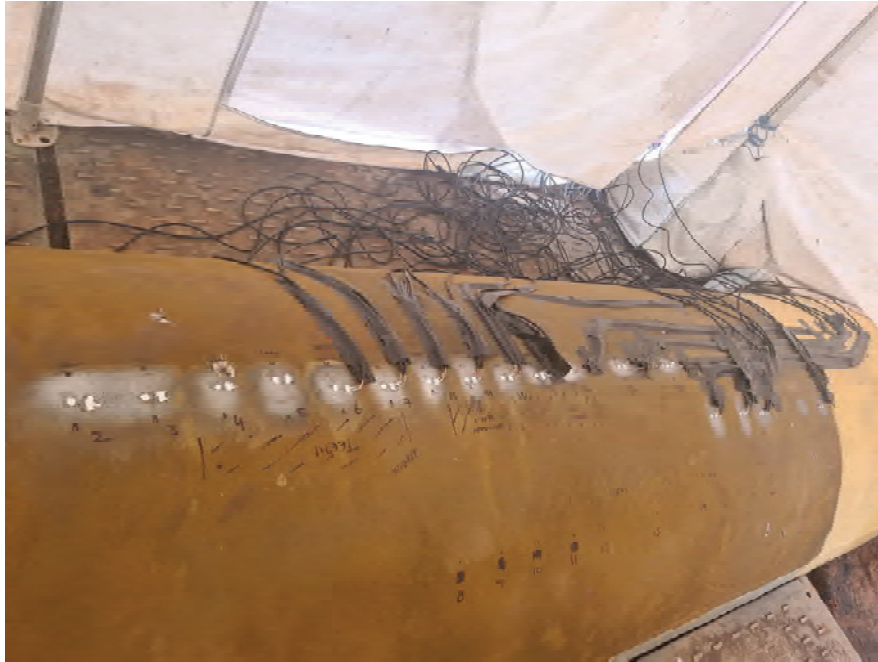
Figure 3. Strain gauges installed at site

The gauges were connected to four Vishay System 8000 StrainSmart data acquisition systems each with 8 input channels. These systems were daisy chained together to give a total of 32 channels (note that each biaxial gauge requires 2 channels) to allow monitoring to occur in both directions rather than only the hoop as per the factory testing. The scan rate was set at six samples per minute to keep the output files to a manageable size.

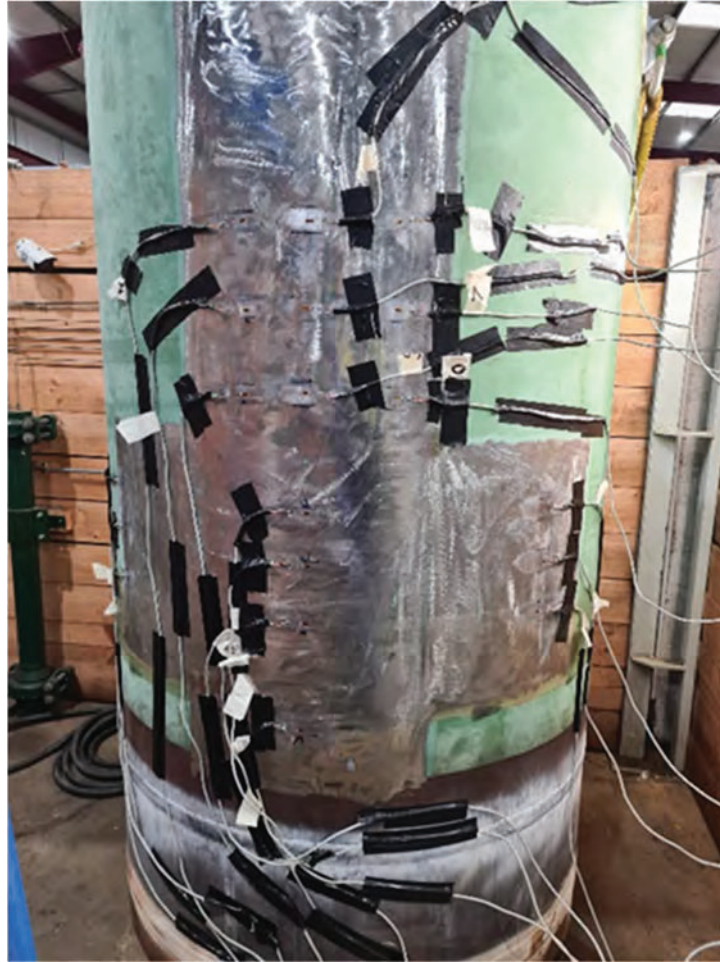
Figure 4. Installation of strain gauges by DNV during FAT

National Gas appointed DNV to support them during the factory test with a mock-up installation testing the STATS in-line isolation tool. This involved the installation of several uniaxial strain gauges to the external surface of a 48" diameter grade X65 pipe with nominal wall thickness of 22.5mm. The output from these gauges were then recorded whilst the Tecno Plug was deployed in the pipe. A subsequent repeat test, this time on grade X80 pipe with 15.9mm nominal wall thickness, was conducted for further assessment.

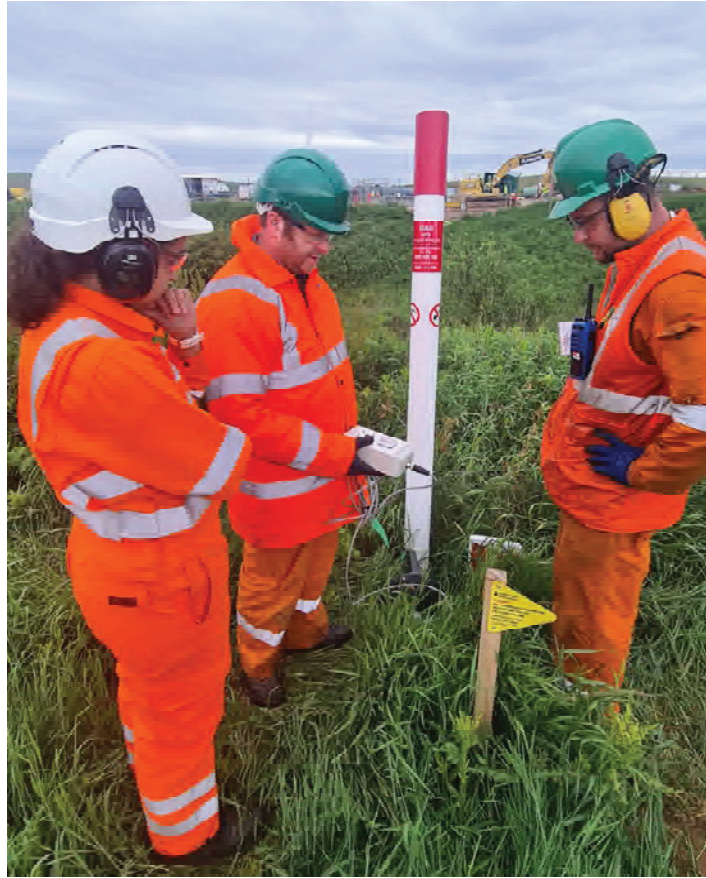
Figure 6. Tool tracking

Where the launch operation differs from standard inspection process is the need to ensure the exact location of the tool is known and tracked from launcher to set location. The tool travels at 2-3m a minute and is constantly tracked and monitored by technicians “walking” the tool and close communication for valve operation. It should be noted the tool was not being deployed any great

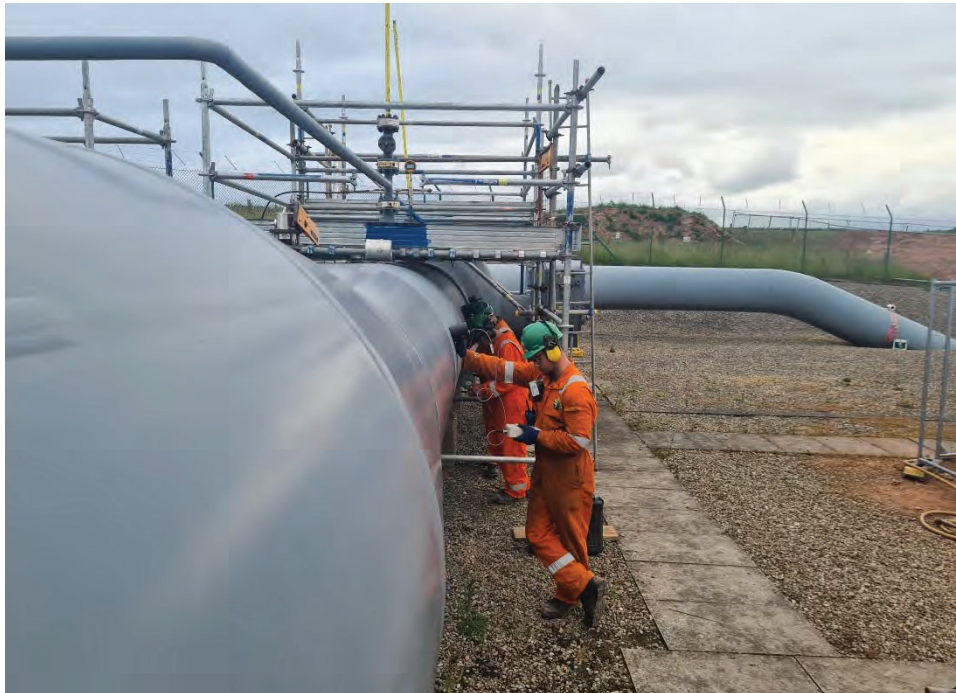
Figure 7. Close monitoring of tool location at receiver

The tool was again walked back the launch site at the very controlled pace with only a minimal section un-trackable due to ground conditions. The weight of the tool also had to be considered, with the speed carefully managed on the approach, so as to ensure the tool travelled back to site but did not land heavy and impact the door closure. The tool was brought to a controlled stop with a high degree of confidence in the correct location, which was confirmed when the door was opened.
