# The Present and Future of Practical Pipe Body Hard Spot Integrity Management

Michael Rosenfeld<sup>1</sup>, Bill Amend<sup>1</sup>, Simon Slater<sup>2</sup>

*Proceedings of the 2025 Pipeline Pigging and Integrity Management Conference.*

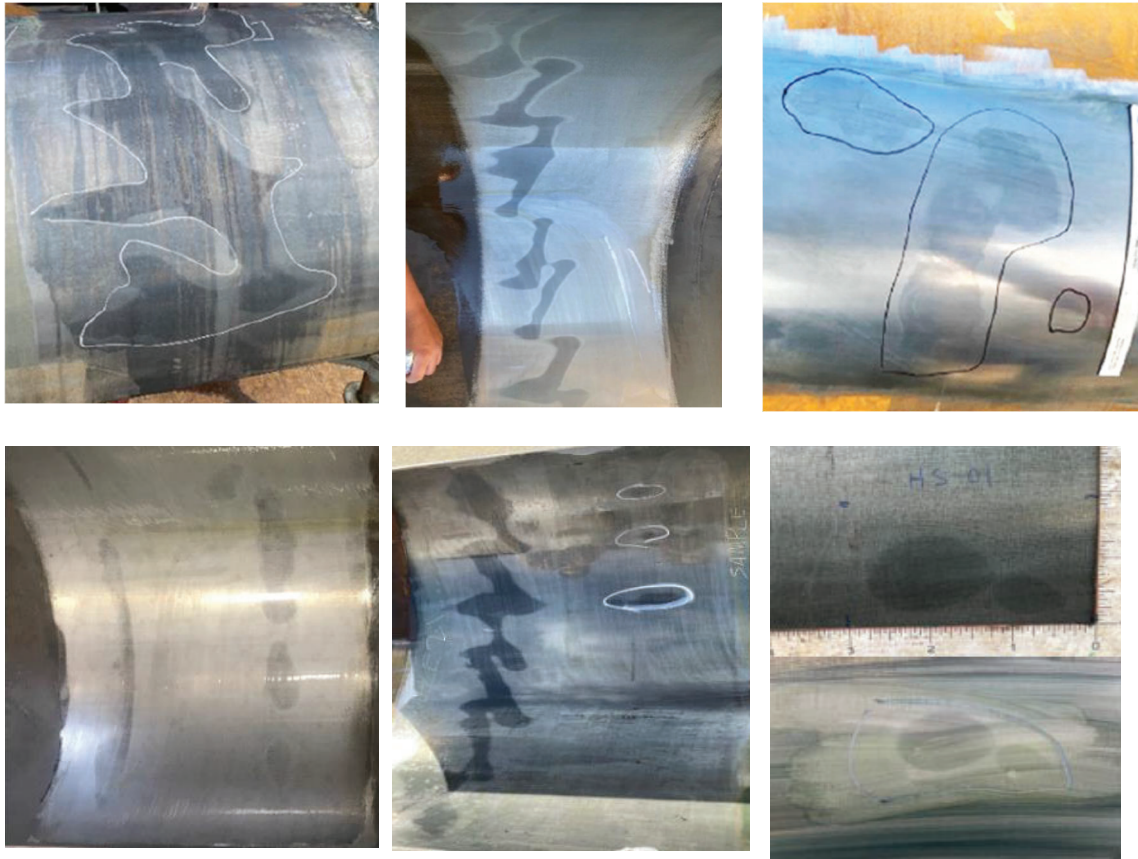
**Figure 1.** Example of different hardness anomaly morphologies observed on the pipe surface

Hardness anomalies exhibit a variety of morphologies. Patterns include sawtooth, splash, single or multiple spots, elongated or oval spots, or nearly round spots. Examples are shown in Figure 1 [4]. Hard spots may occur on the exterior or the interior, can be subsurface or embedded, or extend through the wall. Metal hardness is usually nonuniform through the wall. They may be created from either or both surfaces. The flat plate may be flipped one or more times during the plate manufacturing, inspection, shipping, or pipe forming processes, so hardness anomalies cannot always be assured of being on the outside of the pipe. However, none of the ruptures, leaks, or cracks associated with hard spots for which a metallurgical examination was performed (fewer than half of the incidents) initiated from the inside surface. This may be consistent with the role of CP or external

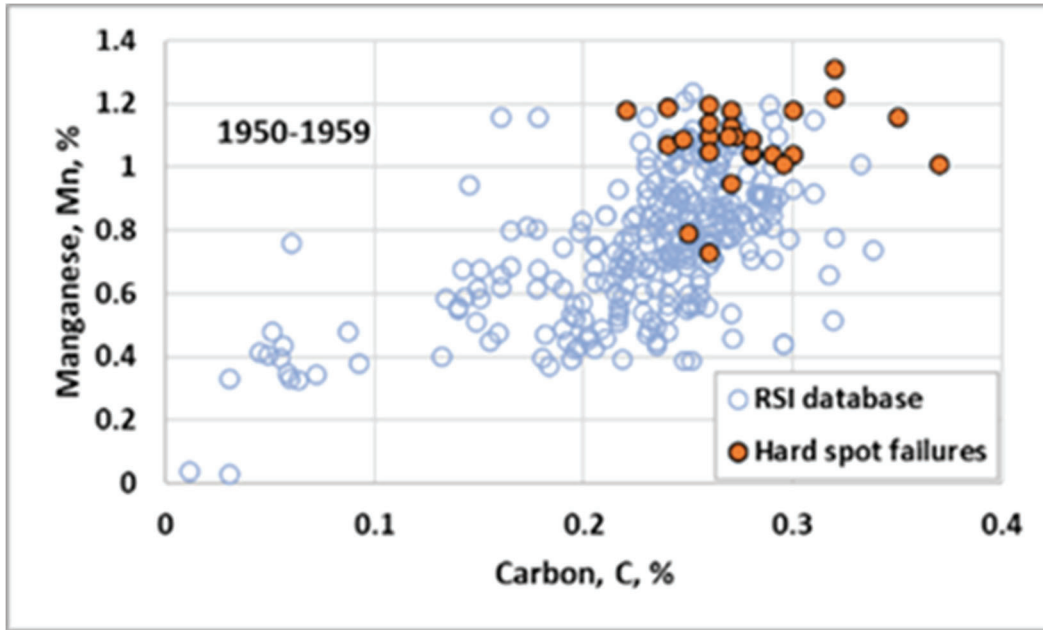
Figure 2. C-Mn composition of hard spot failures compared with general population

Hard spots that failed tended to exhibit richer carbon (C) and manganese (Mn) content than is typical of similar-vintage line pipe, as indicated in Figure 2. A Carbon Equivalent (CE) of 0.45 represented the 45th percentile for hard spot failures but the 80th percentile for the general population of line pipe of similar vintage.

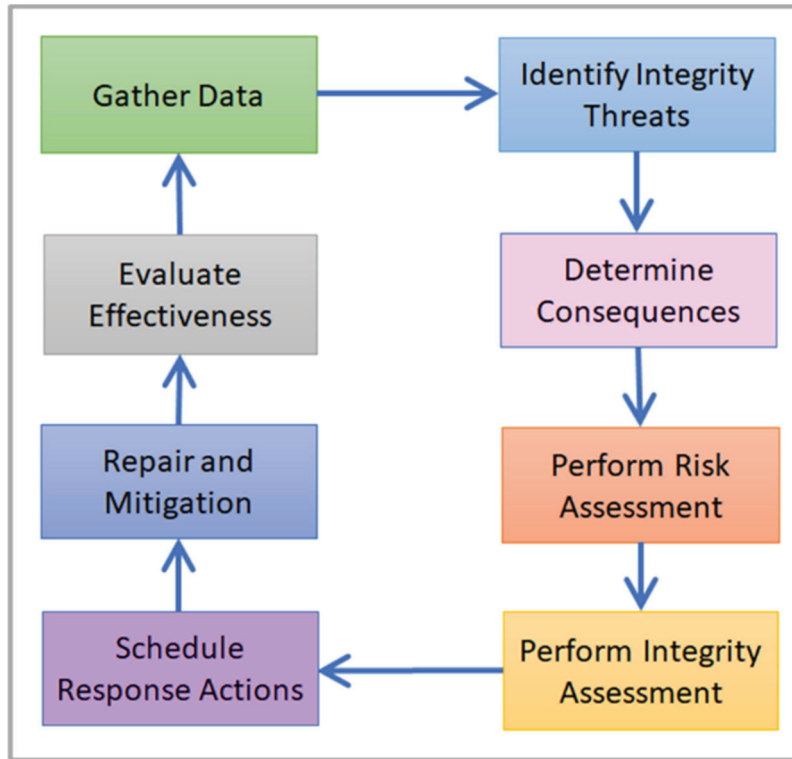
Figure 3. Simplified integrity management process cycle

Figure 3 provides structure for subsequent discussion in this paper, mainly around identifying the scope or severity of the hard spot integrity threat, performing the integrity assessment, prioritizing response to the assessment, and making decisions around repair and mitigation. The authors further note that pipeline operators are already executing on their interpretation of how the IM process applies to the hard spot threat in their systems.

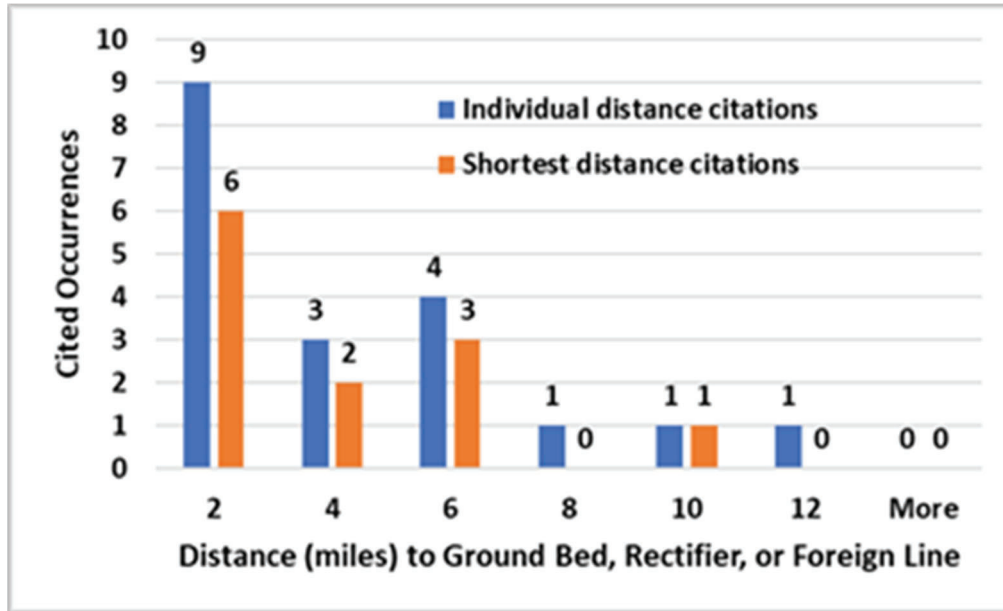
Figure 4. Cited distances to source of cathodic protection or interference

A strong trend of proximity to sources of CP current or interference was evident in the incident review, Figure 4. Apparent sensitivity to cathodic hydrogen is consistent with laboratory studies already cited, and others. No trend with distance downstream from compressor stations was apparent.

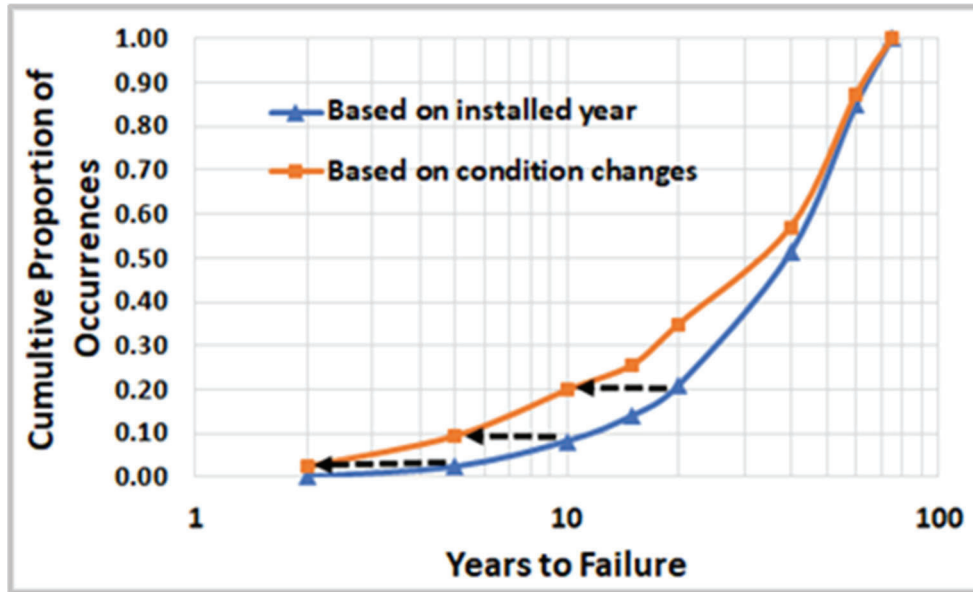
Figure 5. Cumulative distribution of time to failure

Time to failure in hard spots ranged from 2 to 70 years. Changes in operating conditions associated with the cathodic environment due to additional anode ground beds nearby, recorded increases in rectifier output, or flow reversals resulted in shortened time of failure in 50% of cases, Figure 5. When compared to simple service age, time to failure was reduced by half or 10 years, whichever was less. These observations are consistent with laboratory studies of the influence of cathodic hydrogen on cracking time to failure, Figure 6 [12].

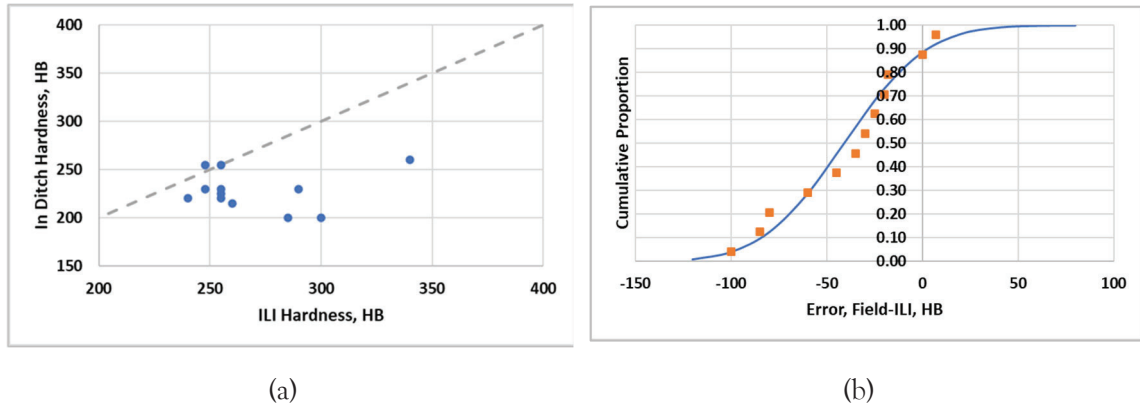
Figure 8. Hard spot ILI results for Operator C

Figure 8(a) is a unity plot for a small data set of 12 hard spots from Operator C. There appears to be a strong tendency for the ILI tool to overpredict the hardness. This is verified in Figure 8(b). The error again looks like a Gaussian cumulative distribution but the ILI system overpredicted the

hardness by 41 BHN on average with a standard deviation of 34 BHN. So, the average error or bias is larger but the scatter is less, compared with Operator B’s data.

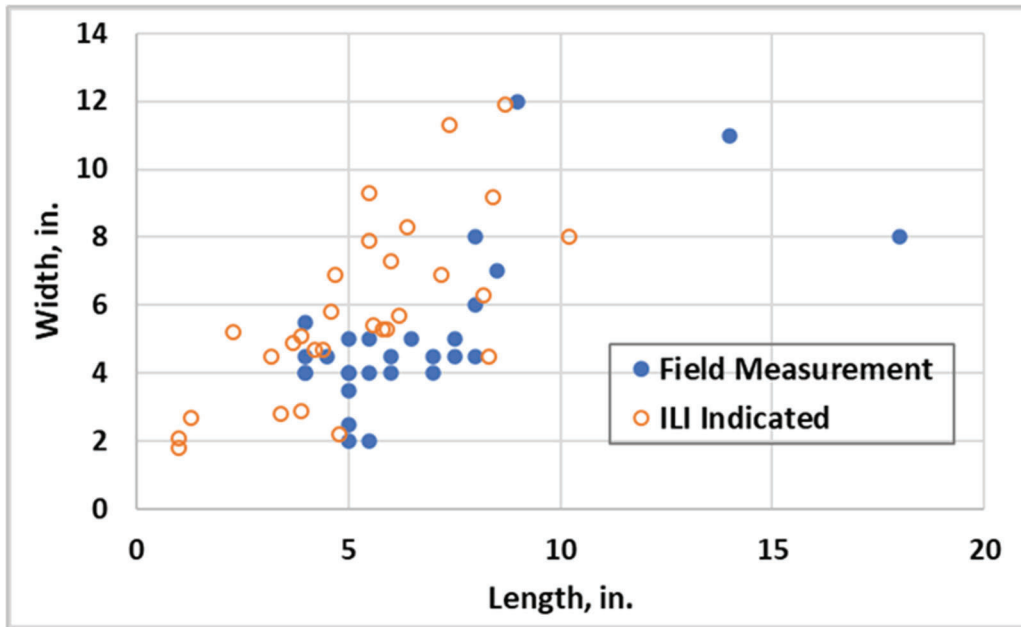
**Figure 10.** Example comparison of indicated and measured hard spot dimensions

Figure 10 compares the lengths and widths as indicated by ILI (orange open symbols) to the lengths and widths as measured in the field (blue solid symbols). Two observations are made. Firstly, length and width generally increase together. Most of the hard spots affecting this particular operator’s pipe (manufactured by Bethlehem Steel) are relatively round or oval in shape. Secondly, field dimensions tend to be a bit smaller than what was indicated. These observations apply to this variety of pipe in one operator’s system, inspected by one ILI system. They cannot be generalized to all hard-spot-susceptible pipe or all ILI hard spot assessment systems.

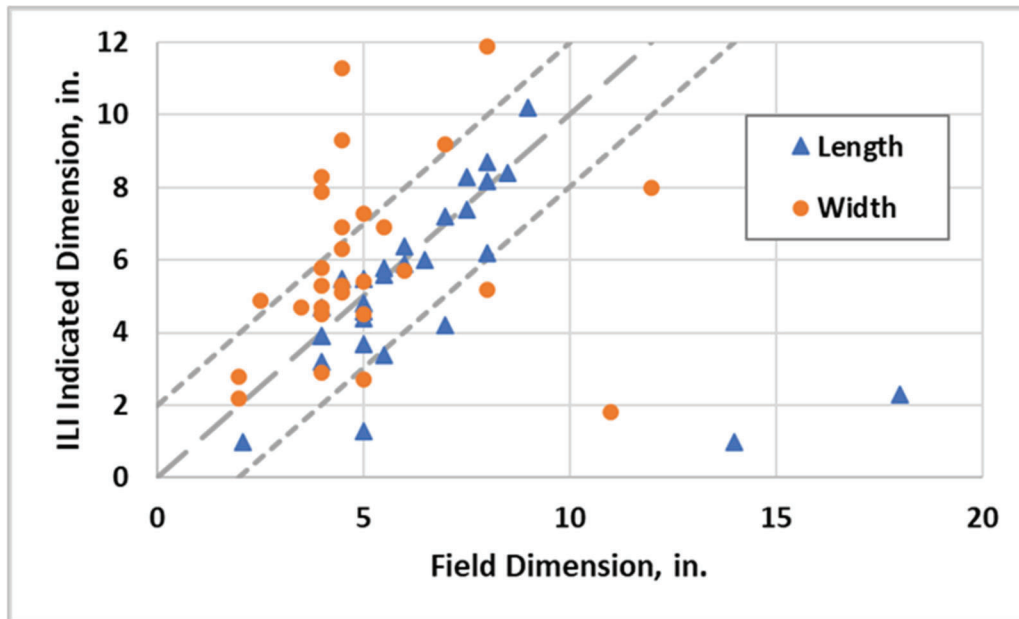
Figure 11. Unity Plot for hard spot lengths and widths

Figure 11 is a unity plot of the same data comparing ILI indicated length against field measured length (blue triangle symbols) and ILI indicated width against field measured width (orange circular symbols). (This is actually two unity plots in one which is only possible because the two dimensions are of similar magnitude.) The central diagonal line represents perfect agreement between the ILI indicated metric and the field measurement while the upper and lower diagonal lines represent an arbitrary error band of  $\pm 2$  inches (50 mm).

The ILI tool underpredicted the lengths by 1.3 inches on average; 82% of the features fell within  $\pm 2$  inches, however, a few were far outside that range. The reason for such large discrepancies should be evaluated. The tool tended to overpredict the width with a lot of scatter; only 54% of the features fell within  $\pm 2$  inches. This may have to do with the primary axis of magnetization being longitudinal. The length dimension is more important from the fitness for service standpoint, which is why an understanding of the few cases of large error on the length estimate should be evaluated more closely. It should also be noted that ILI reports the anomaly with one hardness value over the full area, whereas in-ditch nondestructive examination is usually applied to map out a range of hardness across a grid. Where the hardness anomaly ends is difficult to define as the high hardness region transitions to pipe body hardness, especially if the shape is not a simple 'spot'.

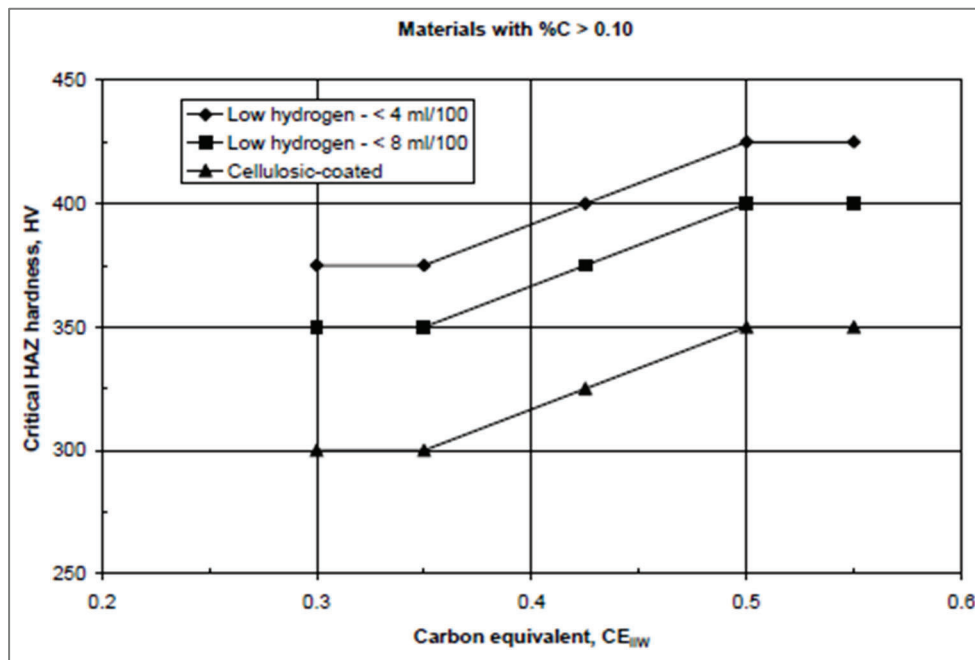
**Figure 12.** Critical Hardness Level for In-service Welds vs. CE IIW and Weld Hydrogen Level (Bruce, et al [17])

martensite is susceptible to cracking from hydrogen that enters the weld zone during the welding process. The steel composition expressed as carbon equivalent ( $CE_{IIW}$ ), can be related to the amount of hydrogen in the weld zone (based on details of the welding process and welding consumables), and the maximum acceptable hardness [19]. As illustrated in Figure 12, the allowable hardness to avoid weld HAZ cracking decreases as  $CE_{IIW}$  decreases (since the hardness of martensite also decreases with lower %C) and as the amount of diffusible hydrogen increases. HV 300 was determined to be a “safe” maximum hardness for all studied carbon equivalents and hydrogen levels, but appreciably higher hardness values are acceptable at some combinations of higher CE and/or lower hydrogen content. The illustrated lower limit of 300 HV for welds made using cellulosic flux-coated consumables (i.e., EXX10 SMAW electrodes) on low carbon equivalent steels is comparable to, although slightly lower than, the hardness limits of HV 320 [20] and HV 318 (from MAT-7-2) for hardness values below which effects of hydrogen embrittlement appear to be minimal, regardless of steel composition.
