Overcoming Operational Obstacles: A Collaborative Approach to an In-Line Inspection of a Unique Mexican Gas Pipeline

Proceedings of the 2025 Pipeline Pigging and Integrity Management Conference.

Abstract

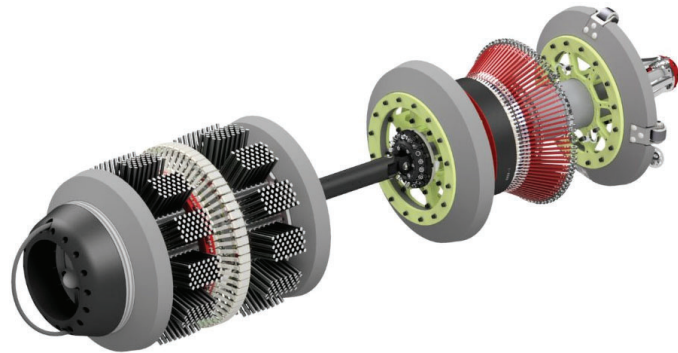
Figure 2. NPS 24 TriStream MFL™ configuration

Likewise, the ILI vendor reviewed and presented the current operational parameters of the standard configuration NPS 24 TriStream MFL™, a brushed and cupped magnetizer (MV) that tows the cupped supported caliper, recorder, IMU module (Figure 2). The ILI vendor reviewed past run history in conventional free swim applications, pull tests and unidirectional wireline tether pulls. The results showed that the DP of the standard tool was approximately 21 psi. The cups and brushes generate the drag and therefore resulting DP to propel the tool down a pipeline. Given the number of cups on the standard configuration and that the brushes are setup to saturate a WT much greater than the WT within the Mazatlán system, in conjunction with the line speeds being slower, there was an opportunity to minimize the drag on the standard configuration, by optimizing the tool subsystems including: magnetic path (brushes) and cups for this line.

The DP of the standard tool was approximately 21 psi. The cups and brushes generate the drag and therefore resulting DP to propel the tool down a pipeline. Given the number of cups on the standard configuration and that the brushes are setup to saturate a WT much greater than the WT within the Mazatlán system, in conjunction with the line speeds being slower, there was an opportunity to minimize the drag on the standard configuration, by optimizing the tool subsystems including: magnetic path (brushes) and cups for this line.

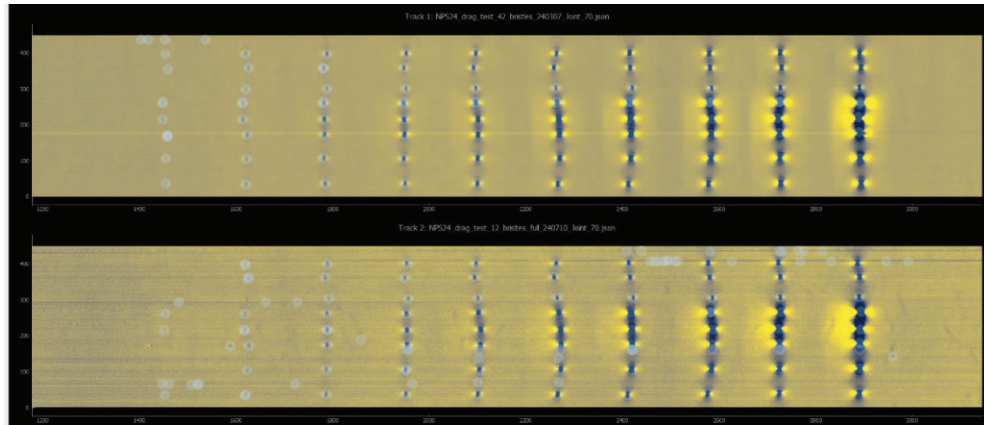
Figure 11. POD comparison using automated analysis in the HWT at speed missioning

speed. A review was completed to see if the POD was impacted due to the significant change in EML/ABL levels because of the brush configuration. Using automated analysis, all features that are currently within the TriStream MFL™ specification were identified. Therefore, the POD was not impacted by the brush configuration change. The features within the HWT pipe segment that were identified using automated analysis are shown in Figure 11, comparing the standard tool brushes against the pack selected for this project

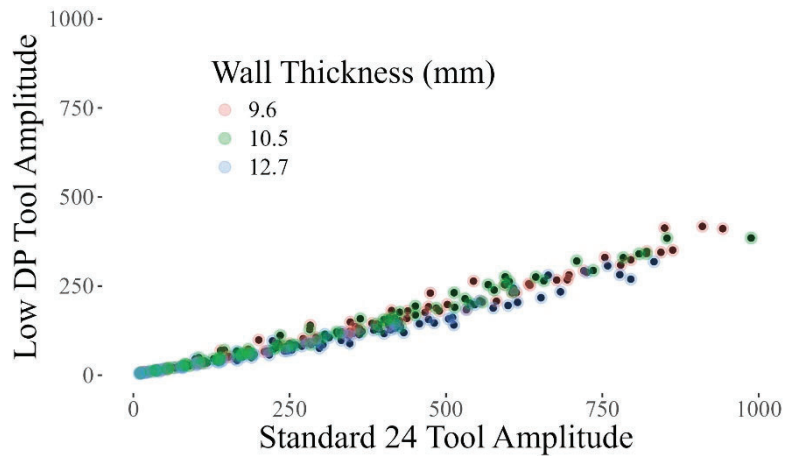
Figure 12. PA unity plot for NWT and HWT

A detailed feature signal analysis was completed to understand the impact of the lower magnetic saturation due to the final brush configuration. As expected, for the same feature, the peak amplitude (PA) measured by the final configuration tool was lower as compared to the standard tool, this change was constant, predictable and as expected. Figure 12 shows the PA of the axial component for the same features of the standard tool as compared to the final configuration for WT 9.6 mm, 10.5 mm and 12.7 mm. Unity of the PA for the same feature would be preferred, given the difference in magnetic strength, the PA on the final configuration was lower. While the PA was a tight fit to the line, the slope is different, which indicates the need to tune the feature sizing model to adjust for this difference.

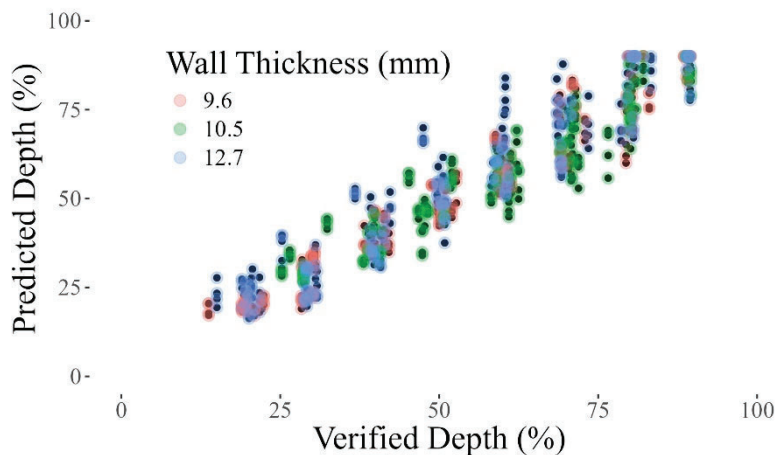
Figure 13. Unity plot for ALG 125, adjusted model specific for this tool configuration

The axial PA analysis demonstrated the need for sizing algorithm adjustment to meet specification. Since the essential variable change surrounded magnetic strength, the current algorithm was able to be tuned for this difference. The unity plot below, Figure 13, shows the blind sizing performance after tweaking the current algorithm specifically for this final NPS 24 LDP tool configuration. This algorithm was a tool specific model required for this configuration.
