Complementary ILI data-driven Analysis to Identify the Interaction of Pipe Geohazards in Colombia's specific Geomorphological Conditions

Lautaro Ganim¹, Edwin Moreno¹, David Classen¹,
Oscar Jair Gualdron², Jaime Aristizabal²

¹Baker Hughes, ²CENIT

Proceedings of the 2025 Pipeline Pigging and Integrity Management Conference.

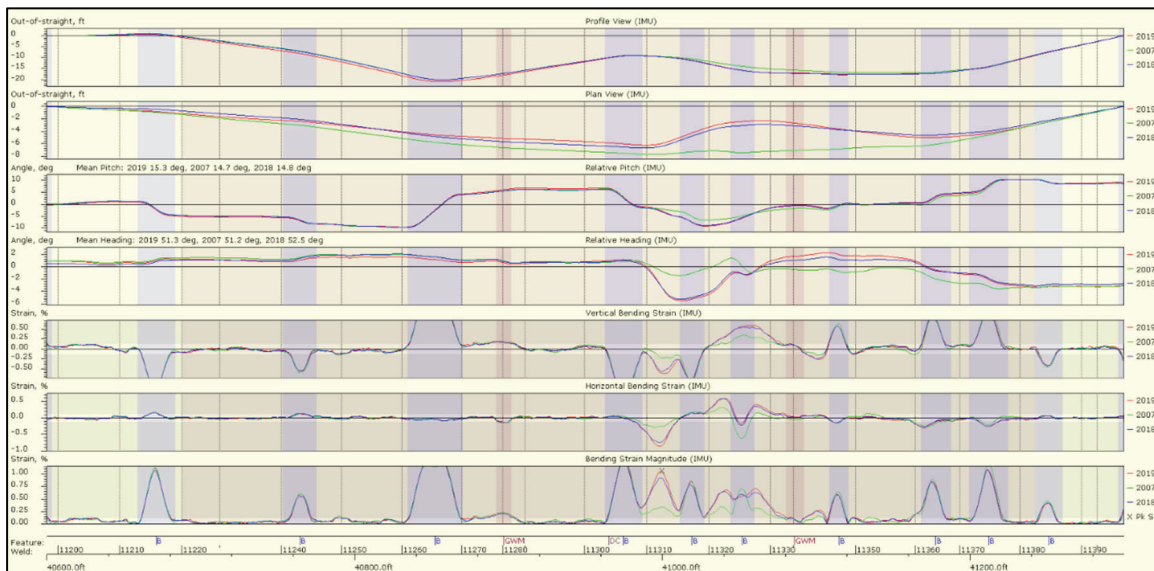
Figure 1. Bending strain plots multiple panels. (Source: Baker Hughes)

During the strain data analysis, bending strain plots are screened to spot signals above the already mentioned thresholds and classify events accordingly (i.e. field bend, deformation, data spike, etc.). In addition to these strain plots, that include the horizontal, vertical and total bending strain, other panels are used. Vertical and horizontal out-of-straightness (OOS) profiles depict the distance between the pipeline centerline and a straight line connecting the start and end of the area of interest. Pitch and heading (or azimuth) represent the tool angle change in the vertical and horizontal plane respectively. Another useful plot includes signals of the IMU gyroscopes, these profiles have a defined signature and are helpful for field bend identification. While bending strain signals can be used to recognize changes in the curvature of the pipeline, when performing a comparison of two or more runs, strain change plots are used to have a direct visualization of those values. Change plots could also include heading, pitch, plan and profile differences. Examples of these plots are shown in Figure 1 and 2 below.

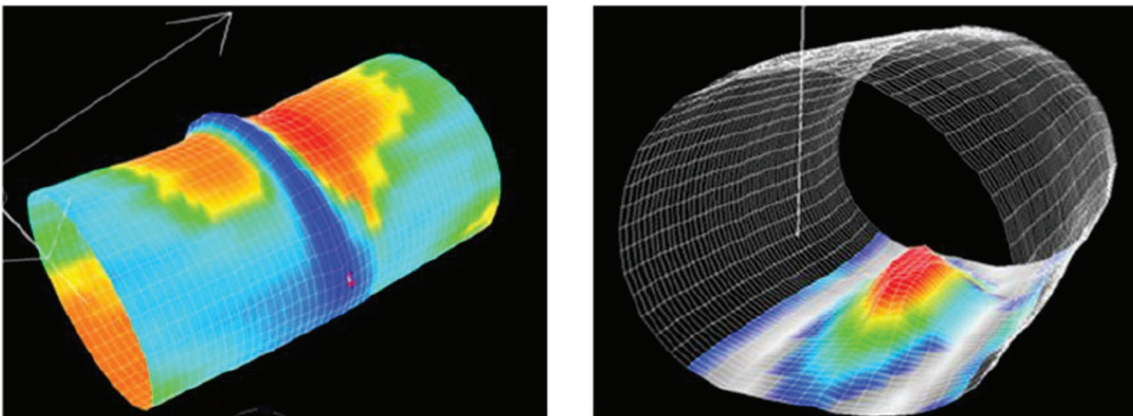
Figure 4. 3-D view representation. (Source: Baker Hughes)

The geometrical data can provide not only a detailed 3-D image (Figure 4) and multiple sectional views but also can be used for fitness for purpose and detailed finite element analysis. Data collected from multiple geometry tool runs can also be used to perform deformation (e.g., wrinkles and dents) growth monitoring due to ground or pipeline movement.

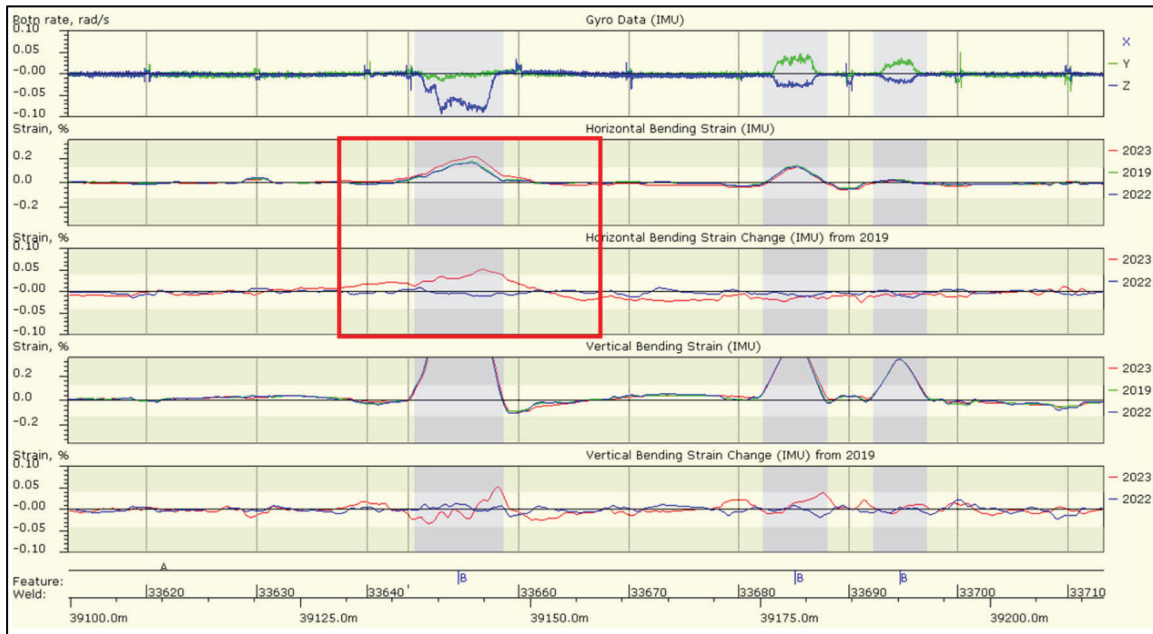
Figure 8. Bending strain plots showing small horizontal strain change. (Source: Baker Hughes)

In this case, during the analysis stage a minimum strain change was visible coincidentally with a field bend. This bend has an under (sag) direction while the strain change can be seen mostly in the

horizontal plane. The change is only visible between 2023 and previous data and is above the reporting threshold at $\sim 0.05\%$. This type of scenario requires extra expertise from the analyst as the change could be masked by the presence of the bend (Figure 8). It is also common to get a response from the opposite direction of field bends in the strain signals that could lead to different assumptions during signal interpretation.

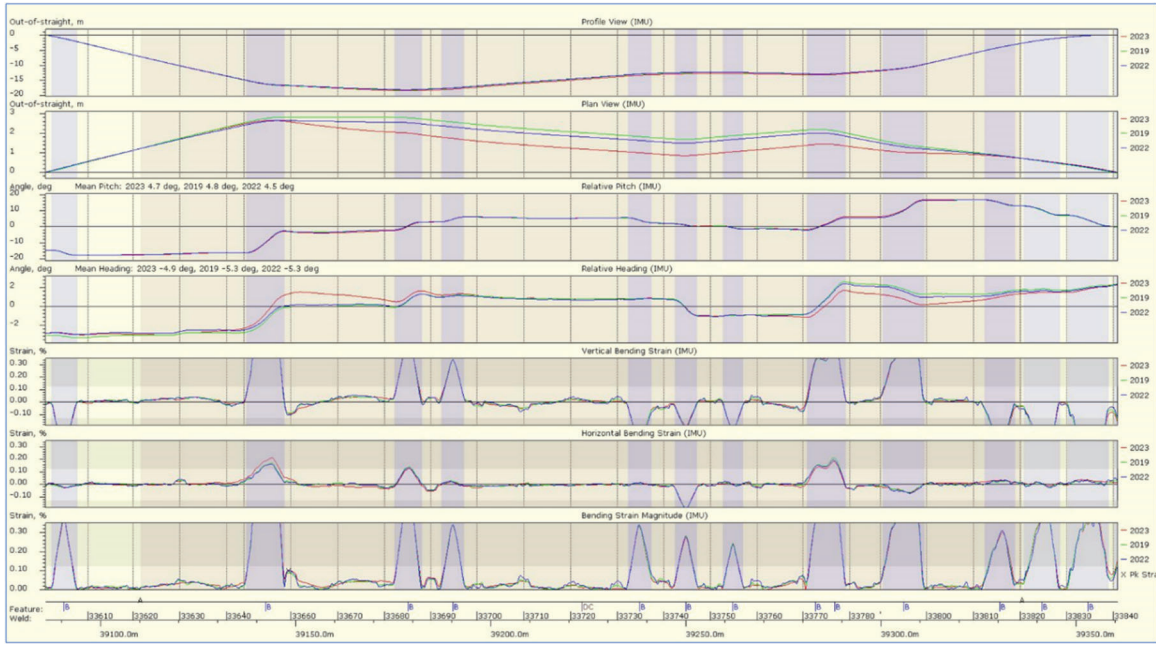
Figure 9. Strain plots showing an extension of ~ 300m. (Source: Baker Hughes)

From this point and with the information of a possible displacement in the area, more plots were brought up for investigation. Considering the extension of the region of concern, all plots were adjusted to show 300m ($\sim 1000\text{ft}$) of the pipeline (Figure 9). Special attention was centred on the plan view difference and heading variation between runs since strain change was predominant in the horizontal plane. This observation led to identification of the displacement in the data.

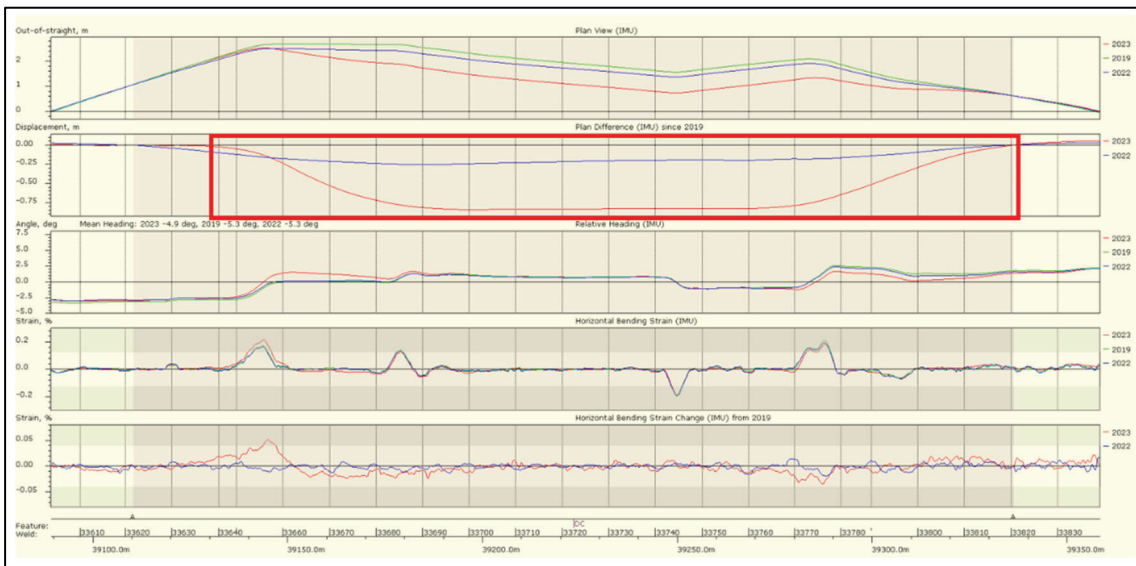
Figure 10. Displacement visible in Plan Difference panel plot. (Source: Baker Hughes)

Based on the horizontal origin of the movement, it is noted that the plan view, which represents the out-of-straightness, shows a variation in the trajectory between the 3 runs. This variation is observed in the plan difference showing a displacement of 0.8m (2.6ft) at its maximum point (Figure 10). It should be also mentioned that the corresponding change in the heading angle helped to determine the limits of the movement. Within the strain change plots there is only evidence of this event at its start, associated with the horizontal strain change observed previously, and close to the end of the displacement with a minimum strain change below the reporting threshold.

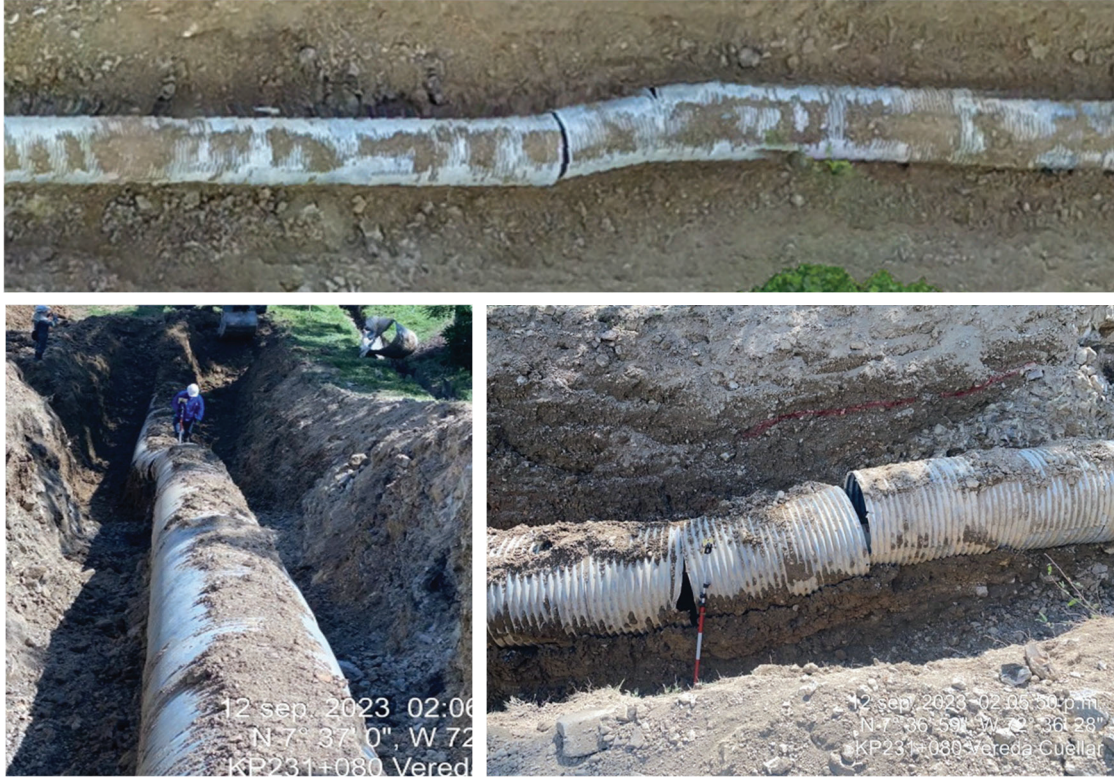
Figure 11. Upstream flank of the movement showing displacement and fracture of the external casing. (Source: CENIT)

This special construction arrangement reduced the actual loading to the pipeline with a visible effect of minimizing the change in the curvature making the identification process not as straightforward. Fortunately, the mitigation system performed as expected supporting the landslide and allowed the remediation action to be planned in a timely manner. Stress relief was first implemented during area excavation. It was noticed that at the upstream flank of the displacement coincident with the horizontal strain change, the external casing was broken. Findings from the in-field verification and remediation of the site can be seen in Figures 11 and 12.

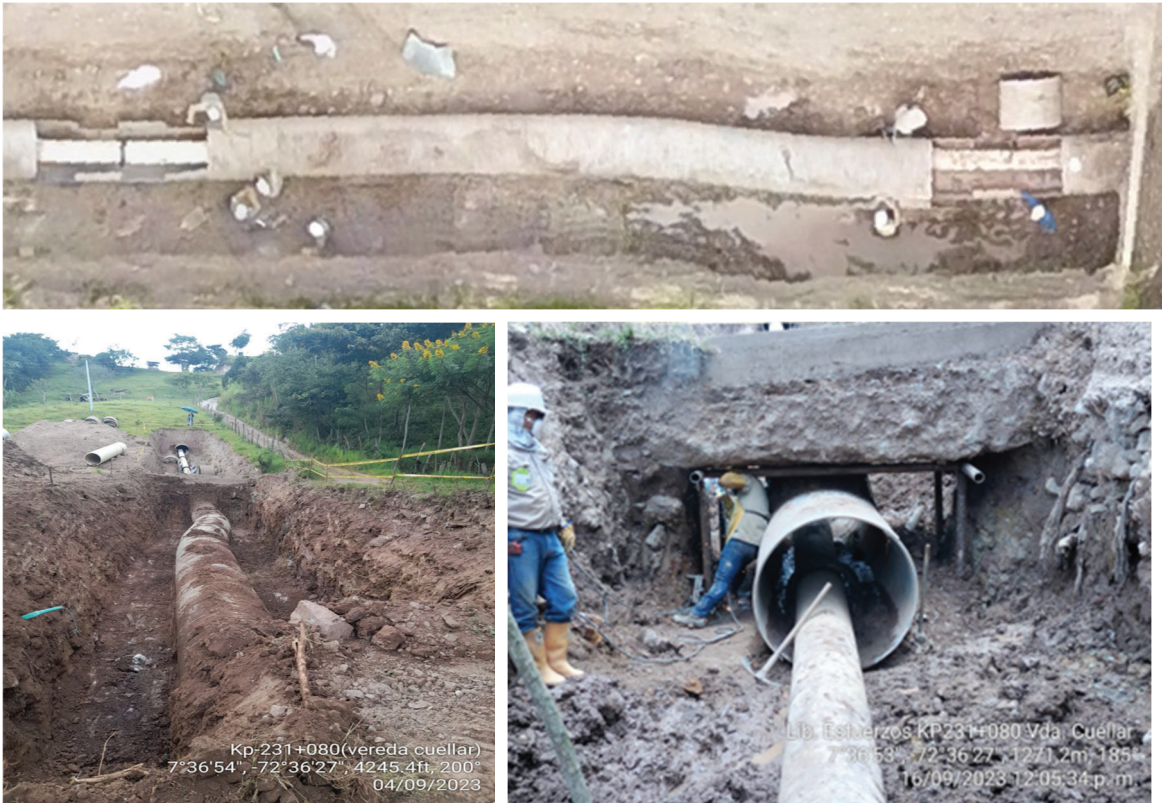
Figure 12. Downstream flank of the movement showing pipeline displacement and eccentric casing section view. (Source: CENIT)

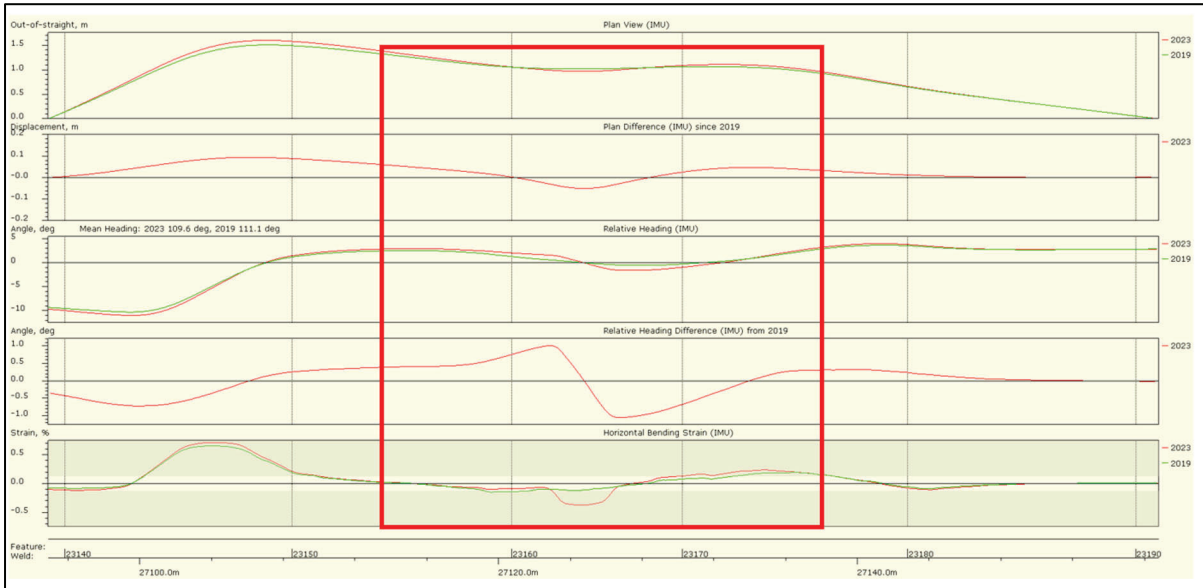
Figure 16. Horizontal strain profile and angle variation. (Source: Baker Hughes)

Strain profile and vertical angle (pitch) showed variation around the area of interest. Profile difference shows a 0.5m (1.64ft) displacement at the wrinkle that corresponds to a 10 degrees angle change visible in the pitch difference plot (Figure 15). On the other hand, horizontal difference was less noticeable with an angle change of 2 degrees represented at the heading difference plot (Figure 16). This is to be expected since the wrinkle was identified at the bottom of the pipe.

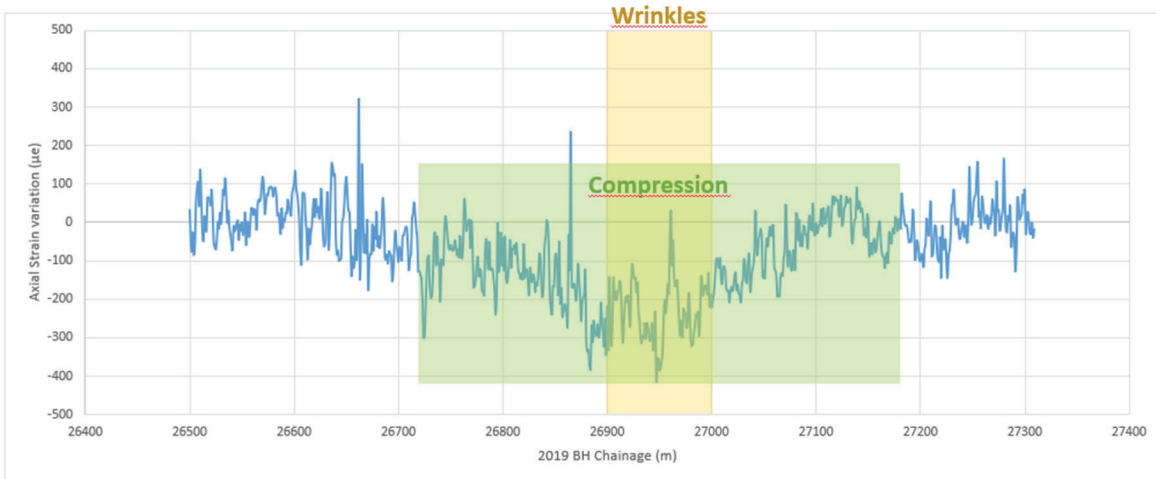
Figure 17. 2019 Axial strain signals. (Source: Baker Hughes)

Loading mechanisms associated with bend deformation (open/close) allowed the interpretation within the strain profiles of the areas of stress concentration by tension and compression. A review of the 2019 axial strain report also revealed that the location of the wrinkle was under compression during the time of this inspection (Figure 17).
