# Remediation of Low Cover in the South Fork Nemaha River - A Case Study

Eric Jenkins<sup>1</sup>, Stella Cunha<sup>2</sup>

*Proceedings of the 2025 Pipeline Pigging and Integrity Management Conference.*

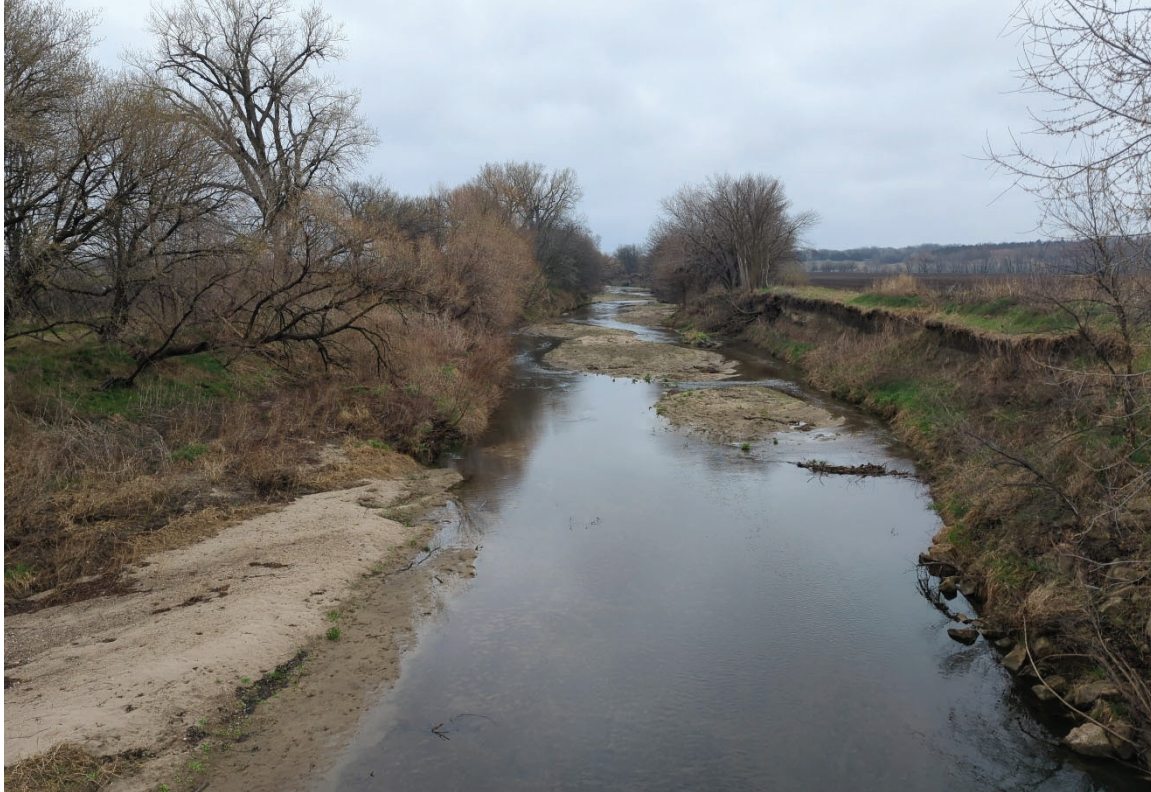
Figure 3. Looking Along the South fork Nemaha River at the L41 Pipeline Right of Way

The South Fork Nemaha River runs in a straight, moderate channel, measuring approximately 60 feet wide and 12 feet deep, flowing from south to north. Its unnaturally linear path in this area is likely a result of human intervention, as the river passes between two agricultural fields. About 200 feet north of a county road bridge, the Enbridge L41 pipeline crosses the river at nearly a perpendicular angle. Along the right of way, the river's eastern bank shows significant erosion, with a near-vertical slope caused by lateral migration and sloughing. Beyond this area of localized erosion, the eastern bank remains steep, with a roughly 1:1 slope, densely covered in mature vegetation.

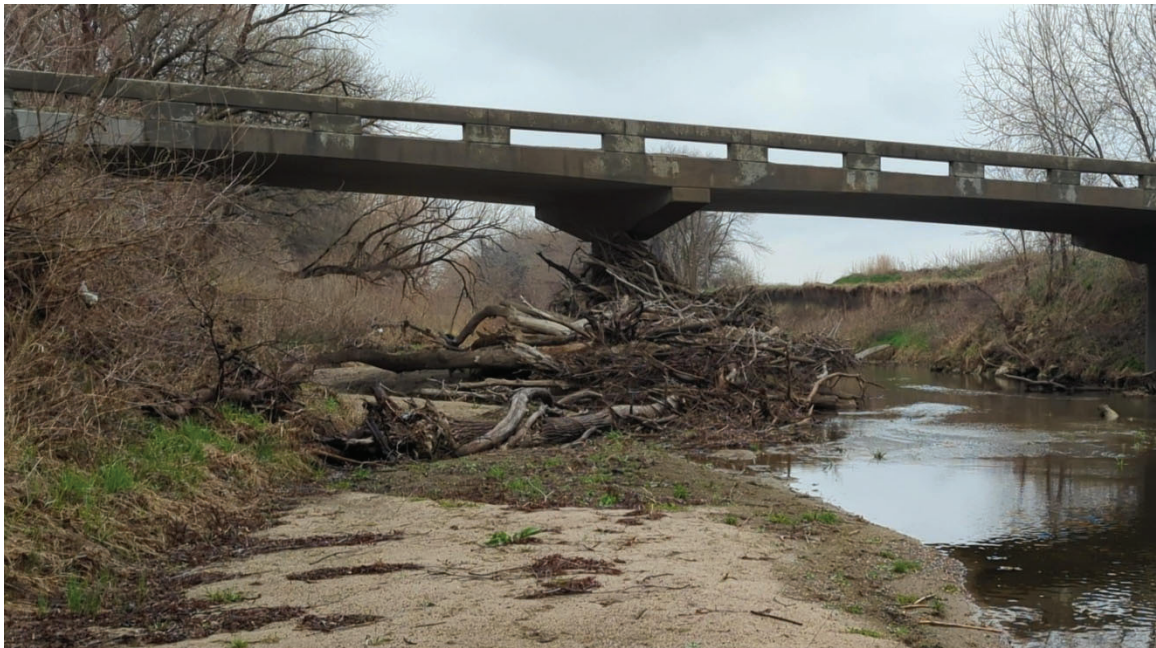
**Figure 4.** Debris Obstruction on West Pier of Upstream Bridge

Two key upstream factors are impacting the flow dynamics at the L41 crossing. The first is a significant debris pile that frequently accumulates against the western pier of the 168th Road bridge. This debris alters the otherwise straight flow of water during moderate to heavy rainfall, redirecting it toward the eastern bank near the L41 crossing. While the flow is moderate and low at the time the photo in Figure 4 was taken, the diverted angle of flow can be seen, with the eroded bank in the background. This redirected flow, combined with the absence of vegetation along the banks within the right-of-way (ROW), is believed to be a major contributor to the lateral migration of the South Fork Nemaha River in this area.

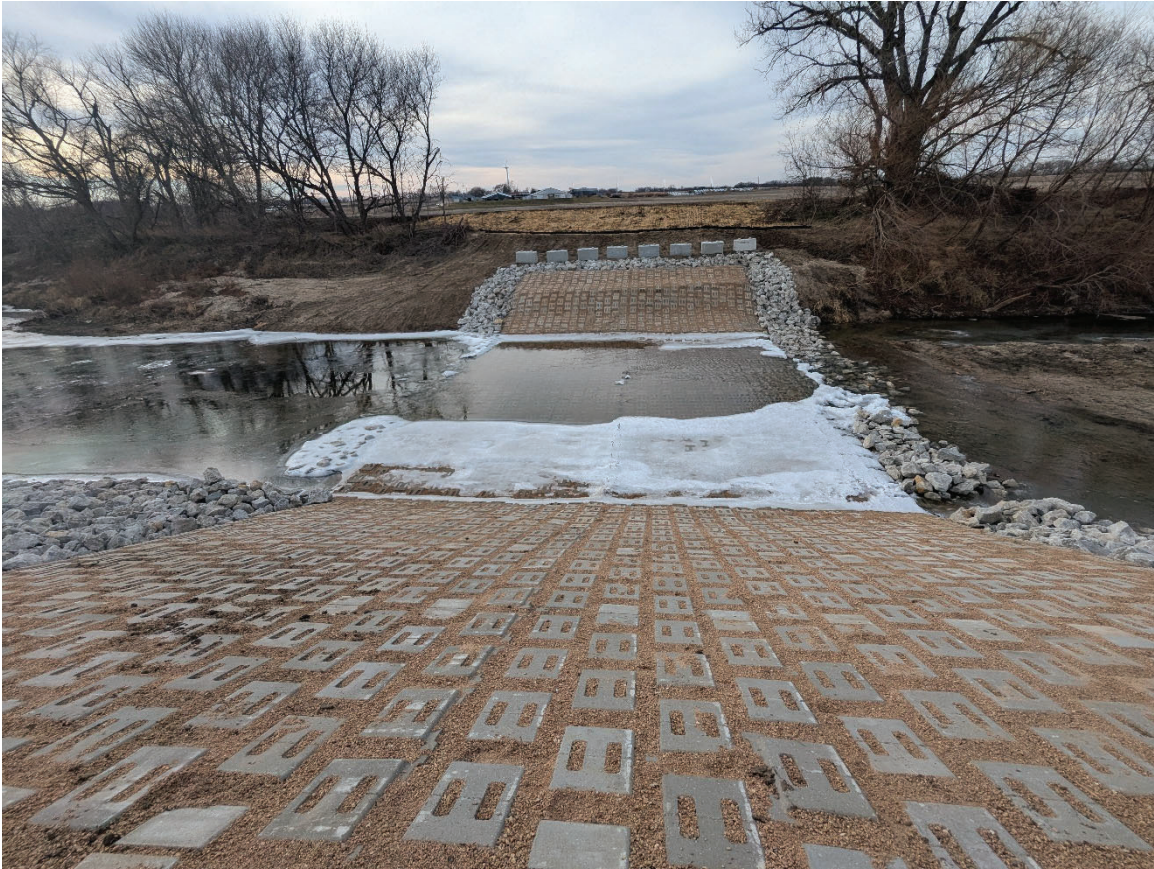
Figure 7. ACM System Spanning the ROW to Top of Banks

The cornerstone of the remediation effort was the use of an Articulating Concrete Mat (ACM) system. Commonly employed in geotechnical pipeline projects, this system consists of interlinked concrete blocks, forming large mats approximately 20 feet by 80 feet in size, connected by steel cables in a running bond pattern. As its name implies, the ACM is designed to adapt to shifting subgrades and can partially self-repair as the river channel evolves. It also provides robust, long-lasting protection with minimal elevation gain. The mats used in this project were 4.75 inches thick and required no additional subgrade construction beyond a layer of geotextile fabric. This feature was critical to achieving the project's goal of minimizing riverbed elevation changes over the pipeline.

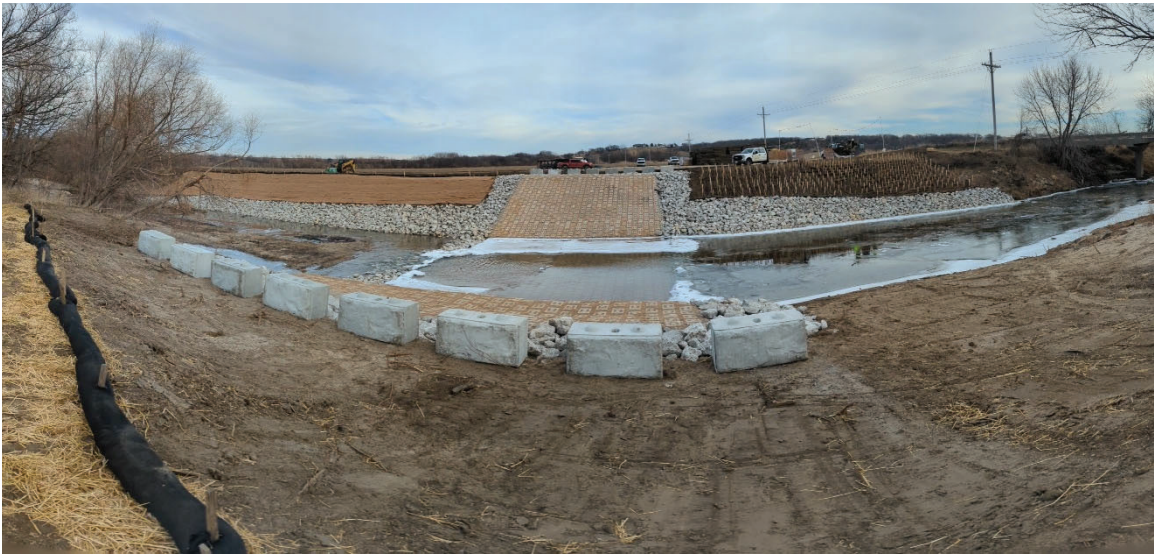
Figure 8. Overview of East Bank

The Hydrology and Hydraulics study conducted during the research phase determined that, unlike the thinner ACM, riprap with a nominal size of 28 inches (AASHTO Class III) was necessary to withstand the required shear forces. This material would be used to fortify the toe of the slope and the banks up to the ordinary high water mark (OHWM), reinforcing the new grades along the eastern bank. Although the creation of a floodplain on the east bank was not feasible due to project footprint constraints, a 2:1 slope was established to provide a gentler transition during flood events compared to the existing steep shear banks. This regraded slope, combined with large riprap, is designed to protect the eastern bank against erosion during typical annual rainfall.
