# Guided Wave Quantitative Contact Corrosion Measurement

**Rhett O'Briant**  
Guided Ultrasonics Ltd.

*Proceedings of the 2025 Pipeline Pigging and Integrity Management Conference.*

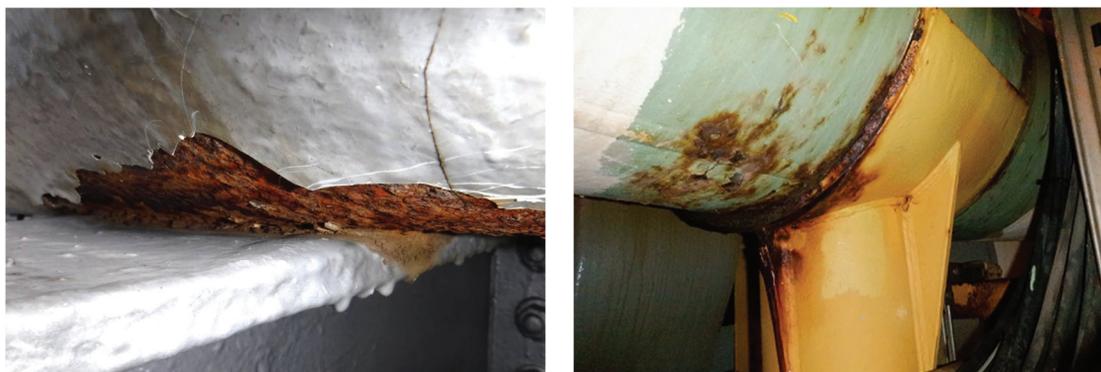
**Figure 1.** Simple pipe support examples

Corrosion under pipe support (CUPS), also known as contact-point corrosion is a very common challenge within refineries, pump stations, gas processing plants, compressor stations and gas measurement facilities. These are areas where pipes are in contact with supporting structures and protective coatings break down to due mechanical movement. Moisture tends to collect in the areas of damaged or degraded coating, forming a corrosion cell. The progression of corrosion further compromises the integrity of the coating, leading to significant pipe wall loss in some areas. Visual and mechanical access to these areas is limited in many cases due to the design of the structural supports, lack of space between multiple pipes, and other factors.

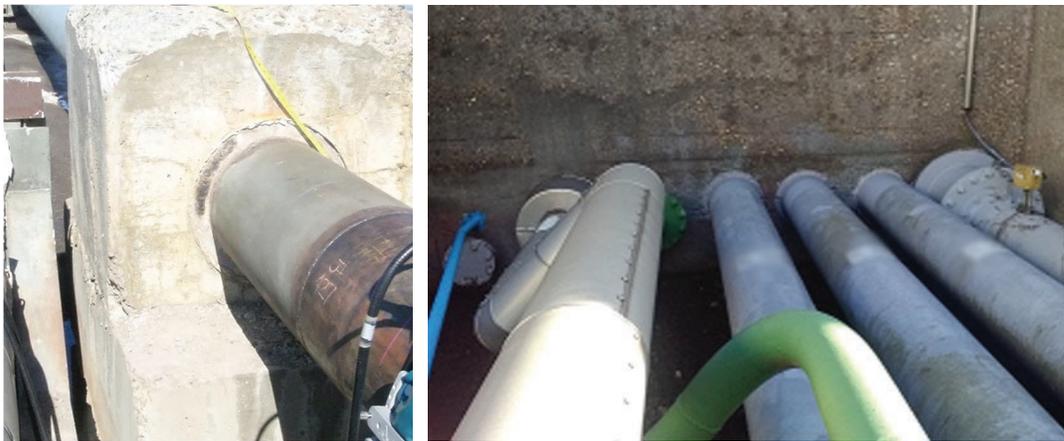
Figure 2. Concrete wall penetration examples

Natural gas and hazardous liquid pipeline facilities are often designed to include locations where suction, discharge, fuel and auxiliary service piping must pass through concrete structures. Over the system service life, pulsation, vibration, temperature cycles and soil movement can compromise protective coatings within the embedded pipe segments. This can be observed visually by the appearance of rust staining and concrete spalling around the interface locations. Wall loss may be noted just outside of concrete interface but in many cases, the damage occurs deep within the embedded section and beyond view.

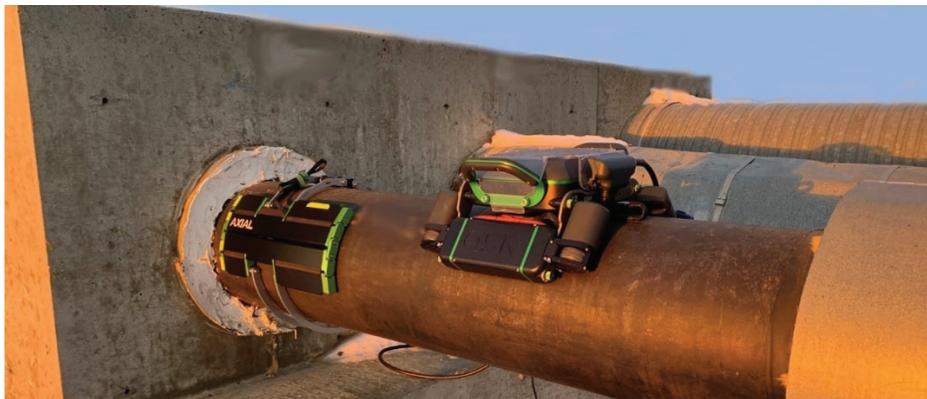
Figure 4. QSR1 and QSR Axial scanning systems at concrete wall penetration

SH wave modes are excited by electromagnetic acoustic transducers (EMATs) arranged in a transmitter-receiver (also known as pitch-catch) configuration for either circumferential or axial scan direction. The circumferential scanning system (QSR1) excites SH waves that travel in two paths around the top and bottom of the horizontal pipe circumference as the scanner physically travels axially over the area of interest [Ref 1]. The EMAT transducers are not in contact with the pipe surface, which allows for minor pipe surface and coating irregularities. Each system is capable of providing accurate wall thickness data under coatings up to 1mm (0.039”) thick.

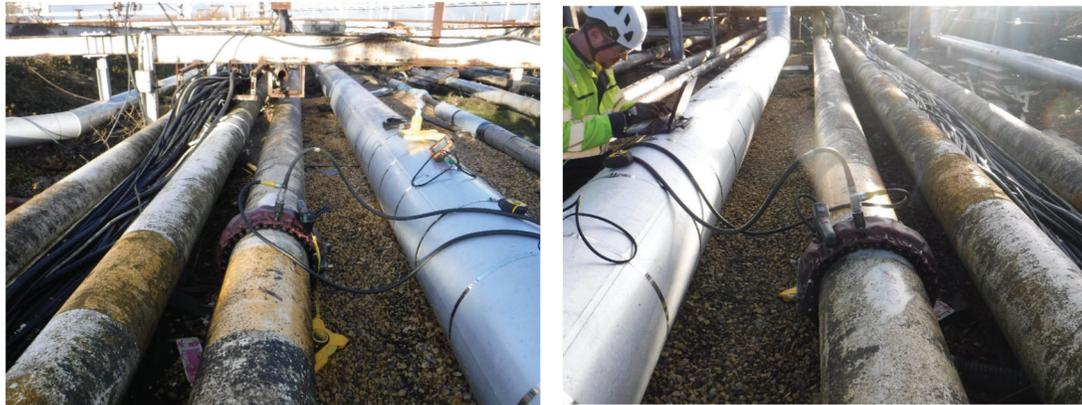
QSR1 scanning was deployed complementary to long range guided wave screening within a processing facility containing horizontal pipe runs supported by tack welded saddle-type supports. The subject pipe was 12” diameter with atmospheric coating.

Figure 9. 12" diameter pipe undergoing long-range screening

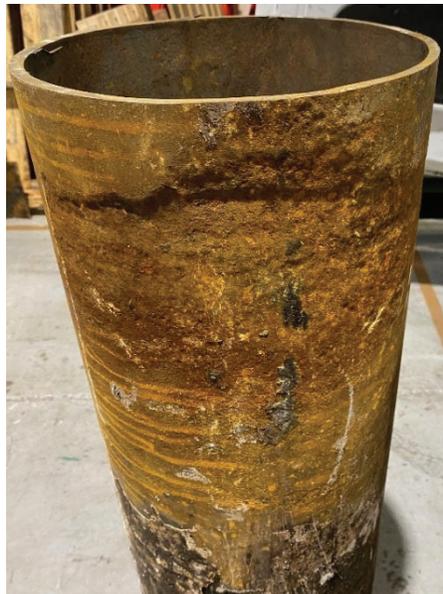
While the machine learning wall thickness profile matched very closely with the qualified inspector's interpretation, it did however, show that the wall loss exceeded 50% of nominal. Based on these reported results, the asset owner elected to remove the pipe from service and cut out the affected section. Visual inspection of the removed specimen validated the guided wave screening and quantitative short range inspection data.

Figure 12. 12" pipe removed from service with significant external wall loss
