Bending the Repair: Expanding Repair Techniques for Circumferential Stress Corrosion

Proceedings of the 2025 Pipeline Pigging and Integrity Management Conference.

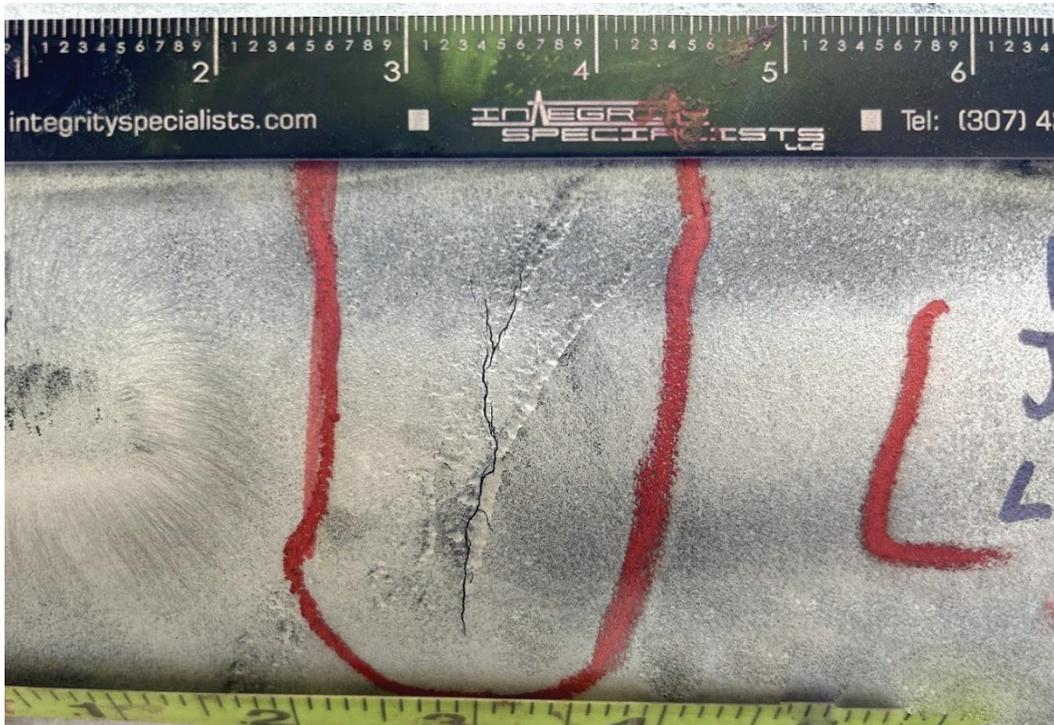
Figure 1. Photograph of the Sample 1 indication selected for repair using a Type A Compression Sleeve.

The pipe material utilized in this program was nominal 10-inch OD x 0.188-inch WT, API 5L, Grade X52 material manufactured by Kaiser Steel in 1963. The line transports natural gas at a maximum allowable operating pressure of 896 psig. The indications selected for testing are summarized in Table 1. Photographs of the features are shown in Figure 1 through Figure 4.

Sample #	Test Condition	NDE		
		Length (in)	Width (in)	Depth (in)
1	Type A Compression Sleeve (Petrosleeve)	0.30	2.20	0.197 (91% AWT of 0.217 inch)
2	Type A Compression Sleeve (Petrosleeve)	2.00	1.90	0.148 (75% AWT of 0.198 inch)
3	Composite Repair (CSNRI Atlas)	0.40	3.00	0.140 (69% AWT of 0.203 inch)
4	Unreinforced	0.80	5.50	0.085 (39% AWT of 0.217 inch)

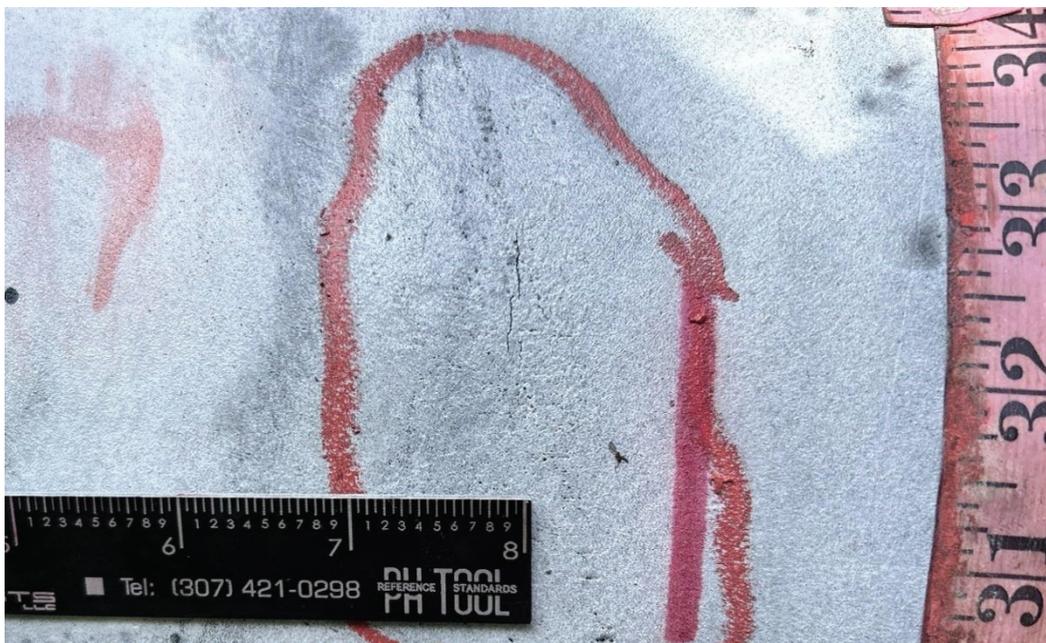
Figure 4. Photograph of the Sample 4 indication selected for unreinforced sample.

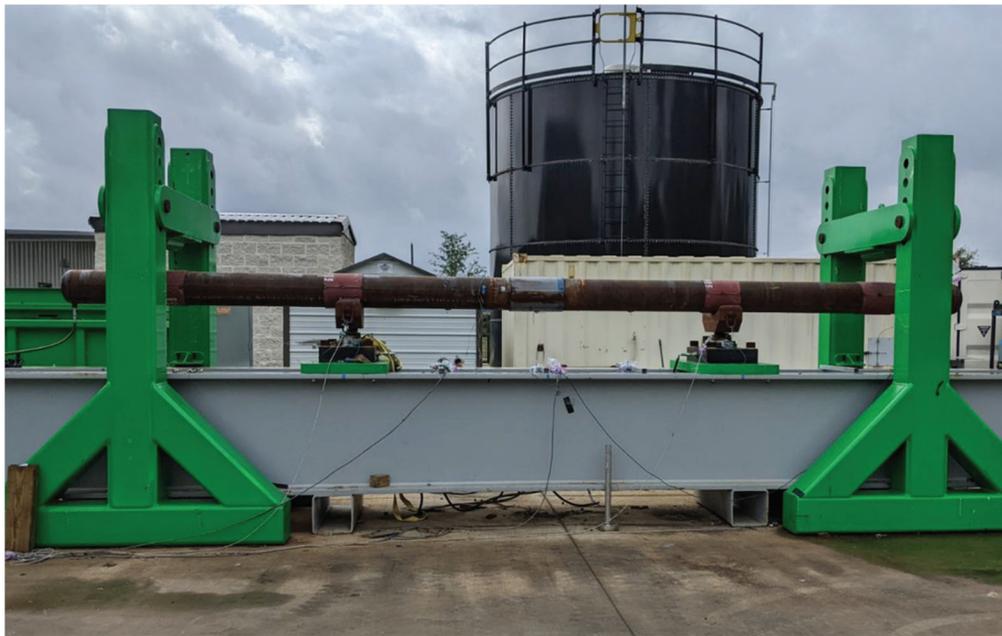
Figure 6. Sample 1 (Type A Compression Sleeve) in test setup.

A representative test set-up is shown in Figure 6. Samples were kept at their maximum operating pressure of 896 psig for the duration of testing. Strain cycle targets were calculated such that the feature’s combined axial stress state is equivalent to 72%, 100% and 125% SMYS for the 5,000, 5,750, and 8,000 cycle runout, respectively. Figure 7 is a representative plot of the sample pressure, minimum base pipe and maximum base pipe strains during the testing and each axial strain target.

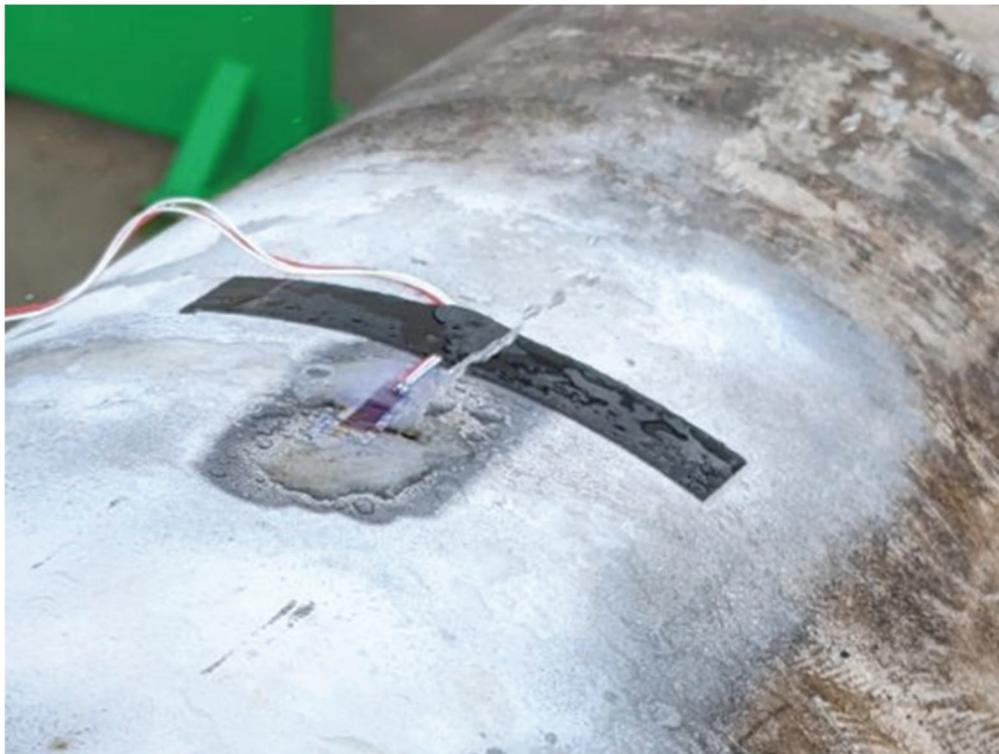
Figure 8. Sample 4 (Unreinforced) leak location.

All reinforced samples failed via gross plastic deformation passing the calculated plastic hinge moment for the pipe sample 109 kip*ft. Sample 4 (Unreinforced) failed within the C-SCC colony and was unable to maintain pressure, shown in Figure 8. Figure 9 through Figure 12 show the samples post bend testing.

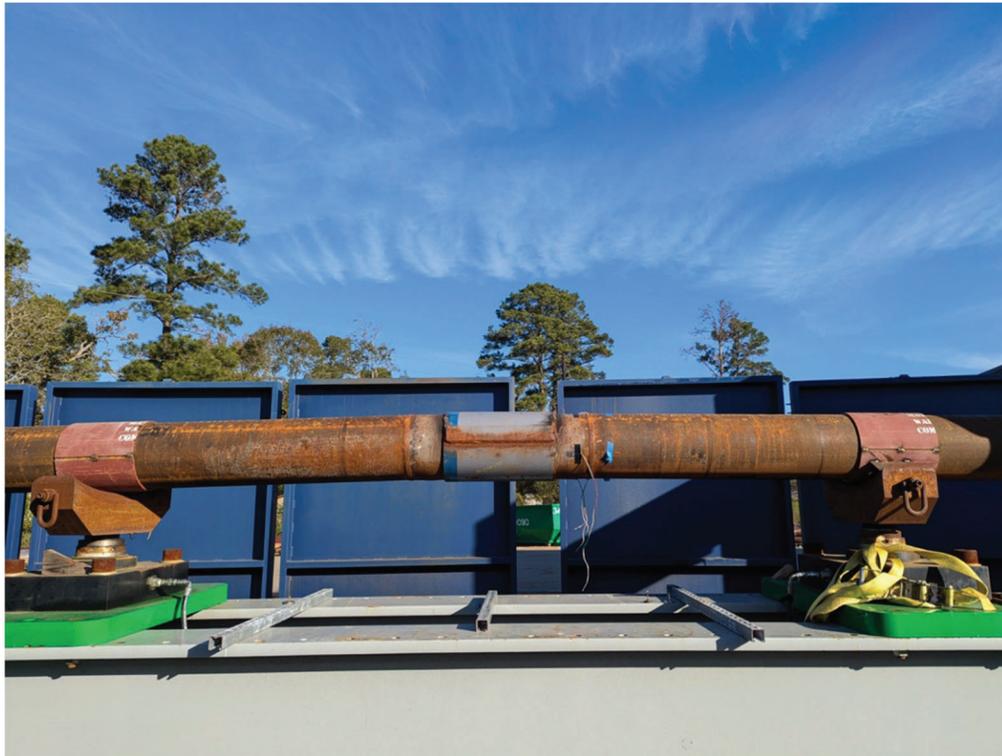
Figure 9. Sample 1 (Type A Compression Sleeve) post test.

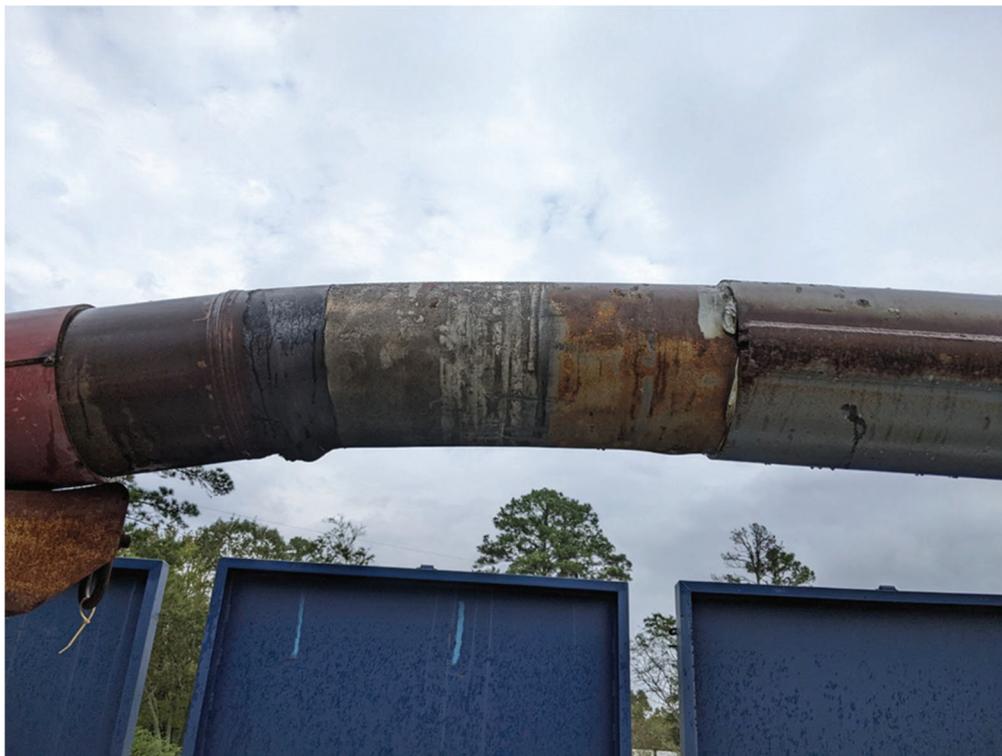
Figure 10. Sample 2 (Type A Compression Sleeve) post test.

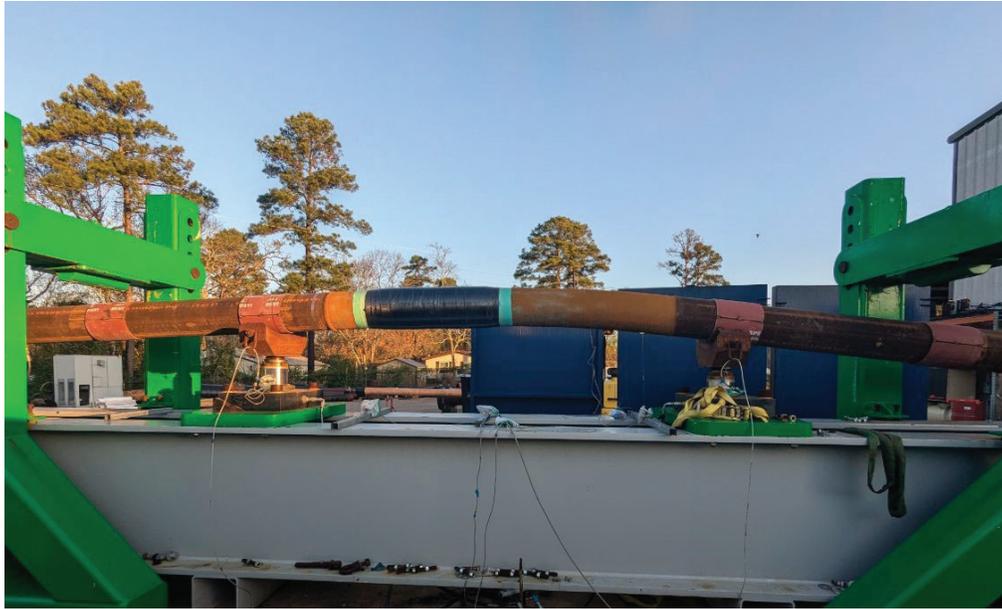
Figure 11. Sample 3 (Composite Repair) post test.

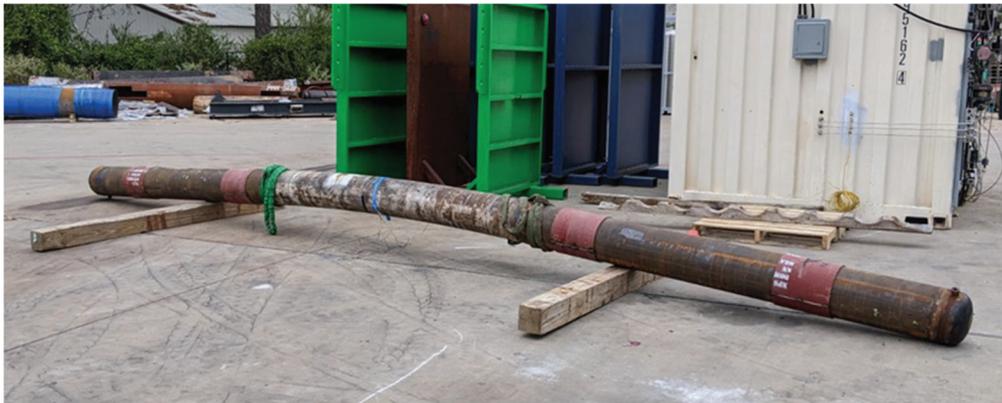
Figure 12. Sample 4 (Unreinforced) plastic deformation post test.

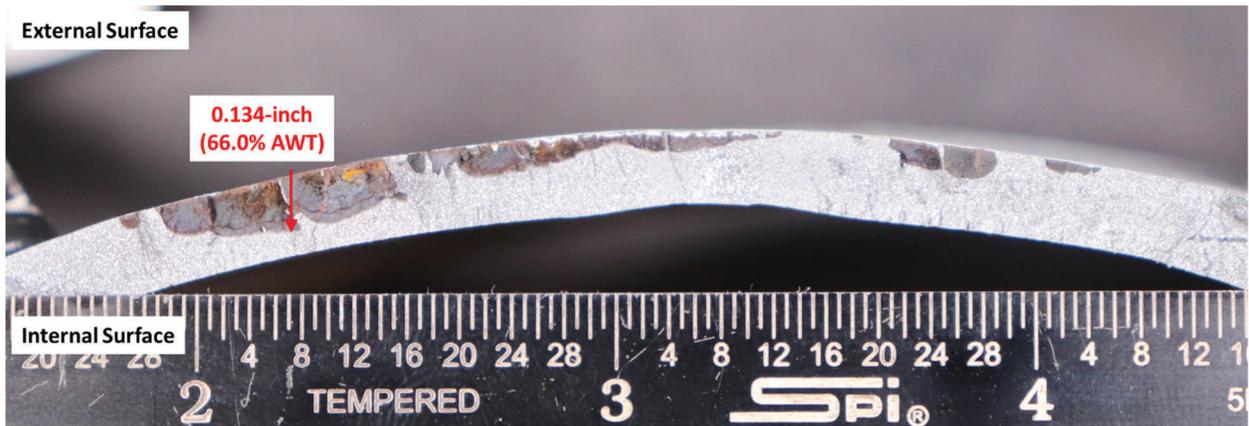
Figure 17. Photograph of the Sample 3 indication after breaking open (Composite Repair). Major numbered scale divisions are inches.

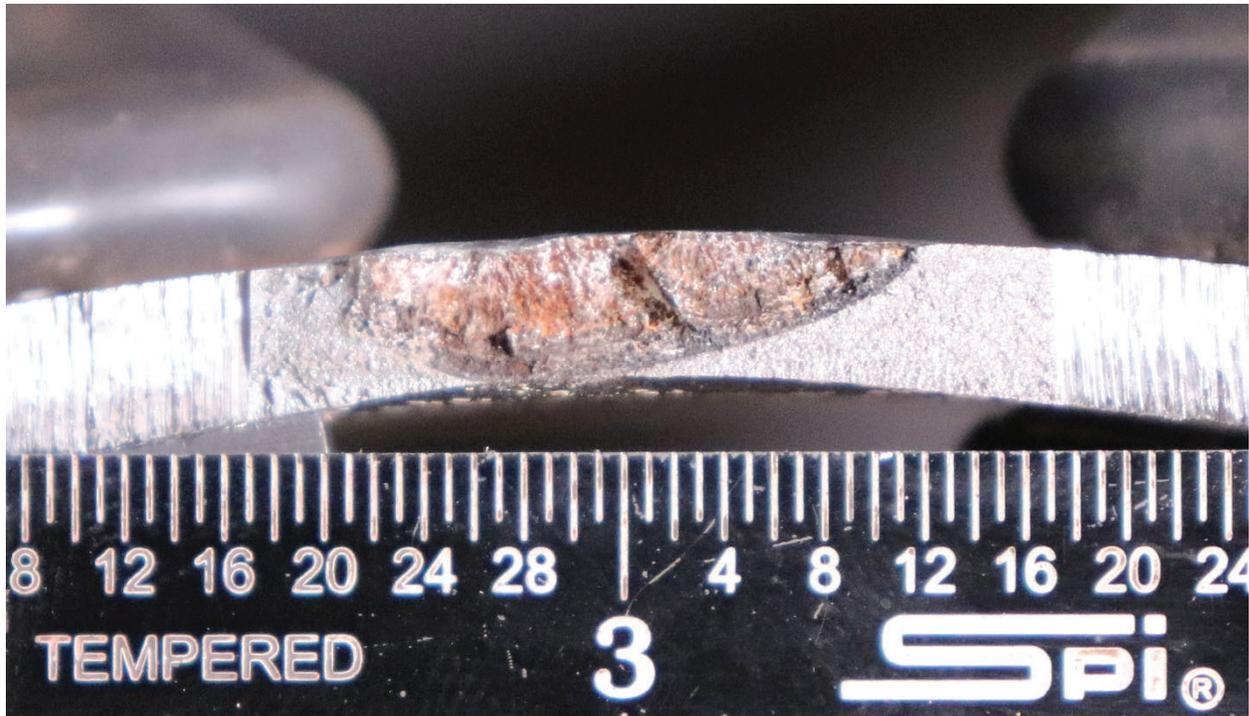
Figure 19. Photograph of the Sample 4 indication after breaking open (Unreinforced). Major numbered scale divisions are inches.
