A case study in the detection and sizing of circumferential stress corrosion cracking

Pipeline Pigging and Integrity Management Conference

Abstract

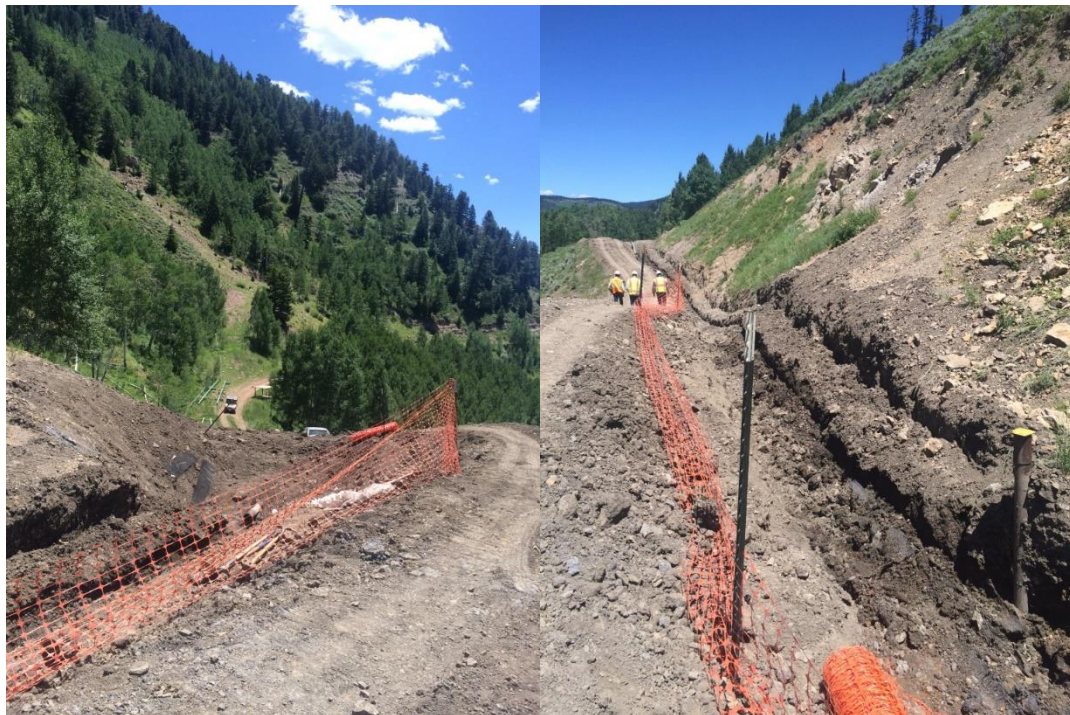
Figure 4: Examples of Terrain Where Circumferential SCC was Found.

A target integrity excavation site was chosen based on CSCC susceptibility factors and frequency of ILI analysis calls. Choosing a site with highly ranked susceptibility factors increases the chance of discovering more low level CSCC that may not be identified by ILI analysis, helping set probability of detection levels. Figure 3 shows an elevation plot for the test ILI inspection, including the approximate location of the validation excavation in an area of known historical earth movement.
