When Third-Party Damage Strikes! An Investigative Approach Using Carbon Fiber Composite Wrap as an Acceptable Method of Repair

Travers Schwarz¹, Steven Kinikin¹, James Fetherolf¹, Davie Peguero²,
Jackson Herrod²

¹Sacramento Municipal Utility District

Proceedings of the 2025 Pipeline Pigging and Integrity Management Conference.

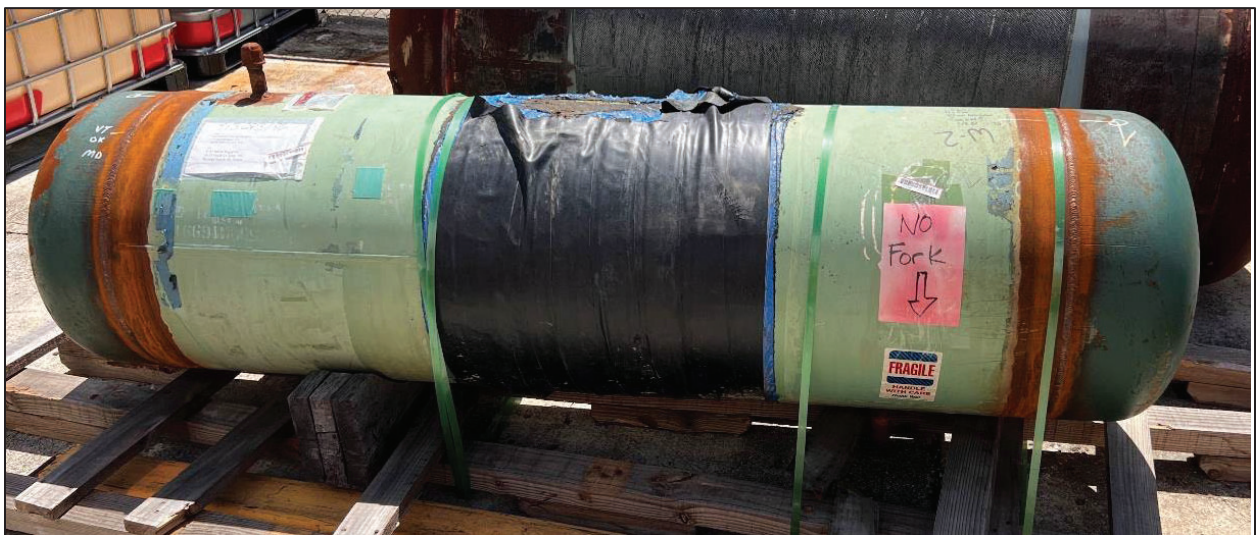
The 24-inch diameter section of pipe with the nonmetallic composite repair was cut out and replaced in April 2024. SMUD, in cooperation with CSNRI, prepared the pipe for hydrotesting (Figure 19) and had the pipe shipped to the CSNRI test lab to further evaluate the structural integrity and adhesion properties of the nonmetallic composite repair that was used to repair the pipe⁶. The testing process included cyclic pressure test, a hydrostatic burst test, and an adhesion test to assess the epoxy bond strength within the composite repair. The purpose for each test was to ensure the pipe could endure repeated pressure cycles, determine the pipes burst pressure, and evaluate the epoxy bond strength under specified conditions.

Figure 19. 24-inch Diameter Pipe with Welded Endcaps

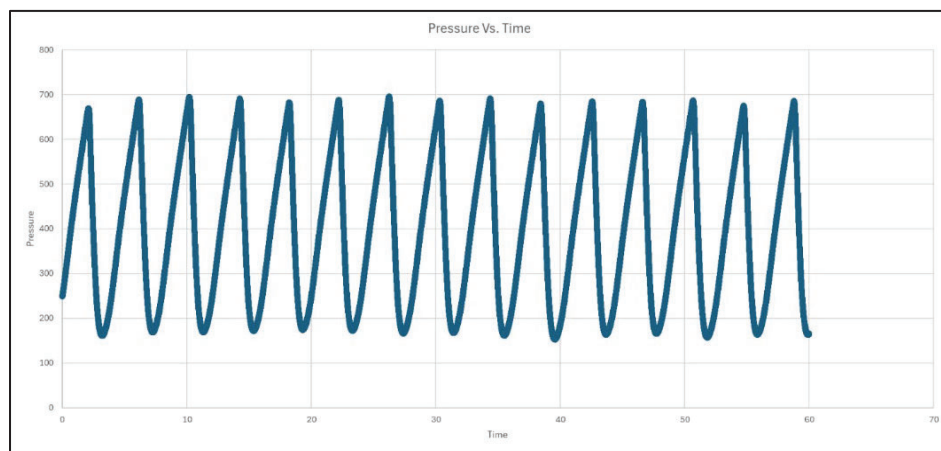
The target test parameters were set to cycle the pressure 40,000 times between 250 psi and 700 psi at a rate of 10 cycles per minute. (Figure 20) presents the data recorded from the pressure transducer attached to the pump, showing the pressure variation over the course of one minute. From this data, it is evident that the actual test parameters achieved were 40,000 cycles between 175 psi and 700 psi at a rate of 15 cycles per minute. (Figure 21) shows the condition of the composite wrap after completing the 40,000 cycles, with no visible signs of damage or fatigue.

Figure 20. Pressure vs. Time

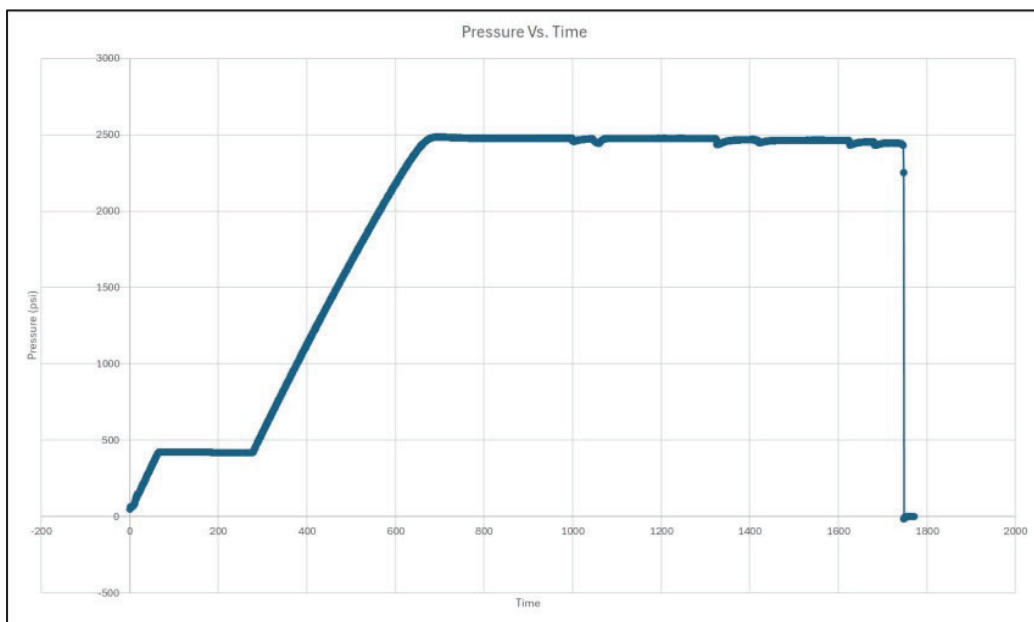
The maximum recorded pressure during the test was 2,584 psi. (Figure 22) illustrates the pressure increase over time. The pressure increased at a constant rate and was held for a few minutes to ensure all connections were properly secured before continuing to rise until failure occurred. Yielding of the pipe began around 2,500 psi.

As the pressure increased, the pipe began to balloon, causing the carbon fiber repair to detach or "pop" off. This is reflected on the pressure-time graph as inverted spikes. These "pops" correlate with the visible damage to the carbon fiber repair seen in (Figure 23), where the thin rings of carbon fiber that broke off with each failure event can be observed.

Figure 22. Pressure vs. Time

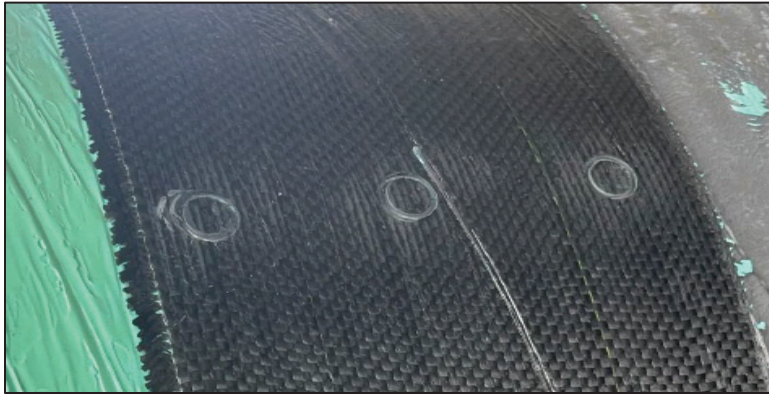
- Identify the area on the composite repair where the dolly will be attached (Figure 24). Ensure the selected area is flat, clean, and representative of the repair quality.
- Drill through the composite repair using a core drill bit the size of the dolly.
- Abrade the surface of the composite repair at the chosen test site using sandpaper.
- Clean the surface with an appropriate solvent or cleaner to remove dust, grease, and other contaminants. Ensure the surface is completely dry before proceeding.
- Sand and clean the bottom surface of the dolly to ensure a strong bond with the composite.

Figure 24. Dolly locations
