# Hydrotesting in the Modern World – What Are We looking for?

**Rick Sugden**  
Kiefner and Associates, Inc.

## Pipeline Pigging and Integrity Management Conference

*Proceedings of the 2024 Pipeline Pigging and Integrity Management Conference.*

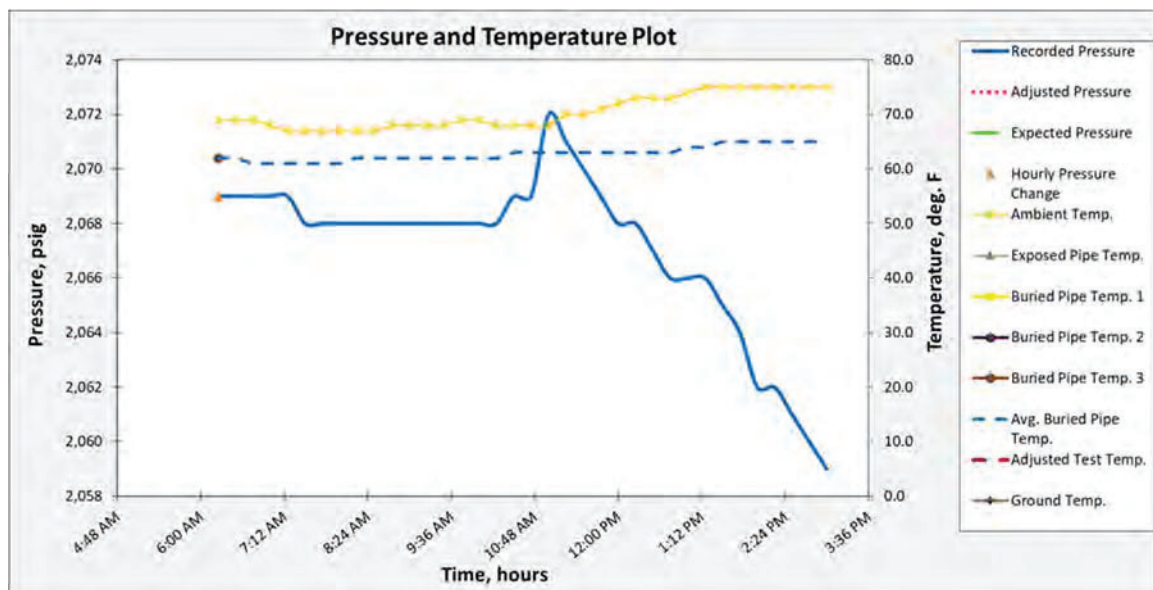
Figure 5. Example pressure-volume plot

During the pressure test, is the pressure rising? If so, is it enough to hide a leak? A one psig per hour leak rate is easily masked by a couple of degrees in temperature increase. Did the pressure rise sufficiently to match the expected growth that would be expected from a temperature increase? Engineers have built calculators to take the inputs of pressure, temperature, length of pipe buried, and length of pipe exposed to calculate the expected change in volume due to temperature effects. Often, companies develop procedures around the allowable difference between the computed and actual pressure or volume changes to guide the engineer on what is or is not acceptable. The ambient temperature's impact on the pressure depends on how much pipe is exposed. Did the inspector record the footage of the exposed pipe? Is there enough significant footage of the pipe to impact the test pressures? Consideration should be made to insulate or protect considerable lengths of exposed pipe from temperature effects. Is there an identified trend in pressures? Leaks can be very small and not very obvious if so. Pressure loss can be slow and relatively minor. The following example, Figure 5, is only an approximate ten psi loss; however, note that the temperatures are slightly climbing. Using a Pressure-Volume Plot from the initial squeeze-up can allow the inspector to estimate the volume of liquid lost into the environment if a leak exists and determine the rate of fluid lost per hour.
