# Internal Ultrasonic Pipeline Inspection for Outer Continental Shelf (OCS) Hazardous Liquid Gathering Lines

Mick Collins  
Intero Integrity Services

## Pipeline Pigging and Integrity Management Conference

February 12-16, 2024

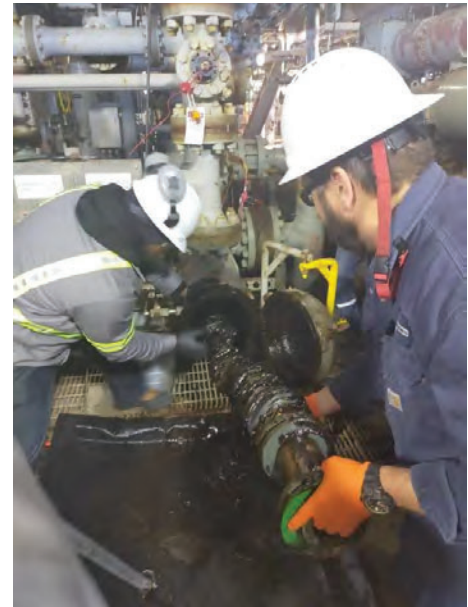
Figure 1 - Short Barrel and tool retrieval

Other mitigating factors included the restrictions associated with launching and receiving the inspection equipment. Short launch barrels 118 inches, 3000 mm restricted the length of the technology. Longer inspection equipment would incur additional engineering effort to lengthen the barrels.

Retrieval of a lodged inspection tool is costly when this occurs onshore; offshore environments significantly increase the cost of retrieval. Therefore, one consideration to reduce the overall risk of a lodged inspection tool was to use a bi-directional system while collecting multiple UT data sets at high pressure. Thus, the inspection tool can return to its original launch point by design or as a precautionary measure.

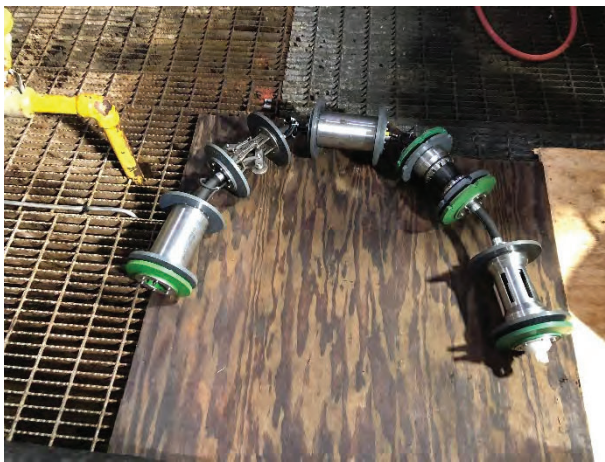
Figure 2 - Surveyor UT tool prior to launch

Once configured, the tool inspected the crude oil pipeline flowing from a platform along the seabed and terminating at a second platform. At a velocity averaging 2,525 ft/h, the inspection covered approximately 110,000 feet in under 45 hrs. This pipeline was initially constructed with seamless pipe with a nominal wall thickness of 0.812 inches, corresponding to an inner diameter of ~7 inches (17.8 cm).

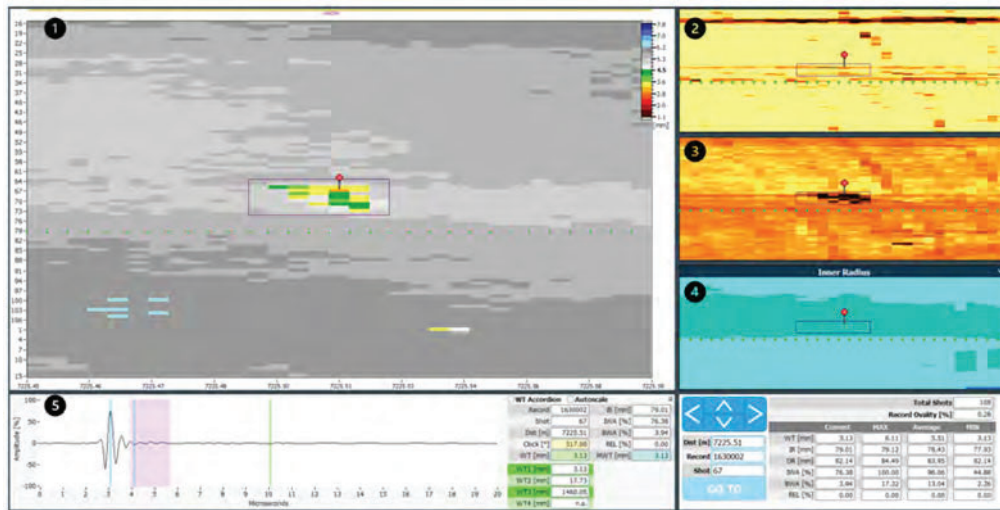
Figure 3 - Example UT Data Explained Below

Area 1: Wall Thickness C-Scan - the pipe has been represented as being unrolled and laid flat. On the x-axis distance is plotted in meters, on the y-axis clock position is plotted in degrees. The color bar in the upper-right corner shows the relation between the colors and the wall thickness values.
