To Dig or Not to Dig - Determining Which Dents Are Suitable for Engineering Critical Assessment per 192.712 (c)

Shanshan Wu¹, Jing Wang², Joseph Bratton¹, David Kemp¹, Luyao Xu¹, Greg
Quickel¹

Pipeline Pigging and Integrity Management Conference

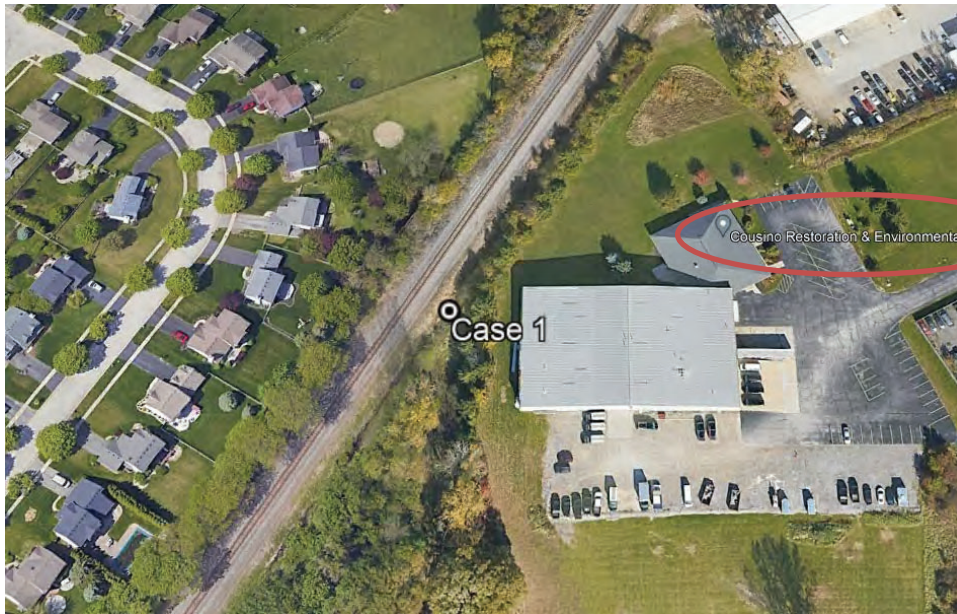
Figure 1. Case 1 Dent Location

The Case 1 Dent is reported to be within a casing under a train track. Refer to Figure 1 for the location of the Case 1 Dent. The most recent 2020 MFL/caliper inspection reported this feature as

“Dent Depth of 1.20% OD with reported strain of 12%, at 5:51 o’clock, commented as associated with debris”. Due to the high strain, this dent was selected for an ECA.

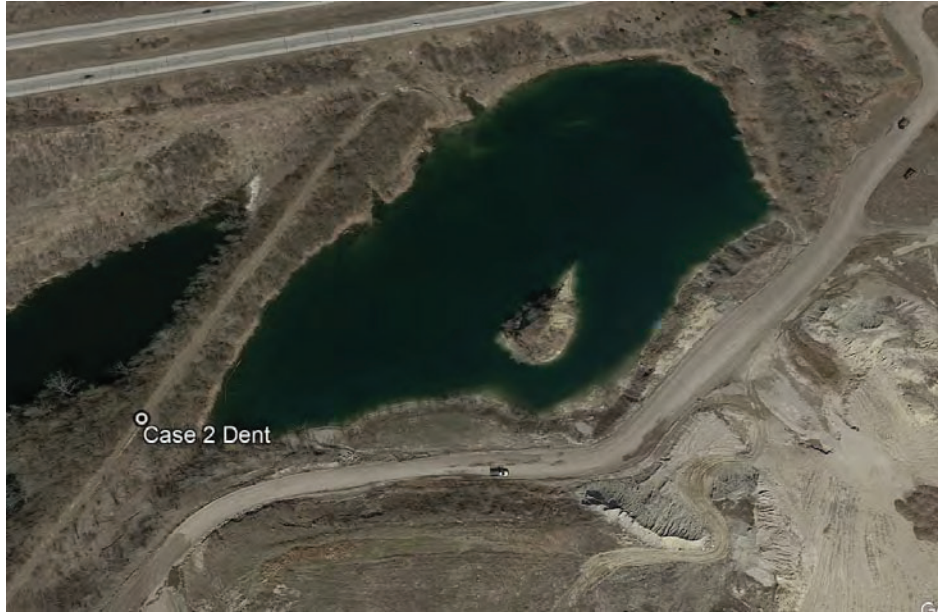
Figure 4. Case 2 Dent Location

The Case 2 Dent is a topside dent with metal loss (ML), with the location shown below in Figure 4. The most recent 2021 MFL/caliper inspection reported this feature as “1.61%OD (0.35IN) – 0.72%OD (0.16IN) (ML – 23%), at 11:15 o’clock with a dent strain of 9.9%. Since this dent was reported as a topside dent with metal loss with high strain, it was selected for a dent ECA.

The concern of a topside dent with metal loss is that the associated metal loss could be a result of potential gouging/third party damage with a higher likelihood of crack initiation within the gouge. Per this particular ILI vendor, various criteria were used to determine whether to report the associated wall loss feature as metal loss or possible mechanical damage (i.e., gouge) and this feature did satisfy the minimum screening criteria to be called as possible mechanical damage.

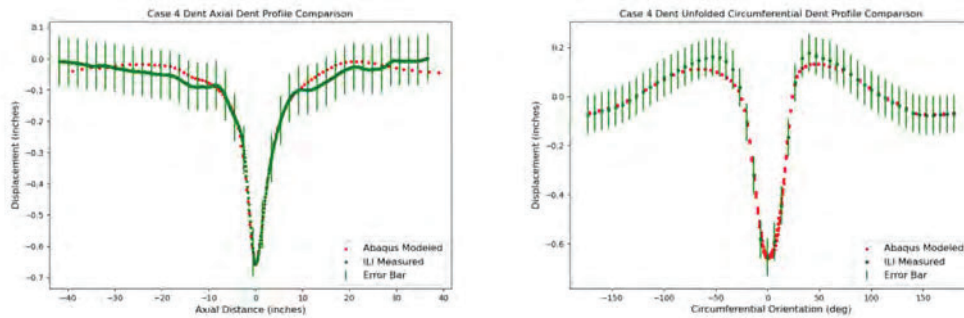
Figure 11. Case 4 Longitudinal and circumferential profiles comparison between ILI and FEA

In the FEA modeling process, the dent was assumed as a constrained dent according to the o'clock orientation and a rigid indenter surface based on ILI caliper data was created for the dent feature to impart the deformation profile into the pipe. The rigid indenter was displaced into the pipe surface in the FEA model using surface-surface contact with hard contact behavior in the normal direction. To simulate the denting process, the feature dent was placed at the 12 o'clock position and rigid shell supports were added at the bottom and sides of the pipe, opposing the force of the indenter into the pipe, in order to simulate potential ovality deformation and best match the axial and circumferential profiles of the FEA results with those reported from the caliper data. **Figure 11** shows the longitudinal and circumferential profiles of the ILI and FEA modeling. It is seen that there is good profile agreement between the ILI and FEA model results, indicating that the FEA modeling accurately reproduced the dent formation process.

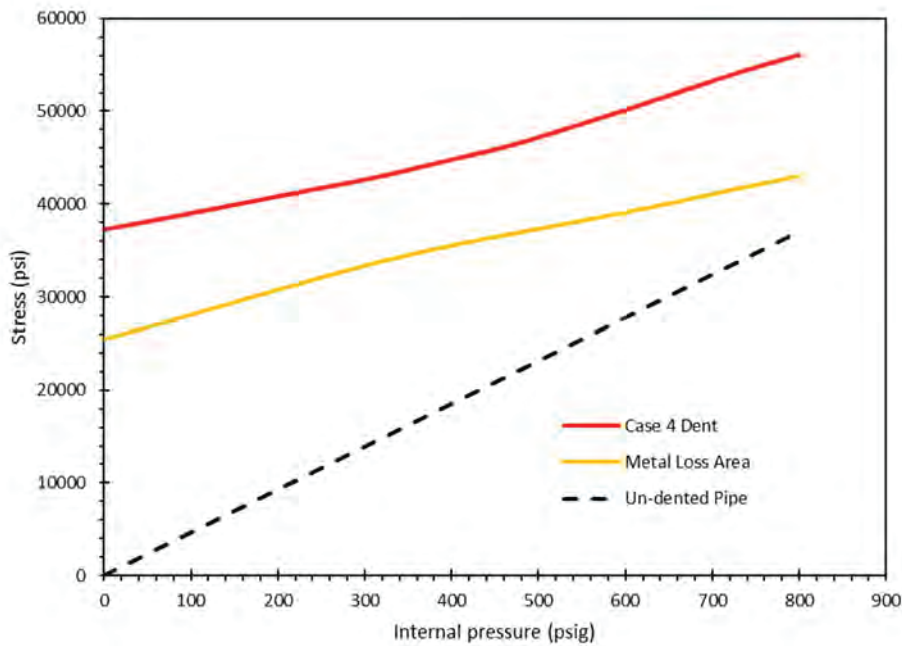
Figure 14. Maximum Hoop Stresses as a Function of Internal Pressure at the Case 4 Dent and Metal Loss Area

The FEA model results for the dent deflection are shown below in **Figure 12** with the associated metal loss feature adjacent to the apex. The equivalent plastic strain distribution is shown in **Figure 13**, where it can be seen that the plastic strain area is concentrated at the dent apex region with a maximum value of 5.53%, which is close to the ILI reported curvature strain of 5%. Furthermore, there is no significant plastic deformation observed in the interacting metal loss region. The maximum hoop stresses as a function of internal pressure at the dent and the metal loss area were extracted and are shown below in **Figure 14**. The hoop stress for an un-dented pipe is also plotted in the figure as a comparison, where it can be seen that the presence of the dent and metal loss features generate a significant stress concentration. Further, the highest stress in the dented region is not located within the metal loss area.

The FEA modelled maximum equivalent plastic strain, lower/upper bound Ductile Failure Damage Indicator (DFDI) and Strain Limit Damage (SLD) values, and the calculated fatigue life of the case 4 dent are listed in **Table 1**. The FEA modeling results show that this dent is acceptable for future service as there is low risk for crack initiation due to low DFDI and SLD values and the fatigue life is greater than 100 years.
