# The Importance of Accurate Data Alignment for ILI Assessments

Lucinda Smart, Benjamin Wright, Dyke Hicks  
Kiefner and Associates, Inc.

## Pipeline Pigging and Integrity Management Conference

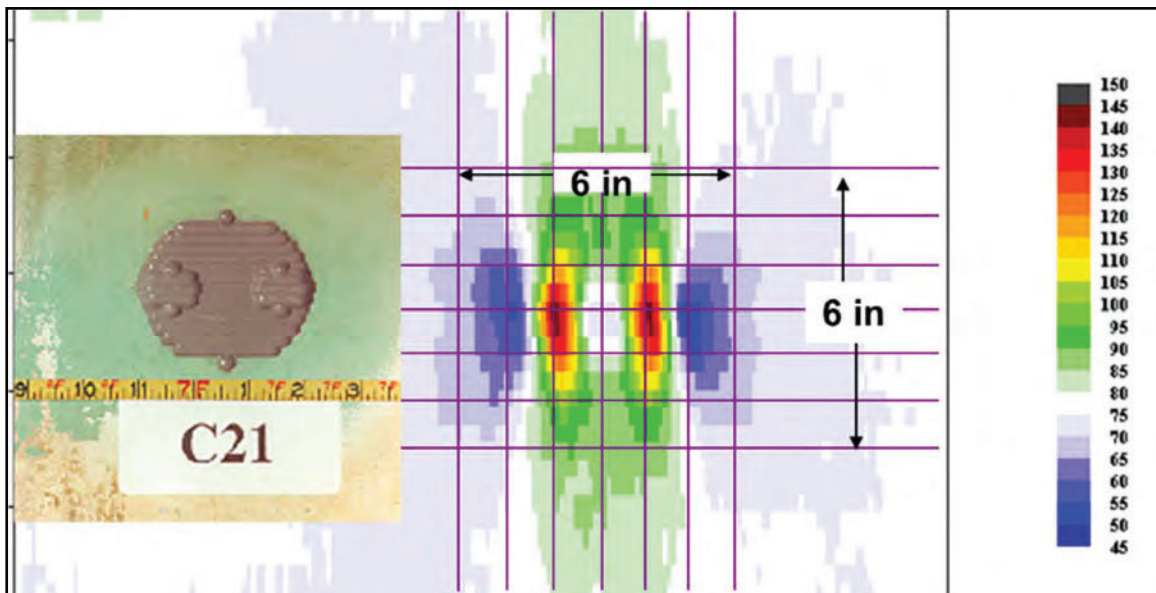
Figure 3 shows the additional complexity of larger metal loss anomalies shadowing smaller metal loss. In the image, a pair of 3t anomalies separated axially by 3t appears to have a white area between them, which is the same appearance as the full wall thickness. However, the wall thickness is reduced by 20% in that area; this is called axial shadowing. A misinterpretation of this image could lead to an underprediction of the severity of depth and, ultimately, the assessment of a CGR if this profile technique is used. With this type of corrosion morphology, it is possible that the underreporting of depth and poor probability of overall detection of metal loss anomalies may exist.

**Figure 3.** Complexity of Larger Metal Loss Anomalies, Pits within Pits

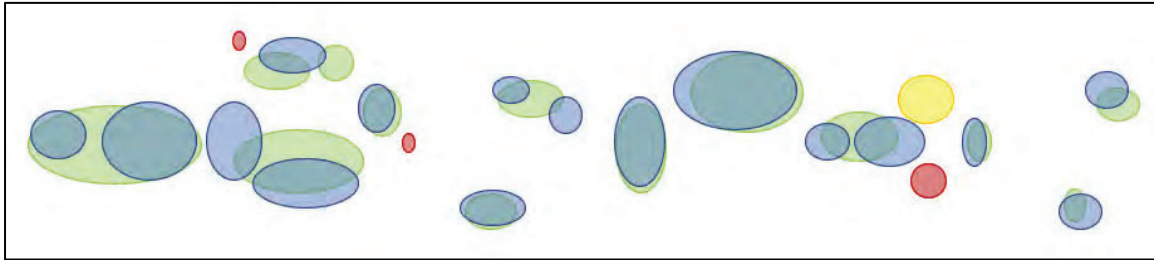
- **All Overlapping:** A match of all available features if any area is overlapping. This is required for a POD or POI assessment in order to understand what the tool is capturing and reporting throughout the entirety of the ILI run and how it compares to the other run.

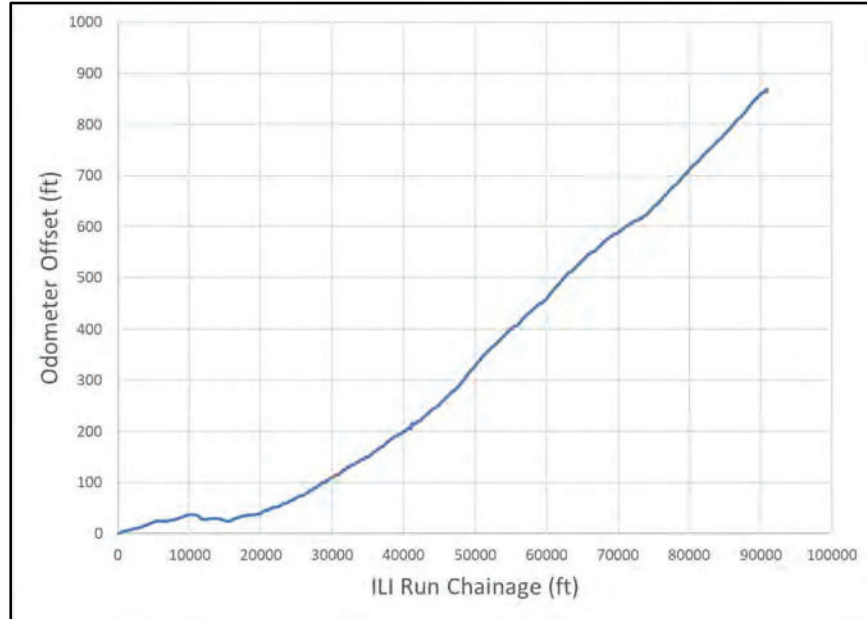
The data from two successive runs were reviewed, and the overall joint lengths were found to be, on average, 0.40 ft offset in length. The maximum difference in joint length was 2.16 ft. The result of ongoing problems with locating resulted in the final odometer length of Run 1 to Run 2 being offset by about 900 ft, as shown in Figure 4.

**Figure 4.** Odometer Offset as a result of poor positioning performance by the tool.

Generally, this problem could be fixed by normalizing the lengths of the joints from one run to the next, assuming the data from the more recent run is correct and normalizing to this data set. However, if this difference is not realized, there will be a problem when a vendor provides a position relative to the upstream girth weld. The metal loss positioning data will be elongated if the joint is overcalling the length from Run 1 to Run 2. In some cases, this difference may not be noticed by the operator if there are little to no defects reported. However, in Case Study 1, an abundance of small pitting corrosion features were the primary type of feature reported. Even a slight offset of half a foot in the length of a joint prevents straightforward alignment of metal loss feature correlation. Depending on the amount of offset in those lengths, the correlated features may be entirely incorrect, as well, since matching defects that may overlap are not truly correlating defects.

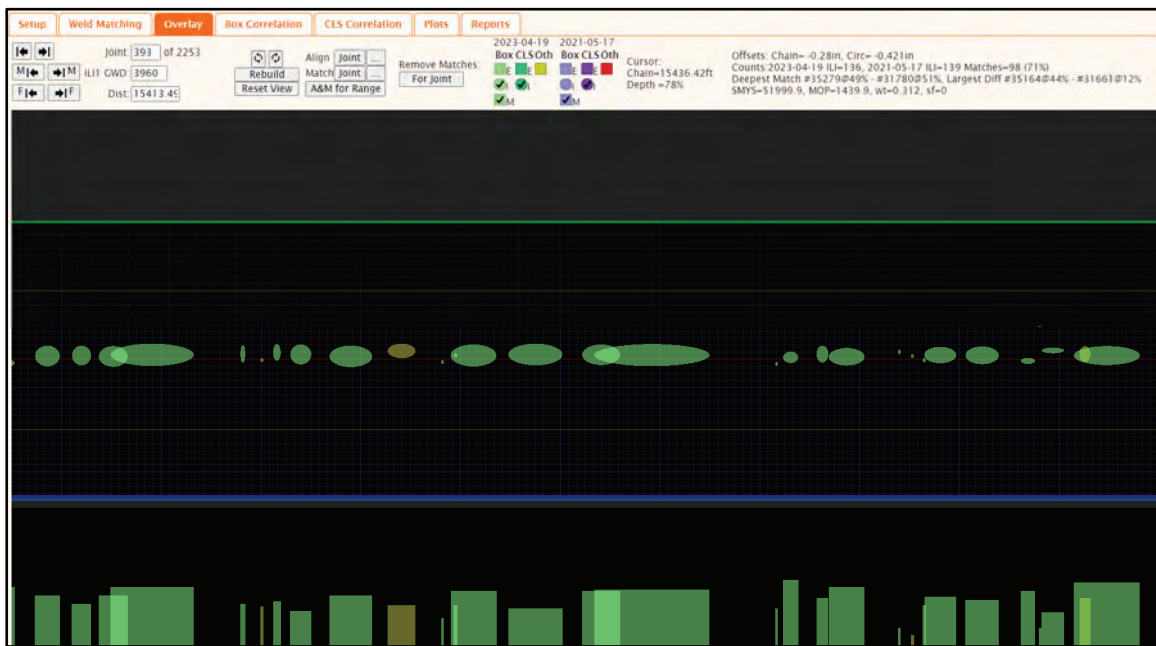
Figure 7. Internal corrosion was reported during the second ILI run. Green ovals indicate correlated features, and yellow ovals are uncorrelated.

Due to the MFL tool reporting a single feature at the upstream end of the axially longer feature, it appears as though a slight axial shadowing effect has occurred. The pattern-matched images for an example joint are shown in Figure 6, Figure 7, and Figure 8. The red and blue ovals in Figure 6 indicate unmatched and matched 2021 features, respectively. The yellow and green ovals in Figure 7 indicate unmatched and matched 2023 features, respectively. The final overlay of the two data sets in Figure 8 shows a single ILI Run 2 feature correlated with two ILI Run 1 features, highlighted by a bright blue arrow in the figure. To obtain a growth rate for an individual anomaly as reported, only one anomaly was correlated to one other anomaly. In this case, the deepest features nearby were used for either run to correlate to show the highest change in depths, which is reasonable to assume given the limitations of axial MFL tools for these axial grooving type indications.

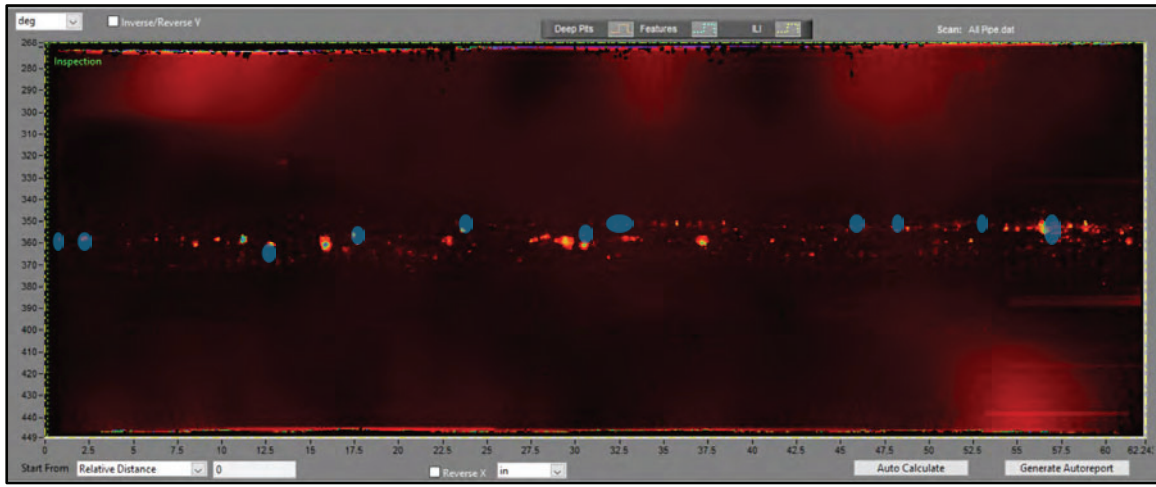
For the data used in each case study, validation data was obtained for a short section of pipe where this internal corrosion was occurring. A ten-foot section of pipe was cut out where leaks had been reported. This pipe was sectioned horizontally at the 3:00 and 6:00 positions, and the internal corrosion was sized using laser profilometry in two separate scans. A five-foot laser scan image output

is shown in Figure 10, where eleven ILI features (blue ovals) were correlated with associated laser indications.

**Figure 10.** Laser profilometry c-scan of the internal corrosion located at the six o'clock position.

But let’s backtrack for a moment. Correlating the features from the cut-out section to the ILI data was not a straightforward process. Several problems were encountered along the way to attaining the final output, as shown in Figure 10.
