Integrity Management of off-axis SCC Through an ILI System and Engineering Assessment

Ron Thompson¹, Andrew Corbett¹, Guillermo Solano,¹
Richard Kania²

Pipeline Pigging and Integrity Management Conference

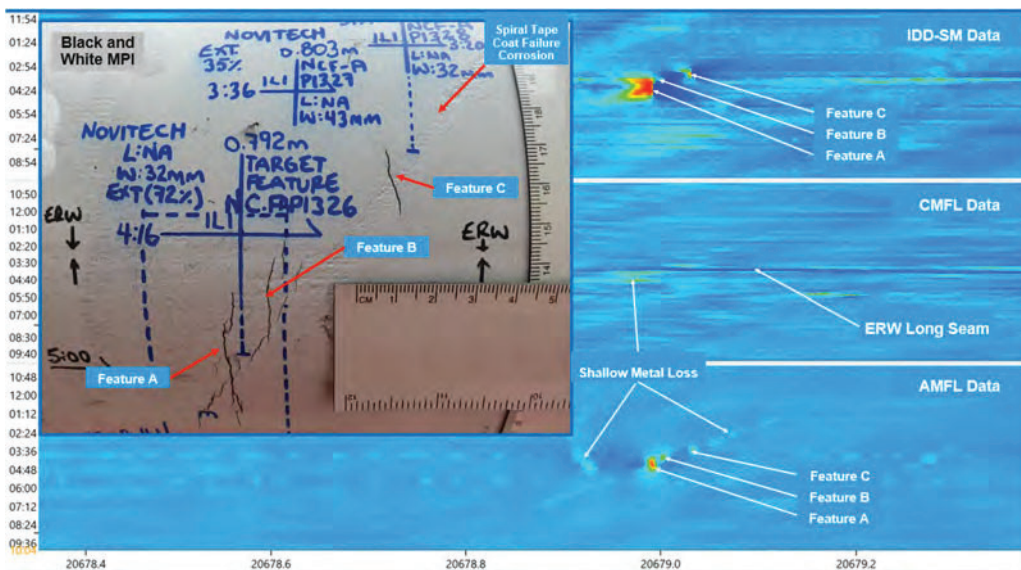
An example of a feature located in such an area is show in Figure 3 below.

Figure 3. CSCC Feature in an Area with no Obvious Bending Strain Indication.
