Microwave Inspection Development and Evaluation for Spoolable Reinforced Thermoplastic Pipe

Chantz Denowh¹, Robert Stakenborghs², Liang Yu³

Pipeline Pigging and Integrity Management Conference

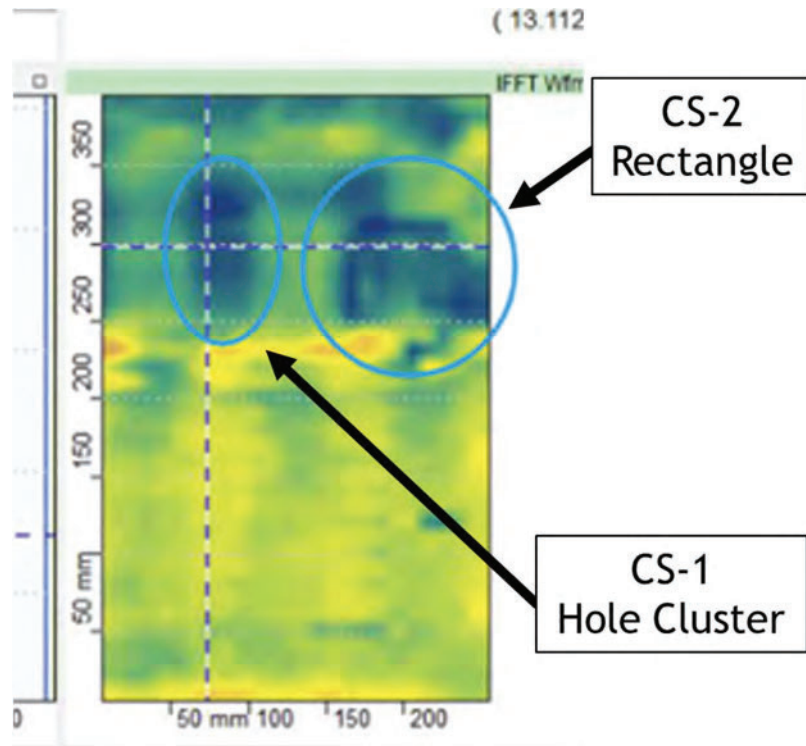
Figure 5: Microwave scan output of defects CS-1 and CS-2

Since the vendor had approximately 4-feet to inspect for the spool containing defects CS-1 through CS-4, the vendor segmented the sample into four (4) sections. Due to sectioning the pipe, parts of several defects were identified in more than one scan. Figure 5 illustrates one section of the pipe scan that includes defects CS-1 and CS-2. Both defects are visible in the microwave scan output. Interesting is that the hole cluster has a similar indication as the wall loss feature even though the volume removal of the wall loss is much higher than the hole cluster. In other words, the hole cluster and rectangle are both shown as general indications when they are very different defects. Figure 6 includes defects CS-3 and CS-4. Only the corner of the trapezoidal cut was visible in Figure 6. The scan also identified another indication that was not artificially created. This indication could be due to the tape arrangement resulting from removal of the outer cover. The vertical cut (defect CS-4) can be seen in Figure 6.

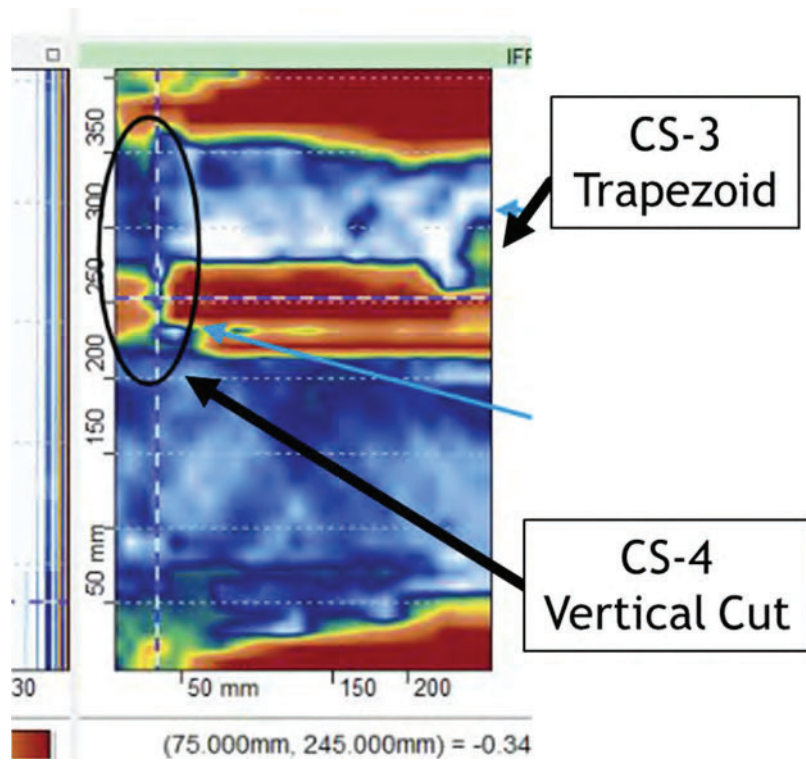
Figure 6: Microwave scan output of defects CS-3 (only part of the defect was indicated in this scan)

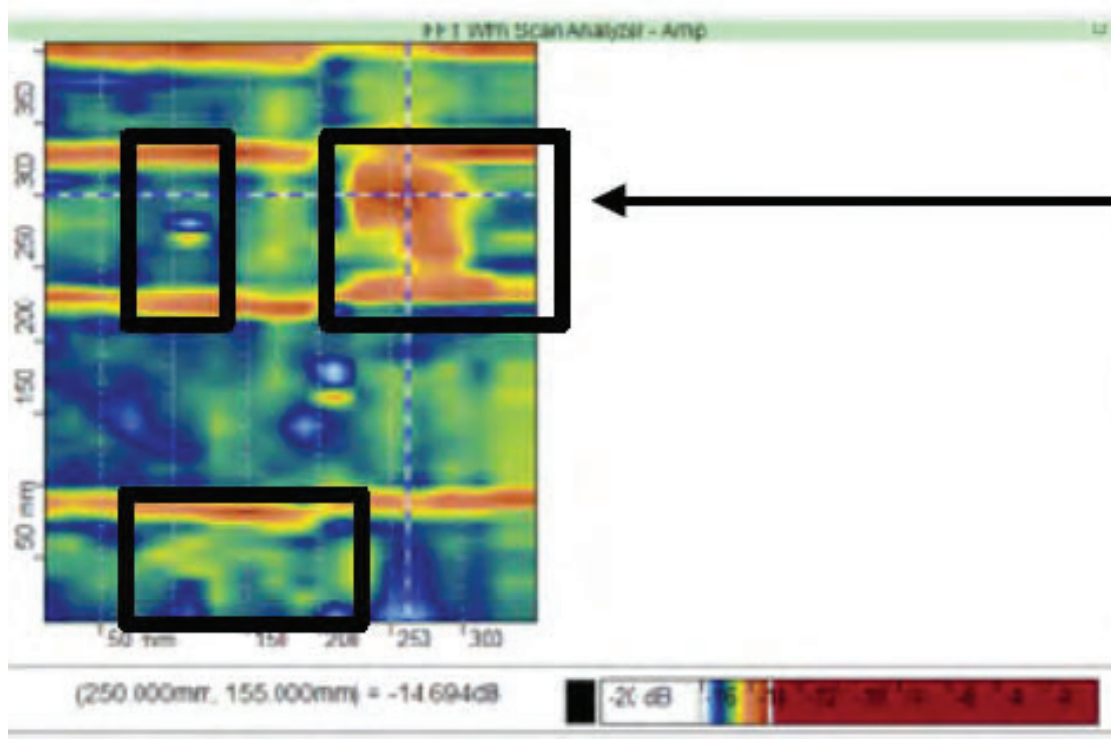
Figure 8: Microwave scan output of defects CS-5 (top left), CS-7 (bottom left) and CS-8 (top right)

Like the first spool, the second closed spool was divided into two (2) sections. The first section, seen in Figure 7, contained defects CS-6 and CS-9, while the second section, seen in Figure 8, contained defects CS-5, CS-7, and CS-8. The axial indications visible in all the scans are clamps that were used to keep the removed sections of the outer layer secure. All the defects were detected by the inspection vendor, except for CS-5, which is to be expected as the reinforcement layer at CS-5 was undamaged (no defect). Defect CS-6 and CS-7 showed up in the scan as general indications of damage but are not clearly defined. The scans for CS-8 and CS-9 not only indicate that there is a defect, but also clearly define the shape of the defect.

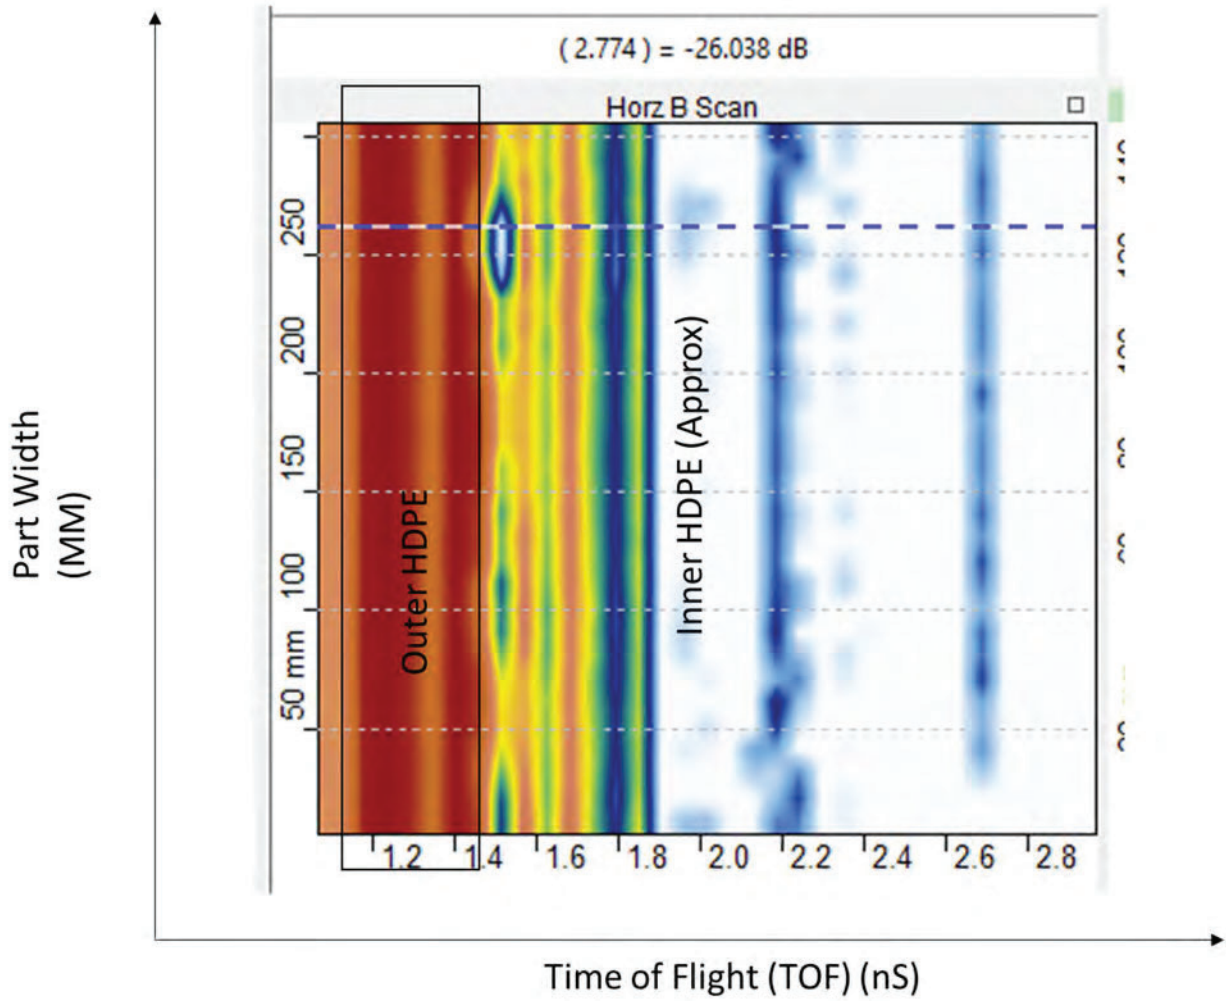
Figure 10: Kink defect microwave inspection output showing the different layers of the RTP and an area with disbondment between the outer cover and reinforcement layers
