# An Identity Crisis, the Impact of Manufactured Bends in Bending Strain Assessments

Rhett Dotson<sup>1</sup>, Alex Brown<sup>2</sup>, Justin Taylor<sup>2</sup>

<sup>1</sup>D2 Integrity, LLC., <sup>2</sup>TC Energy

*Proceedings of the 2025 Pipeline Pigging and Integrity Management Conference.*

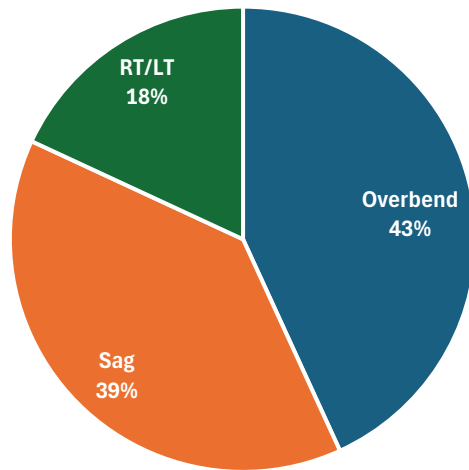
Figure 2: Bend Distribution by Type

**The case study pipeline contained 498 manufactured bends in the digitized construction records for a rate of 11.7 bends per mile. The distribution of bends by orientation is shown in Figure 2. This distribution of bends is typical with over bends and sag bends having approximately equal distributions while turns (right or left) make up only 18% of the total. The distribution of the bends by angle and type is shown in**

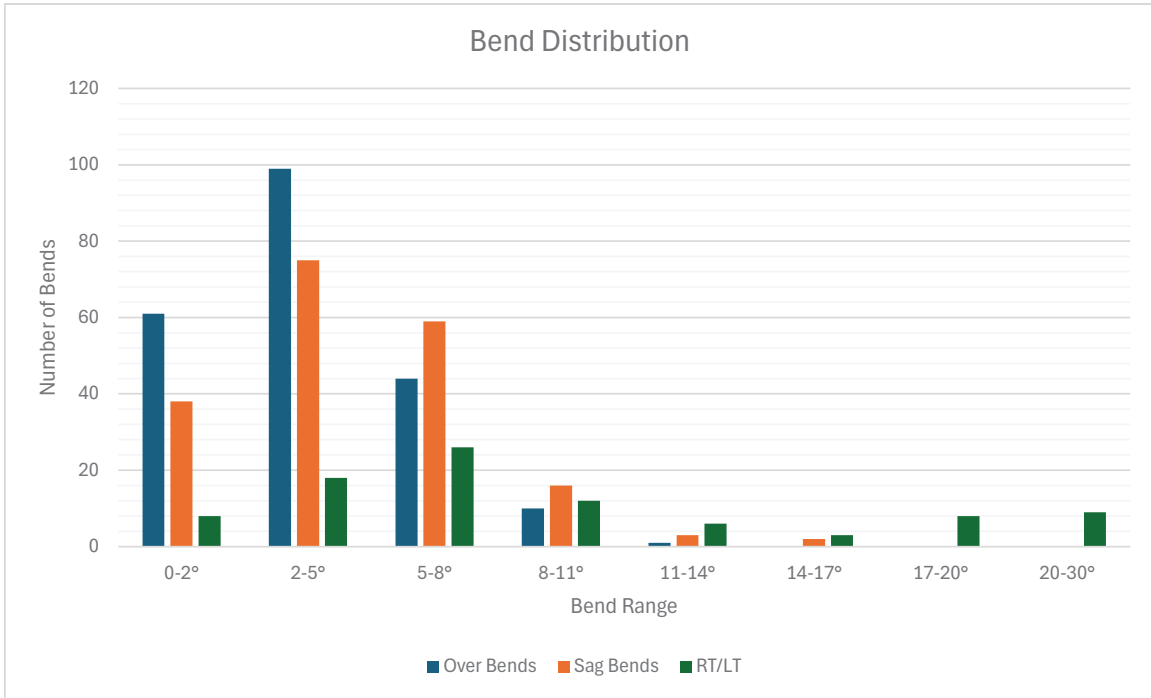
Figure 3: Bend distribution by angle

Figure 3. Small bends with an angle between 0 and 2° make up 21% of the bends in this case study. This is significant as these smaller bends typically represent the more challenging bends to identify in a bending strain analysis. It is also noteworthy, but not surprising, that the largest manufactured bends by angle are typically turns.

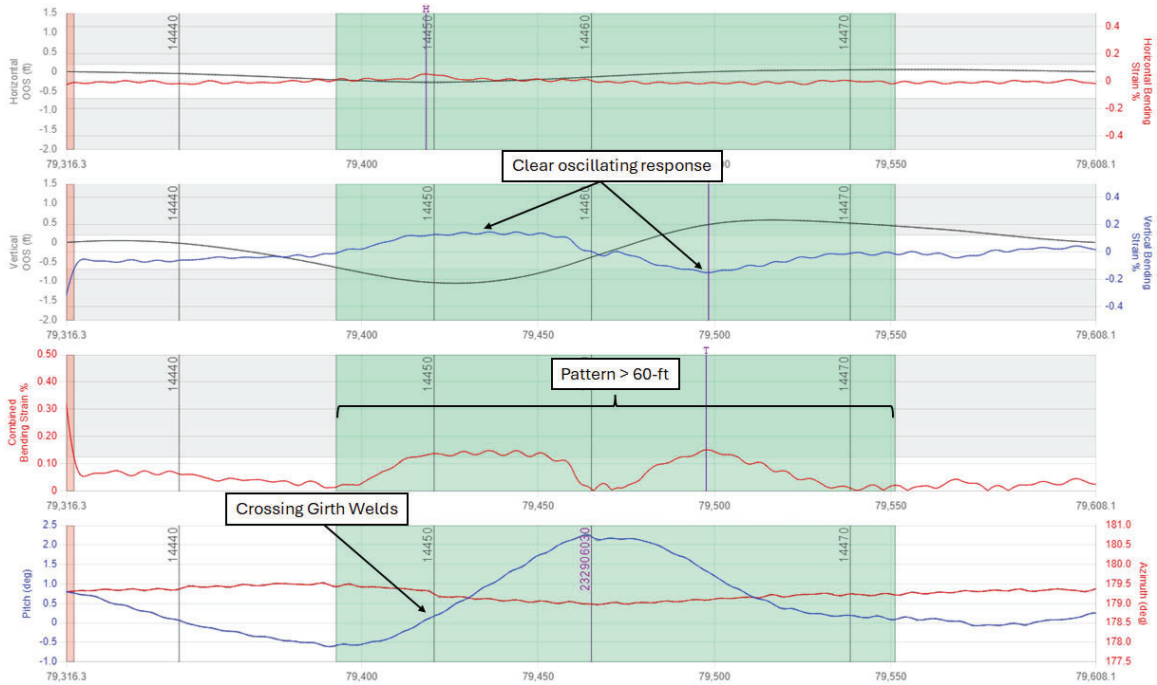
Figure 5: Example bending strain pattern

In contrast, the bending strain feature shown in Figure 5 has nearly opposite characteristics. First, the combined strain exceeds the reporting threshold of 0.125% in the third panel. The strain signal is longer than 60-ft extending across two joints (three girth welds). Second, the pattern has a clear oscillating response in the vertical direction with oscillating positive and negative strain values. Finally, the heading angle clearly changes across girth welds, indicating that the bending occurs over the girth weld. This feature should be confidently identified as a bending strain feature. The general

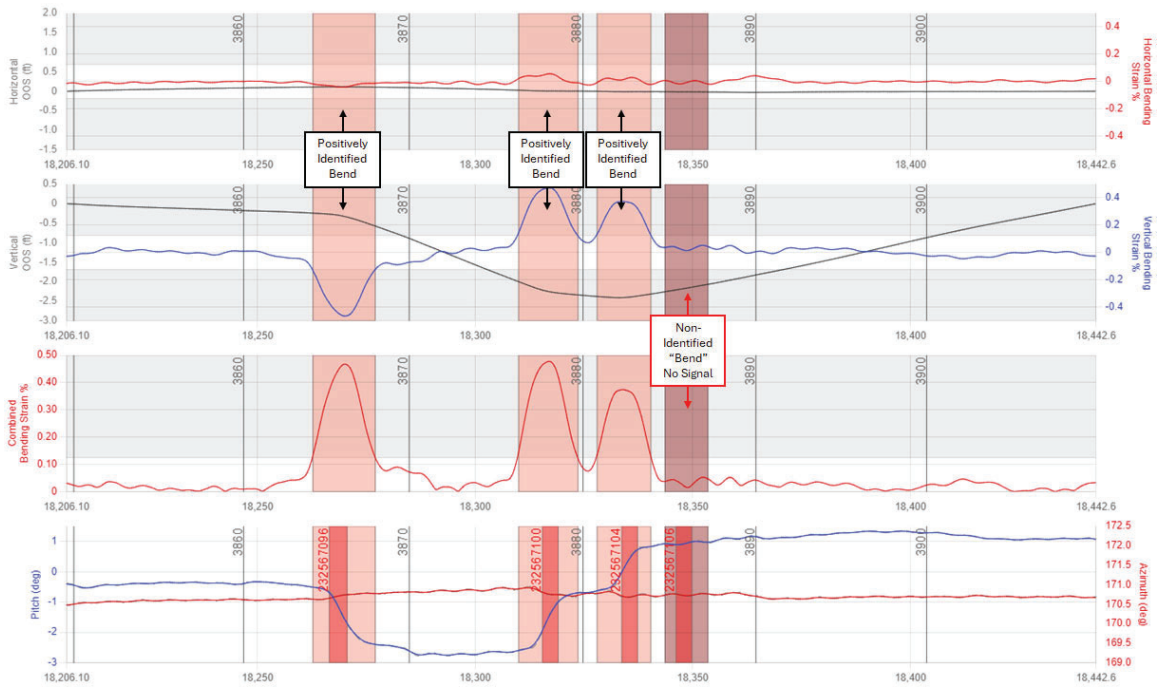
Figure 6: Non-identified "bend" from digitized construction documents

The analysis of the baseline IMU data identified 497 of the 498 (99.8%) manufactured bends from the digitized construction documents. Only one feature that was identified to be a bend in the construction documents was not identified during the analysis. This feature is shown in Figure 6 as the darker red stripe. The three features shaded in pink to the left are all positively identified manufactured bends. The feature on the right in dark red notes a location where a  $1.5^\circ$  sag bend should exist based on the digitized construction records. However, the IMU data shows no reportable signals at this location. While it is possible that this is an example of a false negative, it is more likely that the feature is an error in the digitized construction records. When the authors attempted to locate the feature in the original hand-written construction records, the bend identifier could not be located.

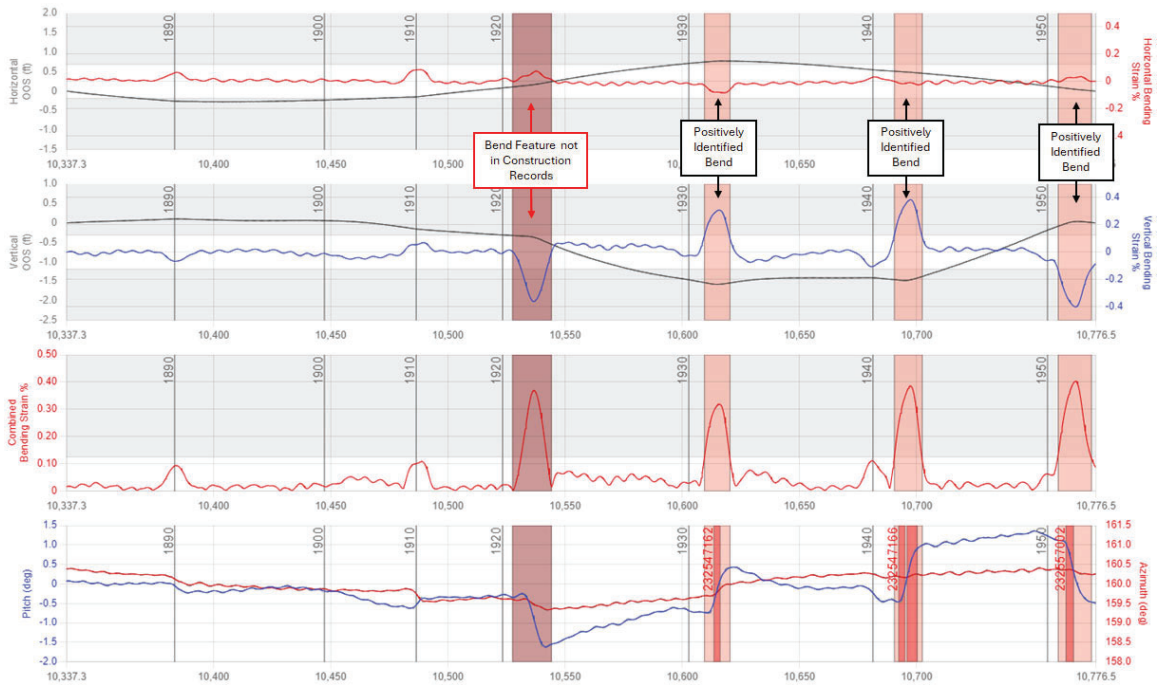
Figure 7: First manufactured bend feature not in digitized construction documents

Two additional bend features were identified during the IMU analysis that were not present in the digitized construction records. These features are reproduced in Figure 7 and Figure 8 and noted with the dark red shading. Both features clearly show evidence of being manufactured bends. The feature in Figure 7 appears as a  $1.5^\circ$  overbend. The feature is nearly identical in appearance to the three signals to the right in the image, which were all positively identified manufactured bends. The second additional bend feature in Figure 8 appears as a  $2.25^\circ$  overbend. Like the previous example, the characteristics of this signal are nearly identical to the other 4 signals in the image, which were all positively identified as manufactured bends. It is the opinion of the authors that both signals are likely construction bends that were not captured in the documentation rather than false positives.

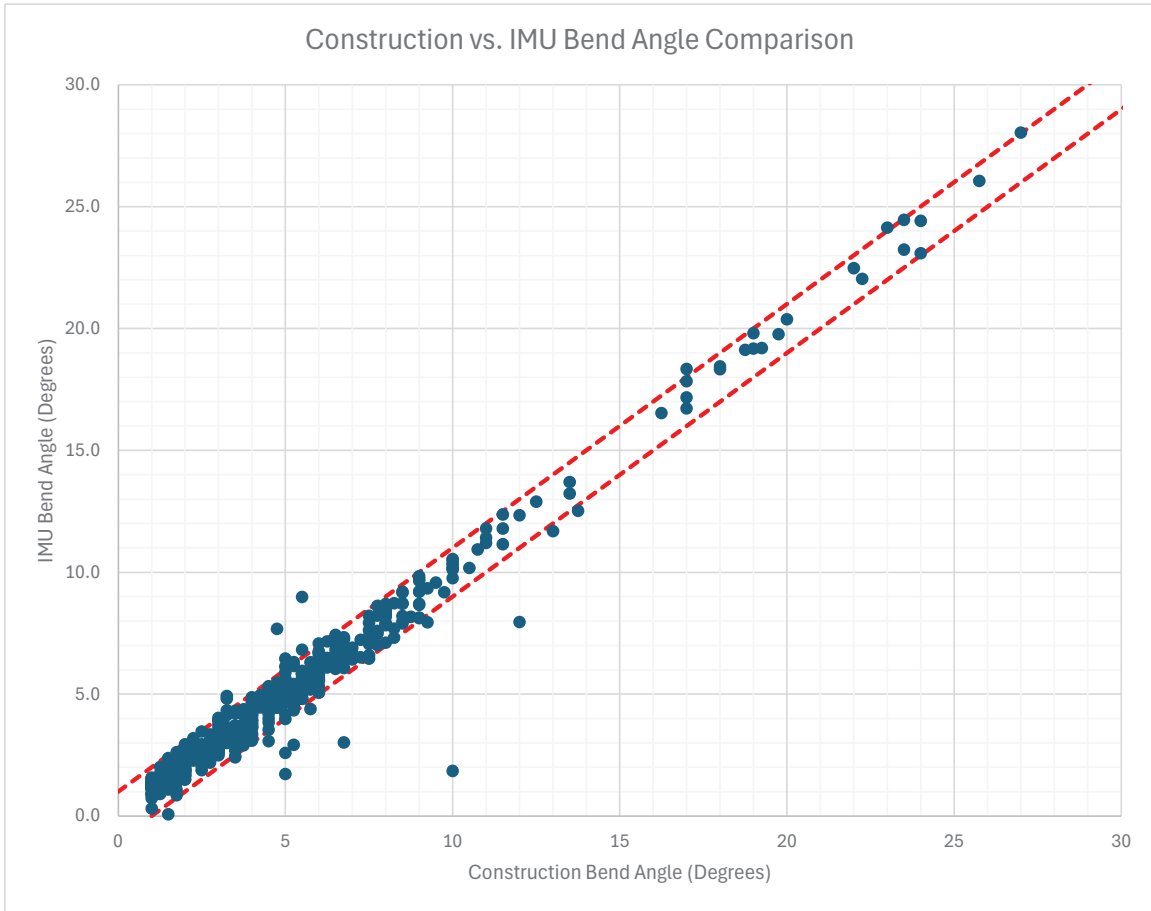
Figure 9: Comparison of digitized construction and IMU-calculated bend angles

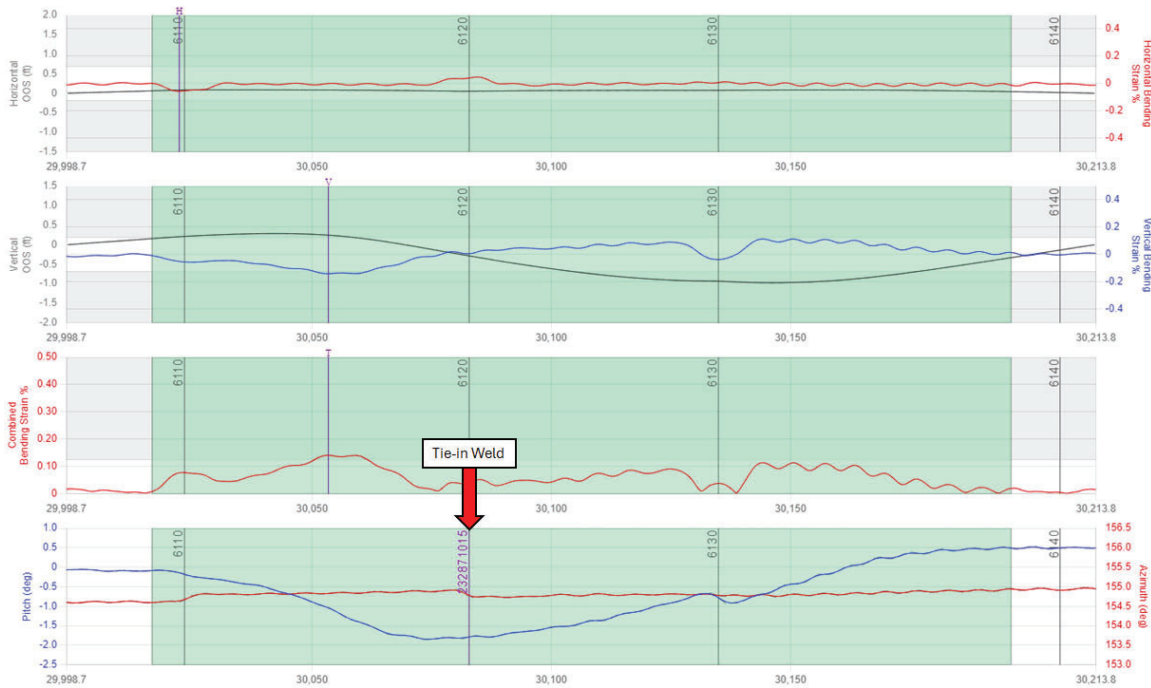
Figure 10: Tie-in weld Example #1
