# High-Resolution Acoustic Imaging ILI: Introducing Triple-threat Detection and Sizing in a Single Pass

*Proceedings of the 2025 Pipeline Pigging and Integrity Management Conference.*

This paper presents the validation of the technology in accordance with API 1163 best practices. A continuous flow loop was engineered and constructed to test the tool's endurance and validate the tool's performance over a variety of anomalies including electrical discharge machined (EDM) notches, manufactured cracks, natural cracks, and wall loss. These results are validated against industry standard tools including a metrology-grade laser scanner and a phased-array ultrasound handheld tool.

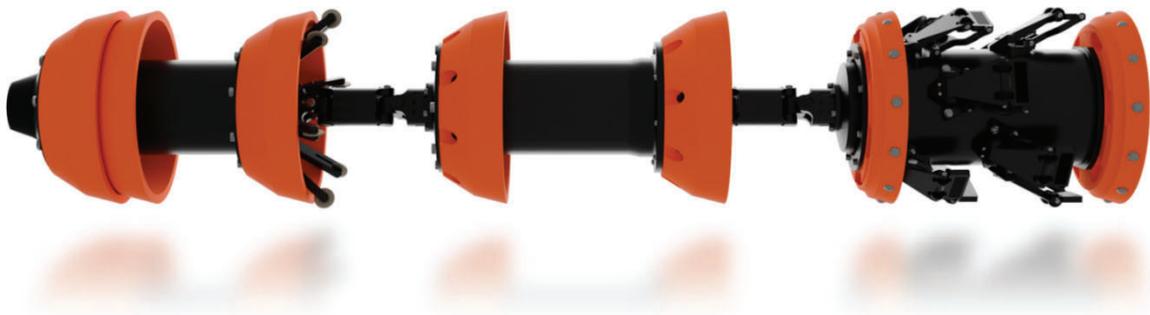
**Figure 1:** High-resolution Acoustic Imaging is deployed in pipelines using a multi-body inspection tool.

The main 3 modules of the configurable system as depicted in **Figure 1** from left to right are:

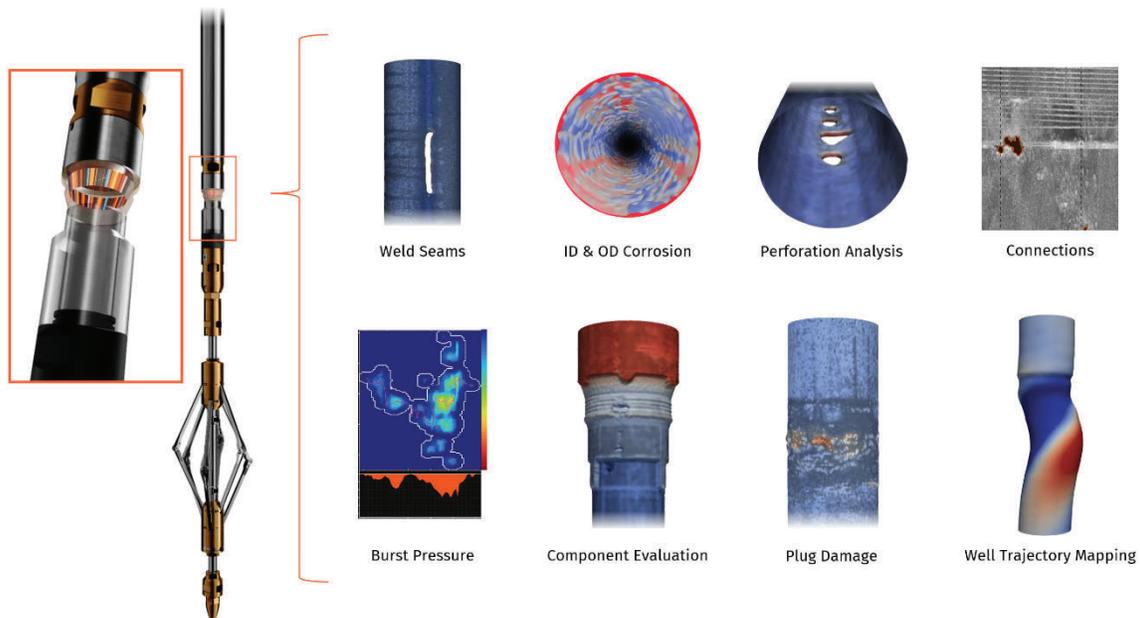
**Figure 2:** High-Resolution Acoustic Imaging in an upstream tool measures casing and tubing to assess for wall loss defects, breaches, deformation, threaded connection makeup, and completions hardware.

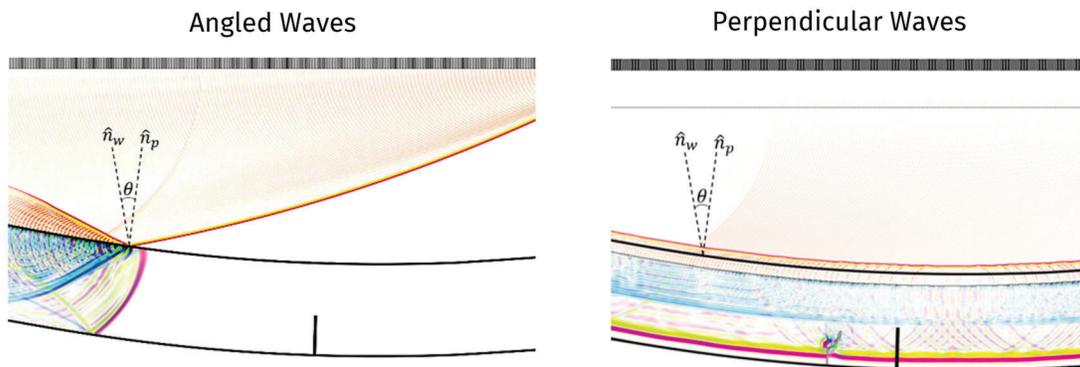
**Figure 3:** The tool generates clockwise and counterclockwise angled diverging wavefront (yellow-red) to create a shear wave (Left, cyan-blue) in the pipe wall and a longitudinal wave (Right) that is perpendicular to the pipe wall to maximize the detection and sizing ability of the imaging modes applied post-run.

1. For sizing defects such as cracks, inclusions, and lack-of-fusion (LoF), it is advantageous to emit diverging waves that impinge on the ID of the pipe at an angle which creates shear waves (Left, cyan-blue in figure below) that propagates in the pipe wall.
2. For sizing defects such as corrosion, pitting, delamination, porosity, lack of penetration, and weld misalignment, it is advantageous to transmit diverging waves so that they impinge normally on the ID of the pipe.

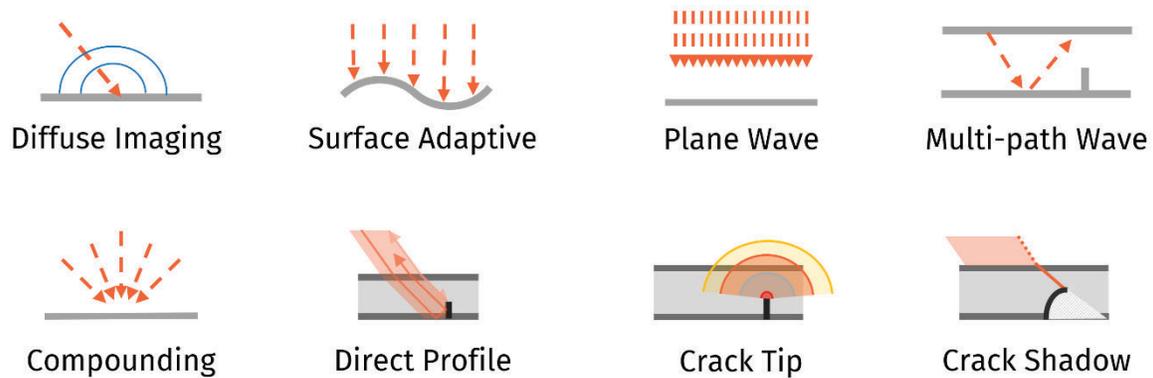
**Figure 4:** Various imaging modes are used to extract different information of each defect.

reflections from material boundaries in different ways, even assessing the lack of signal, and are combined to provide operators comprehensive insight into the root cause of the defect. Multiple imaging modes as depicted in **Figure 4** are combined to collectively create the results of Acoustic Imaging.

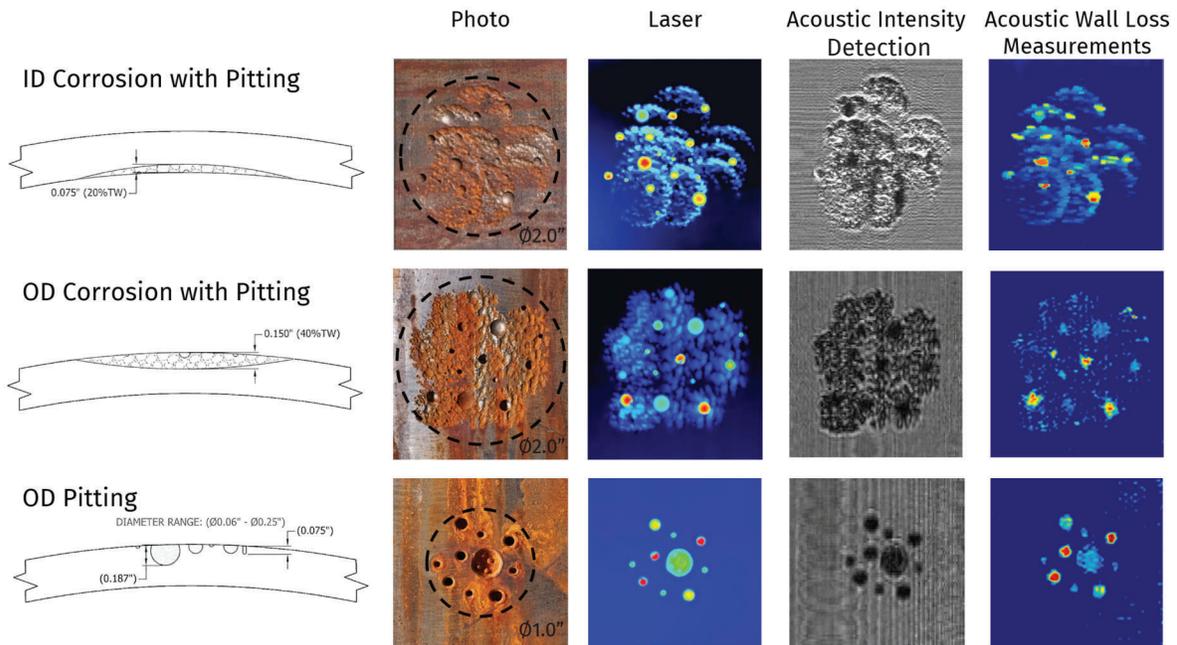
**Figure 5:** OD and ID pitting and corrosion is evaluated with Acoustic Imaging and compared against external laser scans. Acoustic Intensity view (2<sup>nd</sup> right) shows pipe wall surface texture.

Traditional ILI inspection methods to measure pipe wall loss are either limited in resolution with discrete single-element UT probes or are inferred-based MFL measurements. Small but critical defect features like pitting, pinholes, such as microbial-based pitting have been difficult to detect with these methods. The size of these defects is often smaller than the beam size of a single-element UT probe or fall below the resolving abilities of MFL tools. These defects are now being clearly resolved and measured with Acoustic Imaging as seen in **Figure 5** and **Figure 6**.

All surfaces contain varying levels of roughness. When an acoustic wave contacts a material boundary, part of the energy is scattered and reflected due to the surface roughness and imperfections - Diffuse Imaging takes advantage of this property and maps the profile of the surface from the corresponding reflections. **Figure 7** illustrates this principle. Due to the high-density nature of the point cloud measurements from High-Resolution Acoustic Imaging, it is advantageous to plot the intensity of signal returns over the length and width of the scanned area. The Acoustic Intensity view provides a high-resolution texture map of the ID and OD wall surface which can be used to further understand anomalies and provide contextual information that is valuable to understand the surrounding inner and outer surface condition at anomalies. **Figure 5**, 2<sup>nd</sup> right column of images are examples of these Acoustic Intensity views.

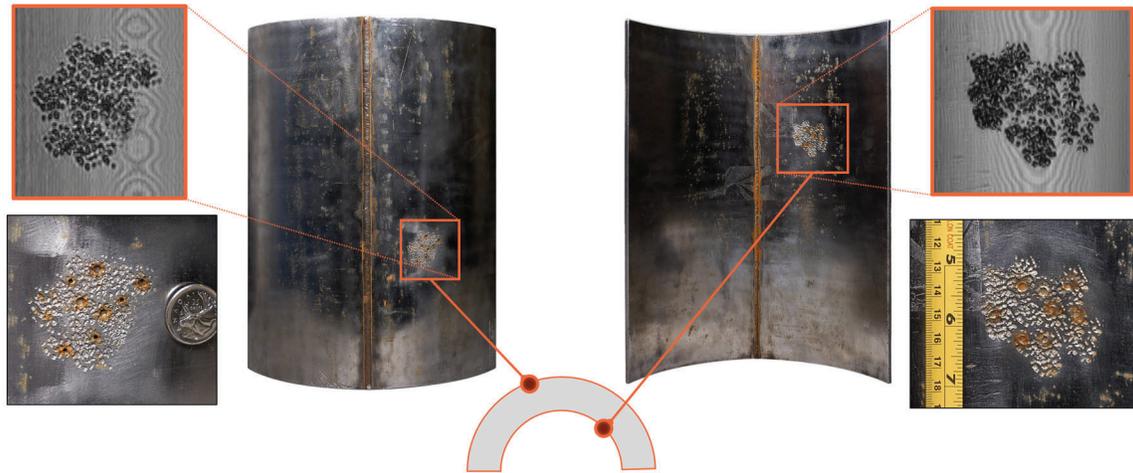
**Figure 6:** Acoustic Intensity Maps Generate Photorealistic Imagery of wall loss defects on the ID and OD. These maps are a useful tool for the detection and root cause analysis of defects, particularly when partnered with encompassing wall loss measurements.

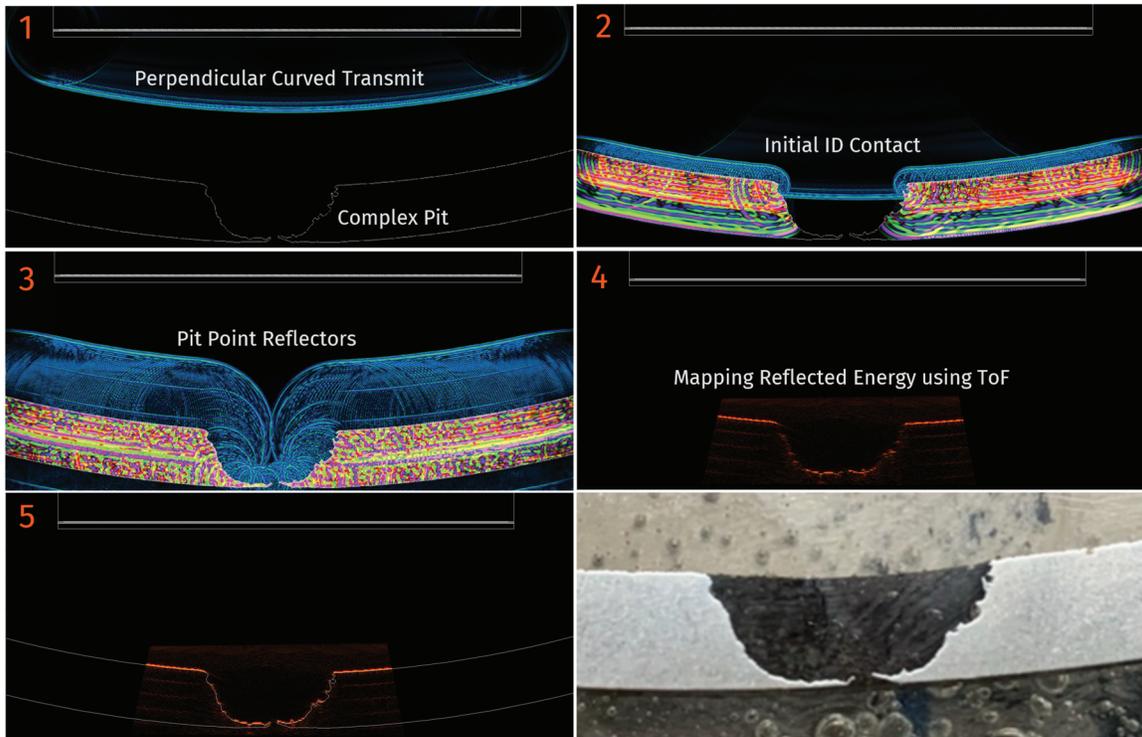
**Figure 7:** Acoustic Imaging uses diffuse imaging to map a complex and representative through wall pit. [1] Delays are applied electronically to optimize the perpendicularity of the wavefront to match the curvature of the pipe. [2] Initial ID contact, discontinuity clearly apparent in at the pit defect relative to nominal ID. [3] Point reflectors of the complex pit boundary create many spherical wavefronts returning to array. [4,5] TOF delays applied to the amplitude signals used to map the point source reflectors of the pit.

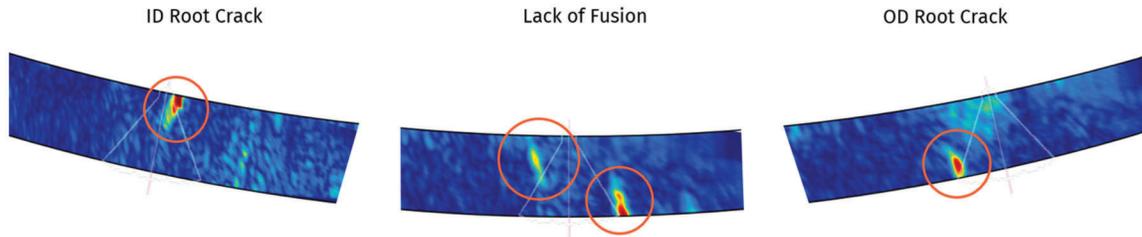
**Figure 8:** Acoustic Imaging ILI B-scan Examples of different discontinuities in Submerged Arc Weld (SAW) Seams.

Acoustic imaging has been utilized to accurately size crack-like defects of various types and provides spatial understanding as to the location and identification of the defects in SAW seams as seen in **Figure 8** and in pipe body **Figure 9**.

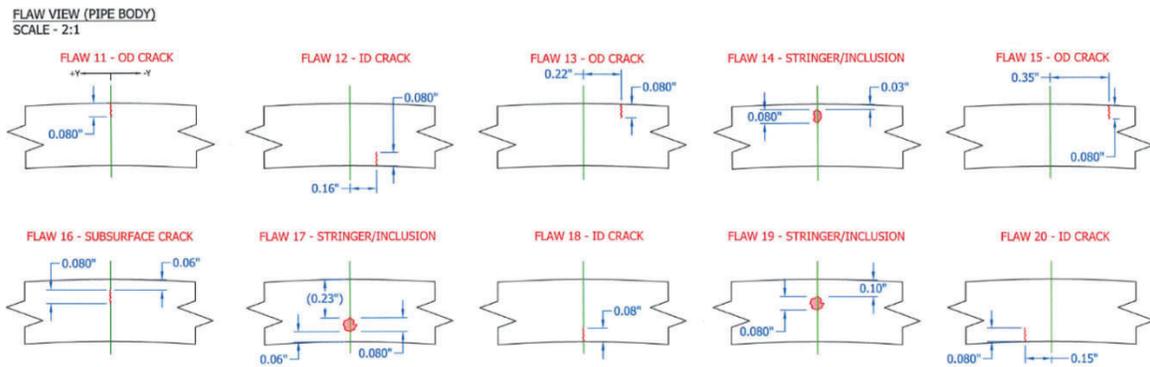
**Figure 9:** Various types of axial crack-like defects in pipes

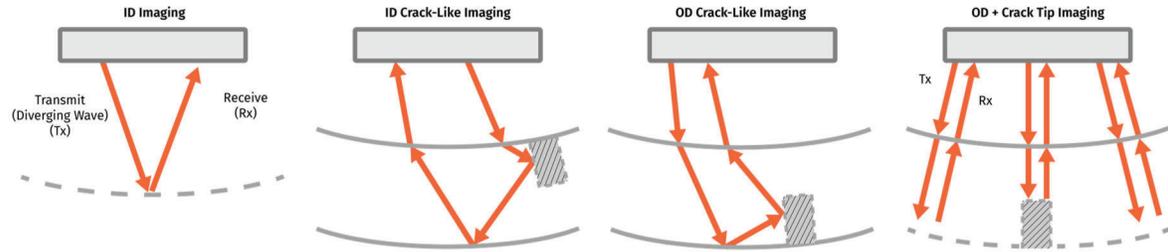
**Figure 10:** Different signal pathways are used to illuminate different key aspects of a defect. The multipath assessments are captured from the same dataset but are completed by uniquely processing each plausible reflection path. Each brings advantages to improved detection, sizing and identification, and the combined results offer more contextual root cause understanding.

Angularly steered diverging waves, or steered transmits, are particularly useful for characterizing crack-like defects. By accounting for the returning signal's time-of-flight, direction of propagation, and refraction of the emitted wave on the ID, and its subsequent reflection on the OD, the defect that reflected the energy (or in some cases, lack of energy) can be accurately mapped to its original location. Since the raw data recorded contains all modes of reflection, different wave paths can be reconstructed to offer more information about the defect. **Figure 10** shows some common reflection paths that are analyzed using acoustic imaging [2].

In addition to creating a shadow, normal transmits also generate crack edge diffractions. When these diffractions are captured at sufficiently high signal-to-noise ratio (SNR), direct modes (see **Figure 10**) can be used to identify the tip and root of crack-like defects with high accuracy. These different imaging modes are then combined to give a clear understanding of the anomaly. From the location of tip and root, users can immediately infer the size and tilt of the crack-like defect. Edge diffractions can appear for both longitudinal and shear wave transmits, but, due to conversion losses, they are generally higher quality with longitudinal waves.

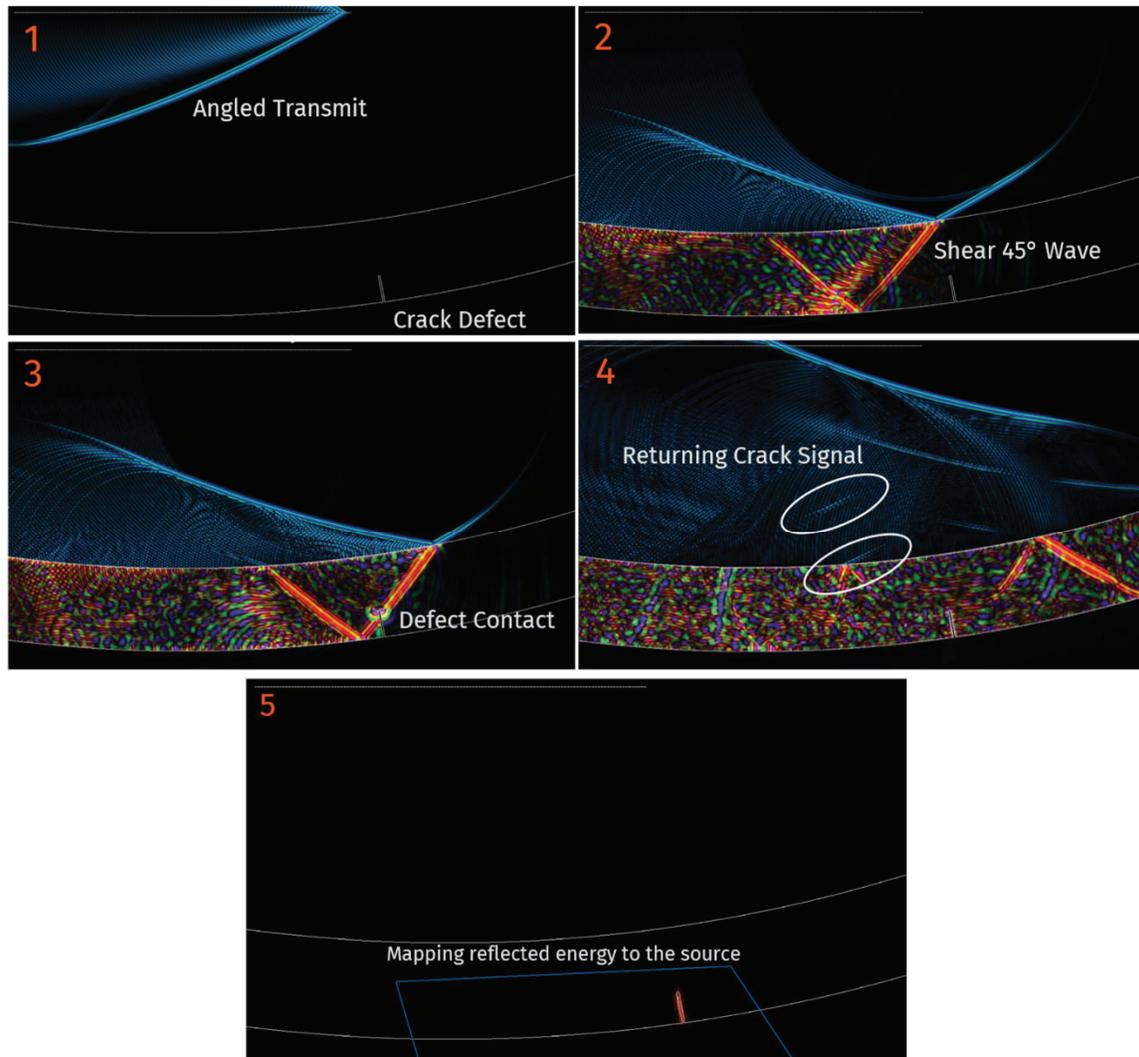
**Figure 11:** Acoustic Imaging used to map energy to a slightly off axis or tilted axial crack. [1] Delays are applied electronically to optimize the angle of the approaching wavefront to optimize the penetration of acoustic energy. [2] Initial ID contact, results in the creation of a shear 45-degree wavefront due to the change in speed of sound at the fluid-steel boundary. [3] Shear wave contacts the tilted axial defect; the tip creates a point source reflector while the face of the defect creates a reflector. [4,5] TOF delays applied to the amplitude signals used to map the point source reflectors of the pit.

The ability to clearly map the returning energy to a specific component or region within a defect is a novel approach that leverages the full array capture of the acoustic imaging platform as shown in **Figure 11**. Additionally, corrections for the multipath calculations can be refined for the most concerning of defects to account for the precise location of the sensor array relative to the pipe wall. Lastly, the transmit pattern and element sequencing are electronically controlled, meaning that custom imaging sequences can be utilized to mimic sectoral scanning results by indexing through multiple transmit angles. For secondary screening or more highly specialized inspections this means that the imaging can be configured in advance to capture the most elusive crack morphologies.

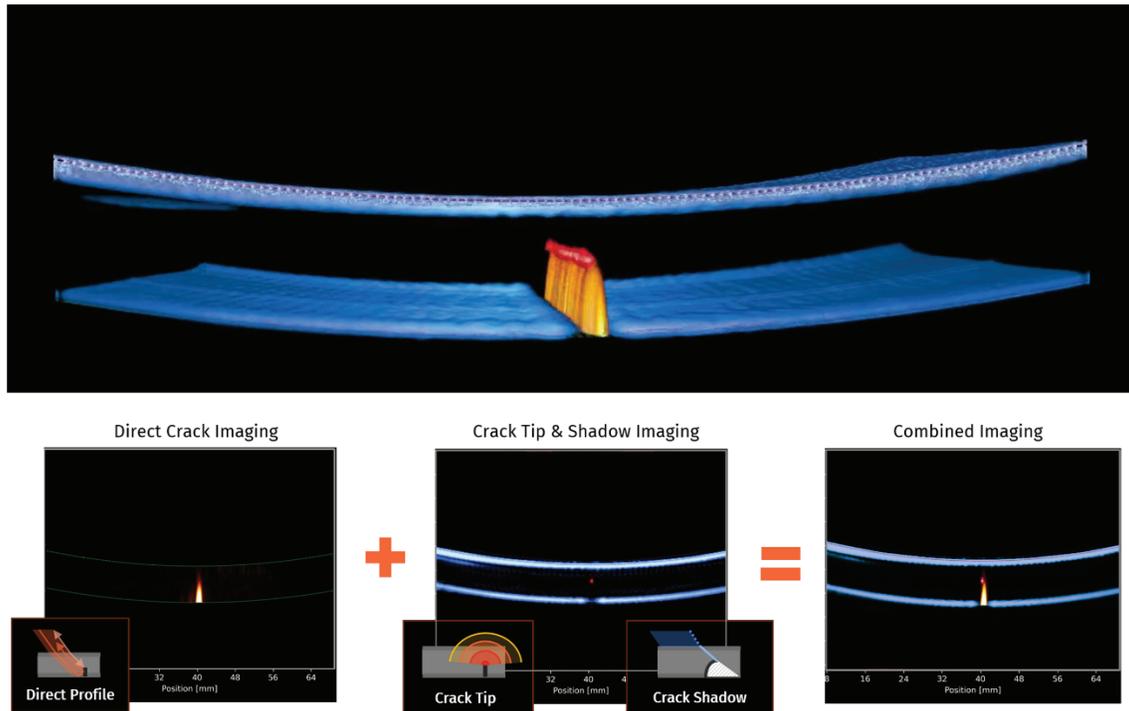
**Figure 12:** Examples of how different imaging modes are applied to cracks and their resulting output.

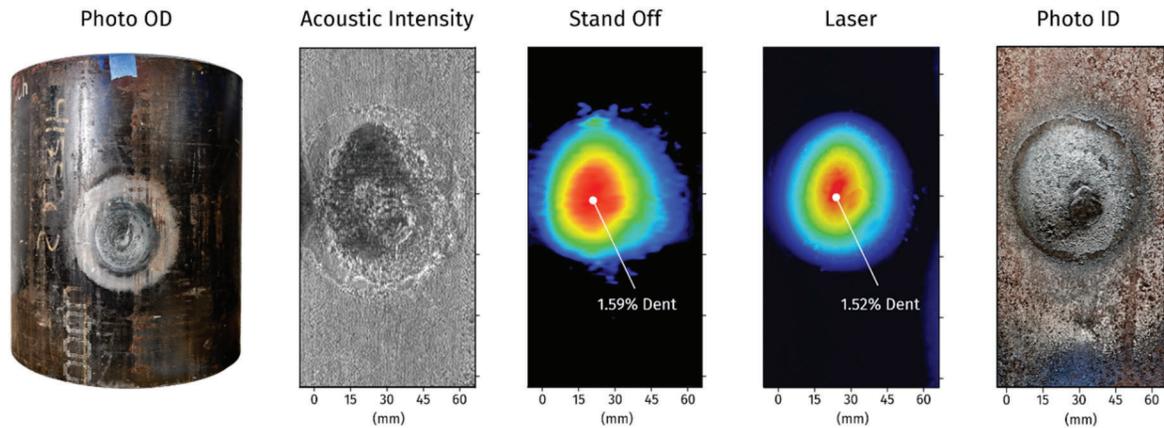
**Figure 13:** A dent in a pipe sample (far left and right) is evaluated with Acoustic Imaging (2<sup>nd</sup> and 3<sup>rd</sup> images) and with a laser scan (2<sup>nd</sup> right). The Acoustic Intensity view shows the ID texture which can be clearly used as a detection method and the Stand Off view shows the ID displacement measured over the dent from the acoustic ILI tool.

in 2025. The images in **Figure 13** and **Figure 14** outline some of the early results that have been gained to date validating the base capabilities of dent detection and sizing.

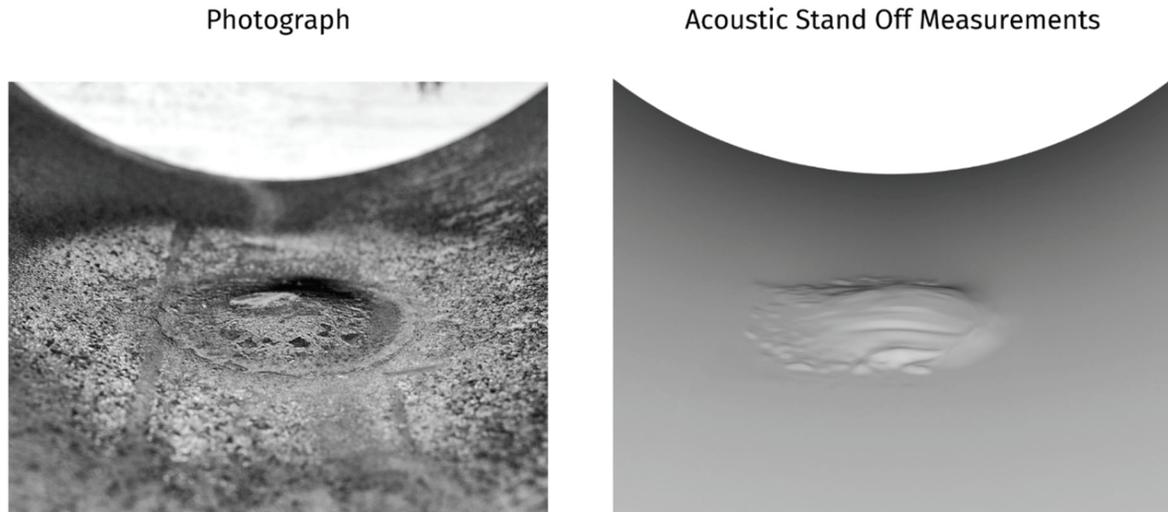
**Figure 14:** Dent geometry is directly measured with the Acoustic Imaging ILI tool and resolves the full contours of the dent.

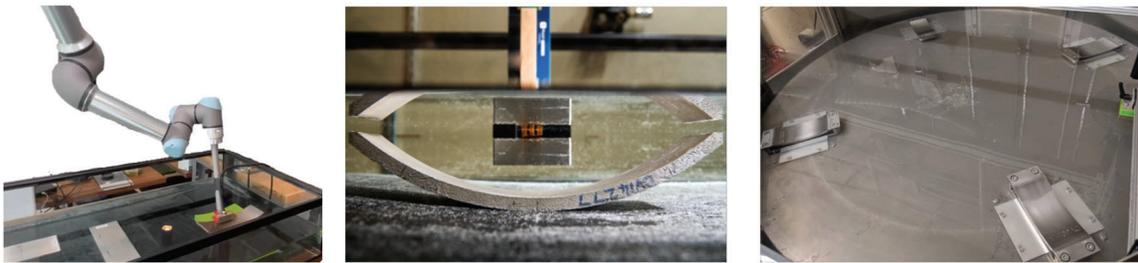
**Figure 15:** Designs are progressively tested in immersion tanks with increasing representative conditions. Left and center image shows the robotic arm immersion tank in which movement past the same defect can be repeated in a highly controlled manner. Right image shows the turntable immersion tank, in which a variety of defects and mechanical features were traversed at representative line speeds.

Once designs and imaging parameters passed the simulation stage, they were physically prototyped and tested to assess their capability to acoustically image and size various defects and samples under diverse conditions. The probes, imaging system, and acquisition parameters were further validated and optimized across different conditions and run speeds in immersion tank setups as seen in **Figure 15**. The Acoustic Imaging acquisition system was integrated with a robotic arm system to enable both axial and circumferential movement, simulating tool motion dynamics along a pipeline in a highly repeatable fashion. This process was iteratively refined across multiple design cycles.

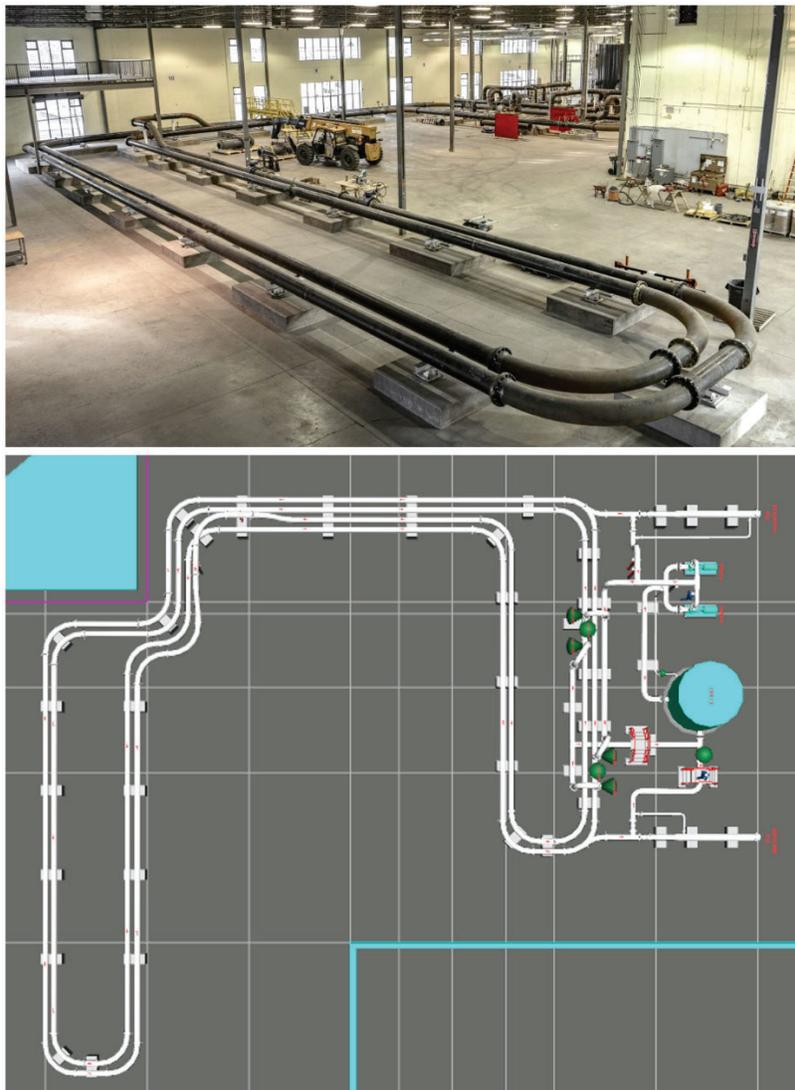
**Figure 16:** A dedicated full-scale continuously looping test pipeline was constructed in an indoor facility.

The fully integrated ILI system underwent testing in a newly constructed 1,300ft long continuous-loop test pipeline seen in **Figure 16**. The dedicated, full-scale, infinity loop pipeline, constructed within an indoor facility, enabled comprehensive testing, refinement, and qualification of the complete High-Resolution Acoustic Imaging tool under conditions closely resembling real-world

pipelines. This setup also allows for the evaluation of tool dynamics and wear when passing over common pipeline features such as 3D bends, girth welds, diverters, barred tees, and valves.

The infinity loop has a large spool section in which multiple manufactured features and cutouts from field excavations were flanged and installed to image multiple times over. Testing and validation samples included EDM notches, flat bottom pockets, manufactured flaws, and real field-removed defects. Real and manufactured anomalies include flaws in welds in the toe, root, centerline (both surface breaking and embedded), hook cracks, as well as lack of fusion (LoF), slag inclusion, and porosity. The length, width, and depth of these flaws were assessed.

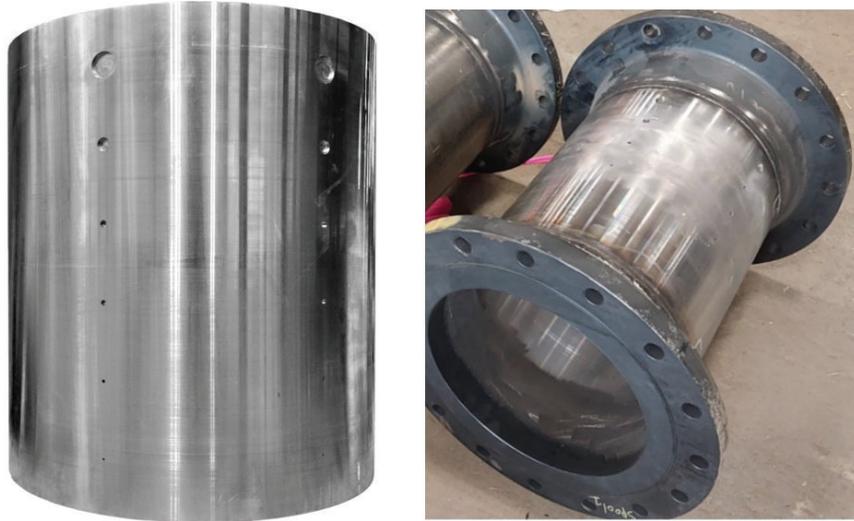
**Figure 17:** A machined pipe sample with wall loss defects of varying diameters and various depths used to evaluate POD and sizing accuracy.

Idealized flat bottom pockets were manufactured in a representative pipe size, material and nominal thickness shown in **Figure 17**. The sample was scanned by the High-Resolution Acoustic Imaging ILLI tool to evaluate the overall performance of the technology and the tool.

The OD flat bottom pocket sample was comprised of an array of idealized OD wall loss defects that ranged in diameter from 25.4 mm down to 1.6 mm. For each diameter of pocket, the depth ranged from 3.1% or 0.4 mm wall loss up to 6.4mm or 50% wall loss as described in **Table 1**. This preliminary study focused on depth range above 12.5% (1.6mm wall loss) or nominal API wall loss specification.

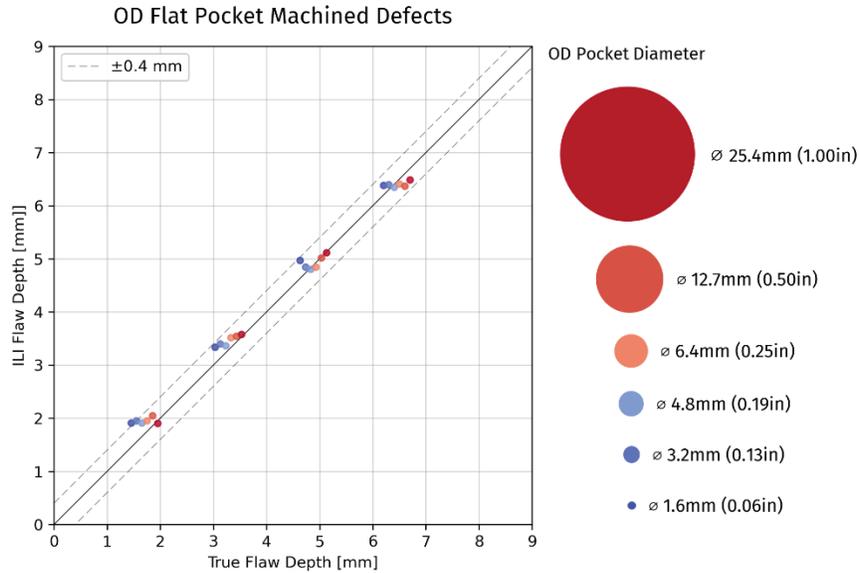
**Figure 18:** Preliminary Unity Plot of OD Flat Pocket Machined Defects ranging in diameter from 1.6mm to 25.4mm.

The aggregate results from imaging the OD flat bottom pockets are presented below in **Figure 18**, which shows depth sizing across defects with a diameter down to 1.6mm with a preliminary accuracy of +/-0.4mm. The critical conclusion is that deep flaws (>5mm) that have a very small diameter (1.6 mm) footprint are accurately sized owing to the resolution of the acoustic imaging ILI as shown in **Figure 19**. Subsequent studies into small and shallow defects are to be conducted, though in practice, it is noted that deep and small diameter defects or pits are typically a more concerning feature to industry.

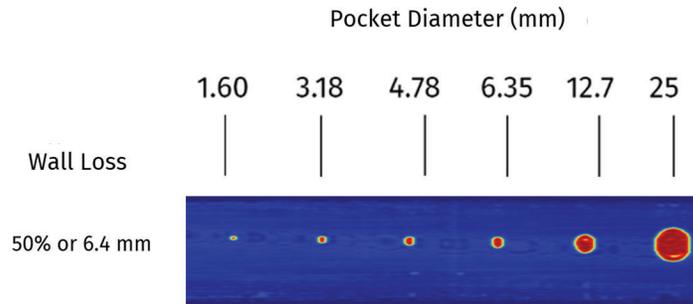
**Figure 19:** Wall Loss Heatmap of 50% through-wall or 6.4mm deep row of OD pockets ranging in diameter from 25.4 mm (1”) to 1.6mm (~ 1/16”)

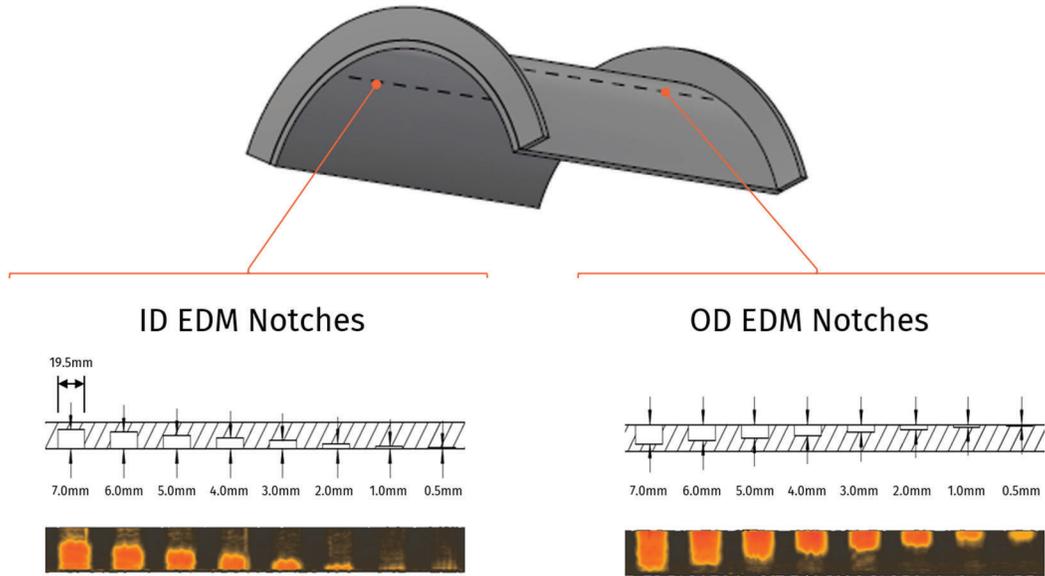
**Figure 20:** Acoustic Imaging B-scan Visualizations of OD and ID EDM notches cut at varying depths.

Samples with a variety of notches were imaged with EDM notches varying in depth from approximately 0.4mm to 7.0mm and in length from just under 1” (19.5mm) as seen in **Figure 20**. The b-scan results of the amplitude responses received at the tool are presented along with the reference dimensions from the as-built sample. The ability to directly size EDM notch defects is also clearly exhibited, however it’s worth noting this behavior is fully expected as these flaws are perfect reflectors and very idealized as compared to real world crack morphologies.

As one would expect, with extremely high axial resolution (0.5mm @ 2m/s) the POD for these ~1” long idealized crack-like EDM manufactured defects was perfect (16/16). This study led to further investigation into the technology’s ability to resolve penetrators, which are much shorter flaws that have the potential to be relatively deep.

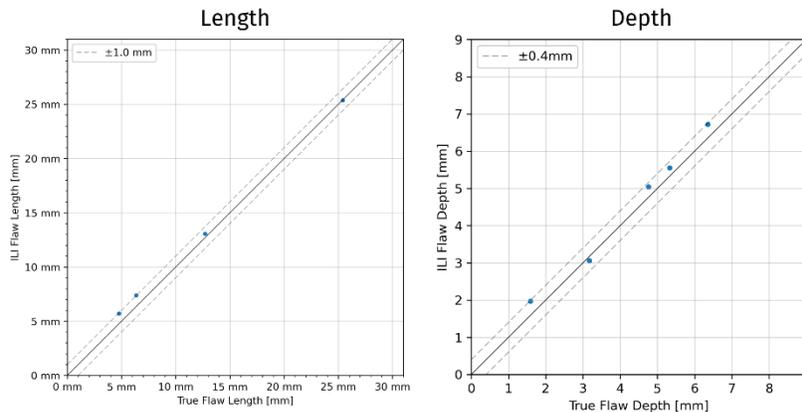
**Figure 21:** Length and Depth Sizing Unity Plots for <1” length Penetrator EDM notch defects.

Additional EDM penetrator sample sets were procured with a typical depth range of 1.6 to 6.3 mm but with very short notch lengths – starting at 5mm and going up to 25.4 mm (1”) representing a set of defects entirely below typical industry length thresholds. The resulting length and depth unity plots are shown below in **Figure 21**.

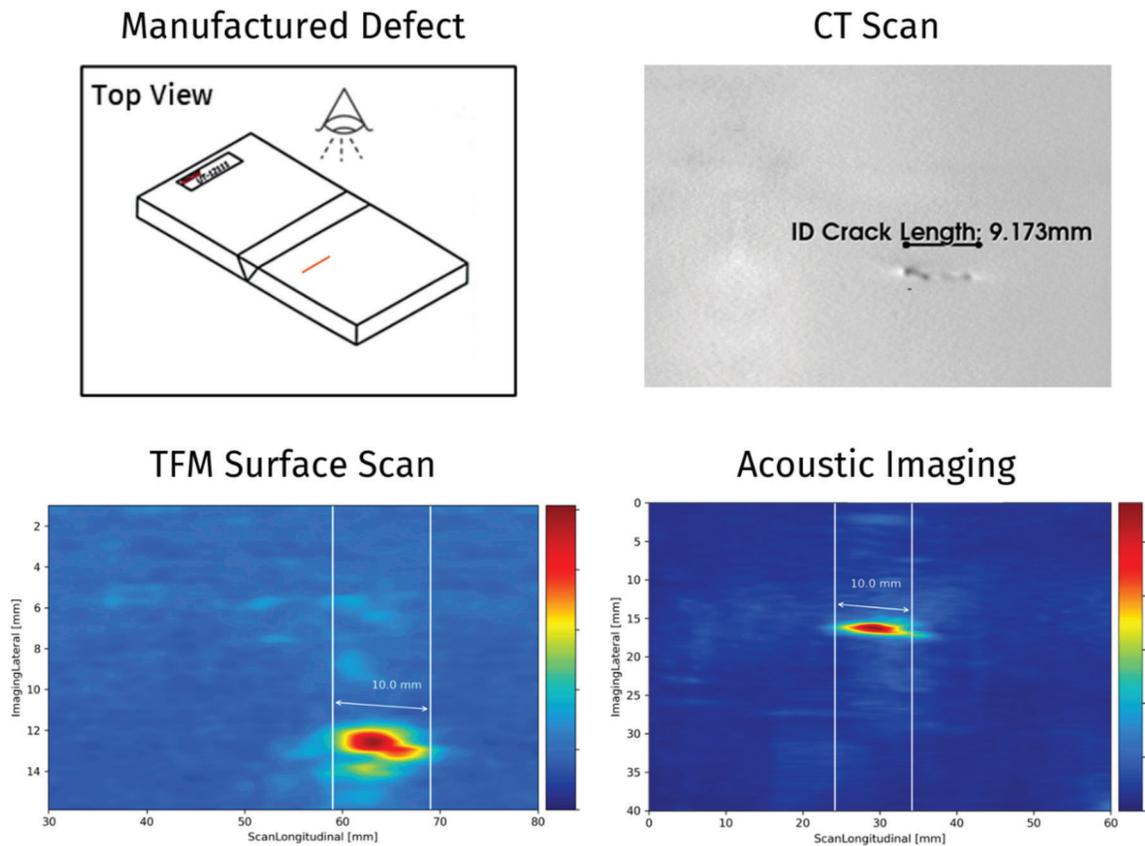
Figure 22: The results from each NDT method show high agreement.

In addition to EDM notch samples a more representative crack morphology was assessed to understand the ability to resolve short crack-like defects that currently would go undetected based on today’s length thresholds. This defect was also manufactured; however, it relied on fatigue-cycling-based manufacturing methods which resulted in a more natural crack morphology. To assess the “ground truth” length both PAUT handheld device operated by a qualified technician and medical grade CT scanning were used to assess the length accuracy of the acoustic imaging ILI.

The ground truth methods and Acoustic Imaging ILI tool results showed general agreement in both sizing the depth and length of the defects as seen in **Figure 22**. However, PAUT was not able to properly resolve the geometry of the flaws, and CT struggled to define the extent of certain flaws and cracks due to absorption effects. Both the OmniScan handheld unit and ILI tool were able to clearly discriminate the boundary and geometry of the flaws in the defect samples.

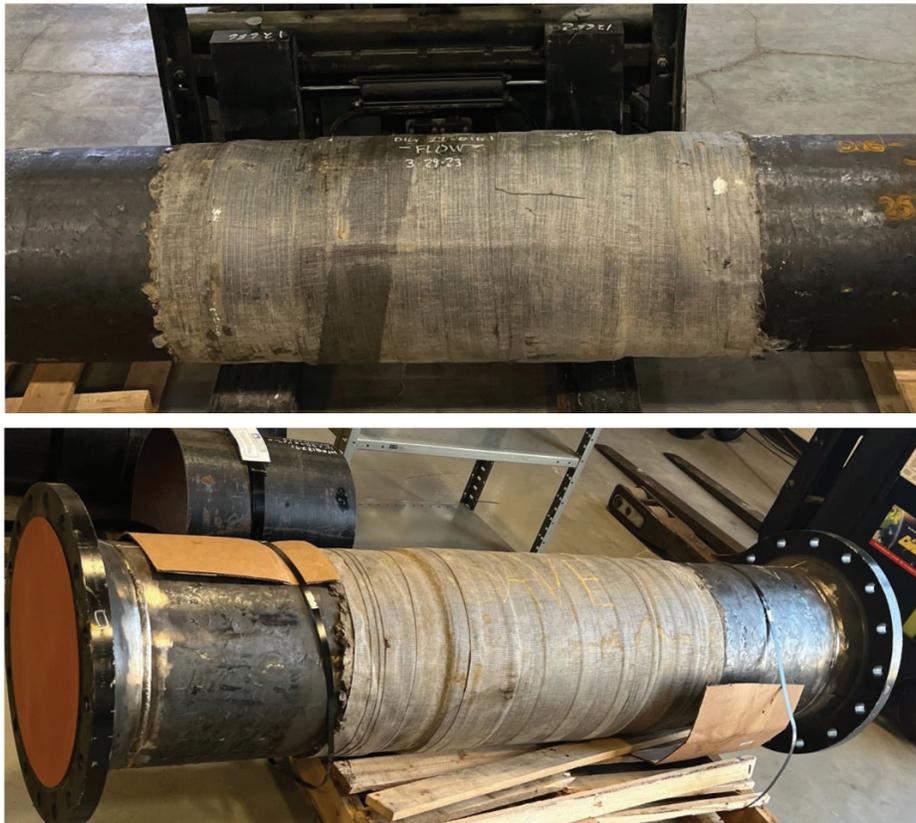
**Figure 23:** Through wall-sleeved LOF penetrator defect removed from the pipeline.

After validating representative lab-grown crack morphology, the final assessment of penetrators was a through wall lack of fusion (LOF) defect that was sleeved and ultimately removed from the operating line. This sample was highly complex in that it came from a 1950s vintage ERW pipeline asset. Prior to removal from service this defect had been assessed with high end ILI tools in five separate inspections (2015, 2017, 2019, 2020, 2021, 2022). It was noted that the defect had a low POD due to short length, resulting in outside of specification depth tolerances. The depth sizing through wall percentage from these runs in chronological order was 27%, 29%, 24%, 45% and back down to 29% - none were near the through wall condition that was identified upon digging.

A pull test setup was configured to be able to efficiently assess the defect and optimize imaging parameters if required. The sample was flanged and fluid filled while a stuffing box-type seal was used to pull the ILI hardware past the region of interest.

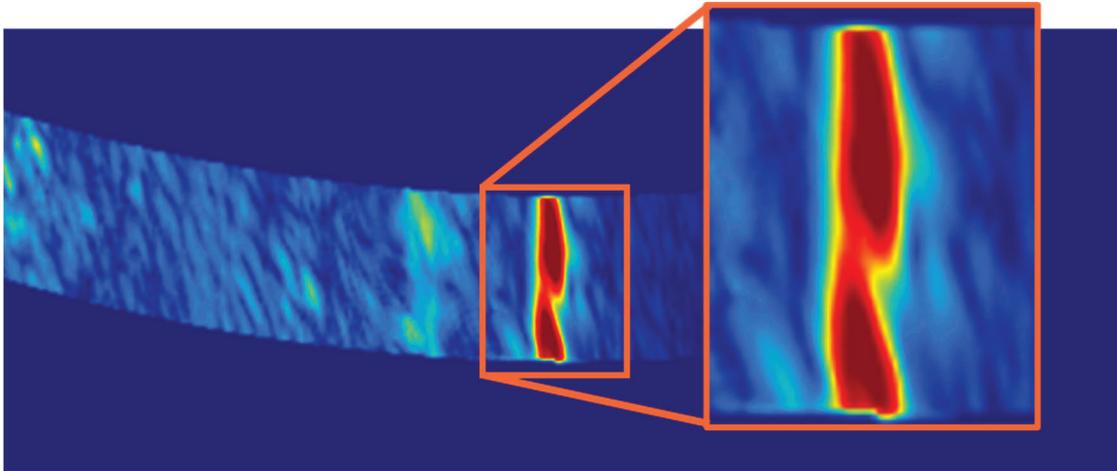
**Figure 24:** Acoustic Imaging ILI Radial B-scan of through wall-sleeved LOF penetrator defect removed from the pipeline.

The tool was able to locate and confirm the defect to be through wall. The imaging results showed a clean response from a 100% through wall feature as seen in **Figure 24**. This defect was found to be 13 mm in length and confirms the need for higher axial resolution tools capable of detecting significantly shorter-length flaws and sizing them with accuracy. When imaging very deep defects, having a relatively long array of sensors ensures that there is no depth-based amplitude saturation

which can occur in a large single element-based sensor beam. A very deep or through wall defect results in a very wide response signal which can be entirely captured using a wide array-based sensor, so long as the array is acting as independent receiver elements. In addition to assessing the LOF feature, the sleeve's girth welds were also detected – enabling the detection of type B sleeves and confirmation of defect under sleeve. Continued evaluation of this sample is ongoing.

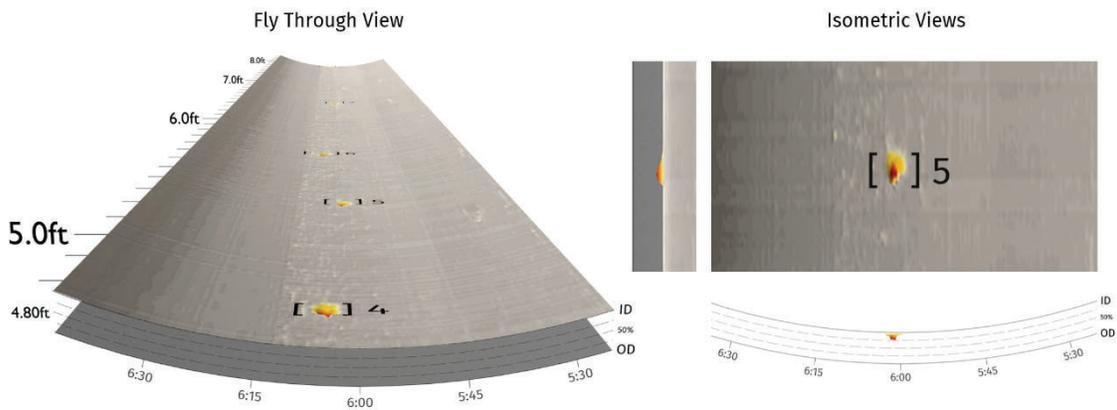
**Figure 25:** A detailed surface map of the defects found and sized is created with Acoustic Imaging.

This run demonstrates the High-Resolution Acoustic Imaging tool's ability to identify and measure pitting or other corrosion anomalies before they become hazardous. **Figure 25** shows ID pitting in 3D that was created from the dense point cloud measurements from Acoustic Imaging. A locally projected cross-sectional view at the base of the figure highlights the varying pit depths and wall loss across the length of the pipe.

The resolving ability and intuitive visualization of the pitting in 3D detail helped the operator understand the severity and characteristics of the pitting. The sharp edges of the pits were clearly identified and enabled the operator to narrow in on the root cause of the pitting defects.

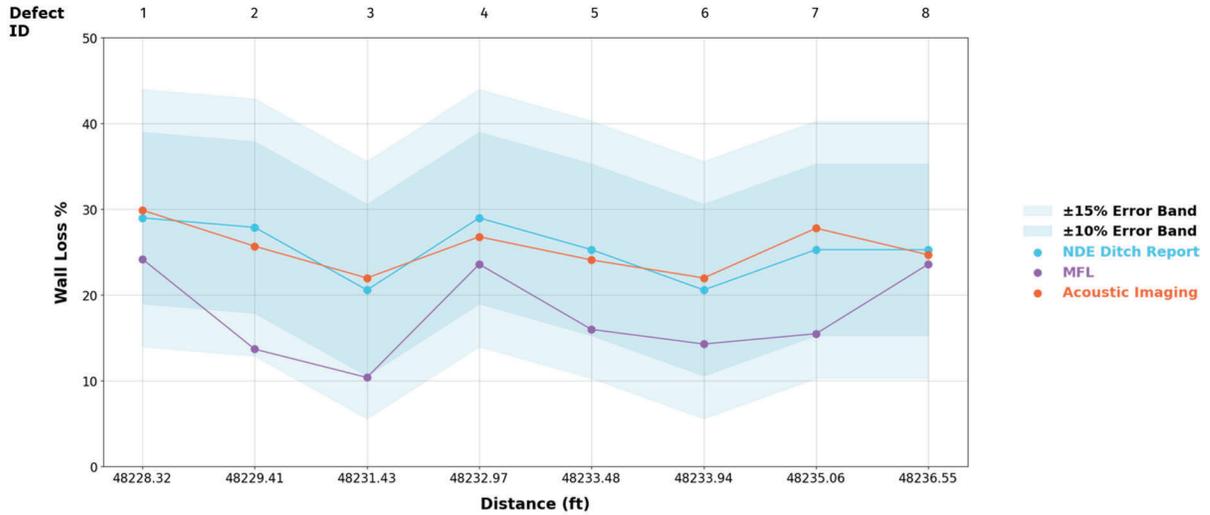
Figure 26: Acoustic Imaging (orange) and MFL (purple) tool results compared to NDE (blue) results over multiple defects.

In general, there was a strong agreement between the NDE data and High-Resolution Acoustic Imaging results. The MFL tool performed roughly within specifications, but it shows a consistent undersizing of the pitting defects when compared to the NDE measurements. The Acoustic Imaging results showed a much tighter agreement with the NDE results. **Figure 26** and **Table 3** below show the differences between the three technologies across the defects inspected.

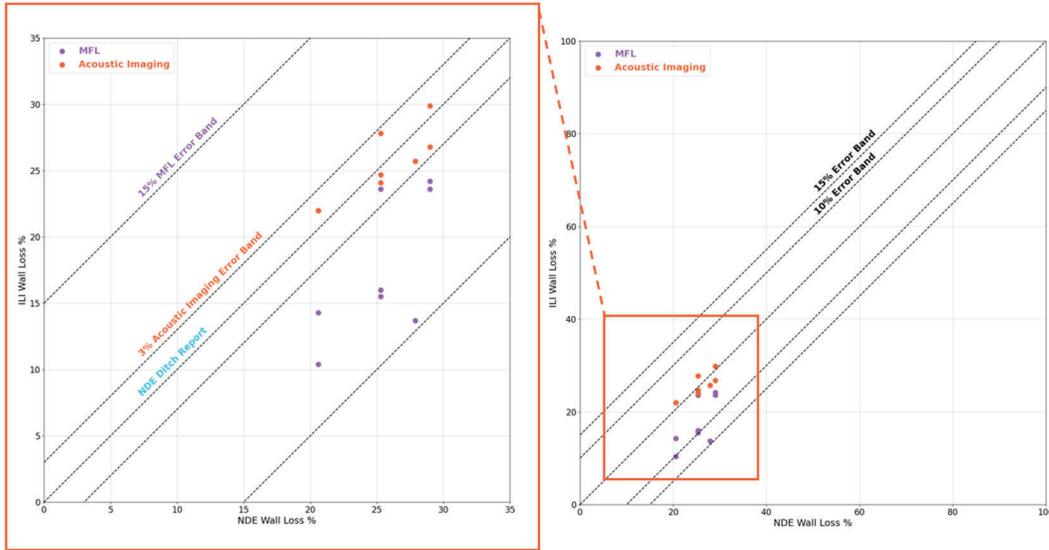
**Figure 27:** A unity plot of the defects reported by an MFL tool and Acoustic Imaging tool compared to in-ditch surface measurements. The MFL results show systemic under-call bias with an  $\sim 15\%$  error. The Acoustic imaging results are evenly distributed around unity with a  $\pm 3\%$  accuracy.

Results from both Acoustic Imaging and MFL are plotted against NDE results as seen in Figure 27. These unity plots illustrate the lower error bounds of the Acoustic Imaging tool and its ability to accurately size defects.

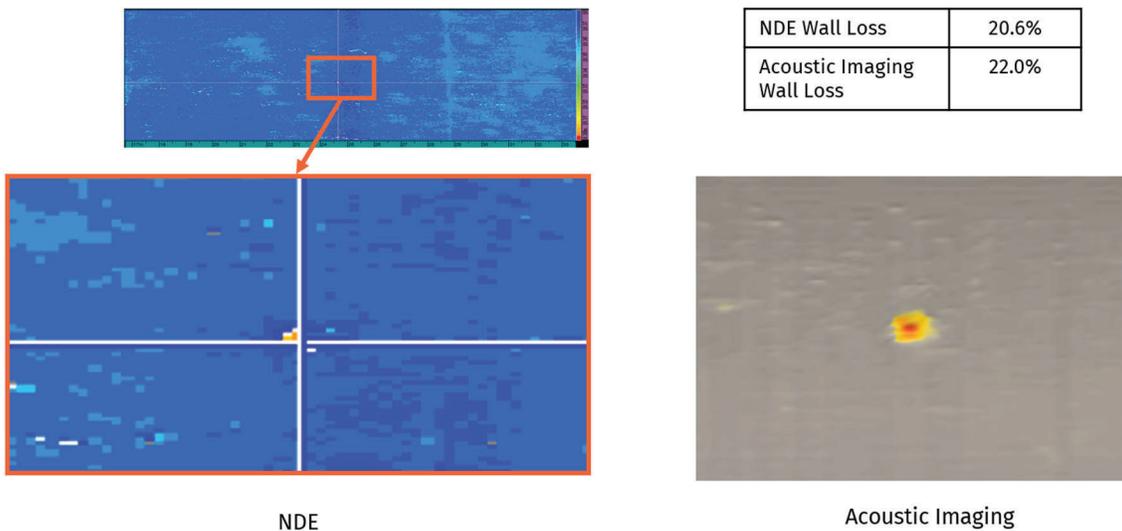
**Figure 28:** A side-by-side comparison of the resolution and defect-resolving ability of the ground truth NDE method vs the Acoustic Imaging method.

Field non-destructive evaluation (NDE) measurements done in the ditch, obtained using technologies such as TFM, are widely regarded as highly reliable for evaluating internal diameter (ID) defects in pipelines. However, in certain cases, particularly with pitting, the resolution of NDE reports can be limited, as the shapes are often depicted with only a few pixels, making precise contour and depth assessments challenging. In contrast, Acoustic Imaging provides a high-resolution 3D profile, allowing for clear visualization and accurate measurement of the pit's exact contours and depth as seen in **Figure 28**.
