# Improvement of ILI Sizing Accuracy for Problematic Corrosion Profiles

Pablo Cazenave, Katina Jimenez and Ravi Krishnamurthy  
Blade Energy Partners Ltd.

*Proceedings of the 2025 Pipeline Pigging and Integrity Management Conference.*

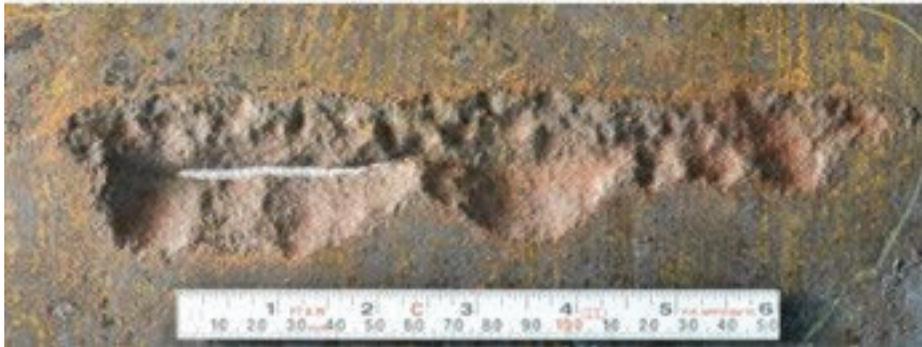
Figure 1: Leaking corrosion feature

These corrosion defects were classified based on their shape, distribution, and association with other features like welds. Examples of these profiles are shown in Figures 1, 2, and 3.

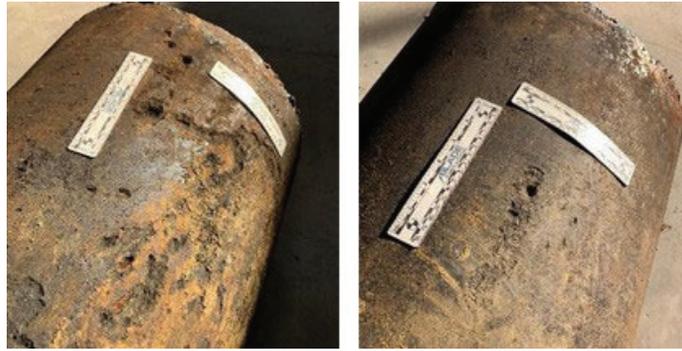
**Figure 4:** Example of corrosion features recovered

The sleeve removal process exposed deep and complex corrosion features, providing natural corrosion profiles for the project (see example of complex corrosion profiles in Figure 4).
