Novel Approach for Detecting and Identifying Complex Cracking in LF-ERW Pipe, a Real Case Study

Christopher Newton¹, Jordi Aymerich², Sayan Pipatpan², Tannia Haro²,
Santiago Urrea², Alex Hensley²
¹Phillips 66 LLC, ²NDT Global

Pipeline Pigging and Integrity Management Conference

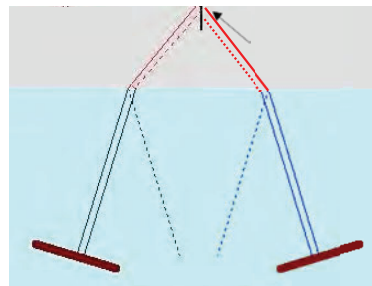
Figure 1. Schematic of clockwise and counterclockwise UT sensors interacting with an ideal crack. The CW Sensor is transmitting while the CCW Sensor is also in transmission mode (no Pitch and Catch technique).

Ultrasonic crack inspection tools rely solely in the Pulse-Echo (PE) technique, which uses piezo-electric transducers to generate a 45° shear wave in the pipe wall. This wave reflects off cracks and returns to the sensors. This idealized hit-and-reflection is called the Corner Echo, Figure 1, depicts a schematic drawing of a clockwise (CW) and a counterclockwise (CCW) sensors corner echo between an ideal external crack and the outer diameter. A typical ultrasonic crack inspection uses both CW and CCW sensors. Due technology own limitations, PE technique can size cracks with $\pm 10^\circ$ of tilt and $\pm 5^\circ$ of skew (Figure 2 for the definitions of tilt and skew).

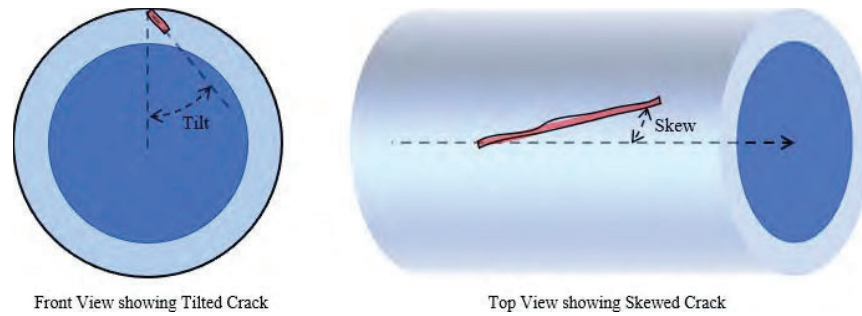
Figure 2. Schematic of tilted and skewed ideal cracks.

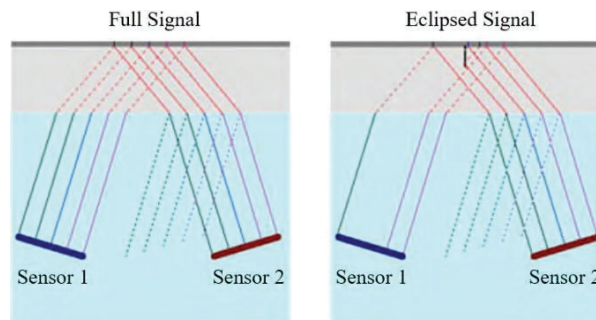
Figure 3. The Pitch and Catch technology principle. Full signal with no shading (left) and eclipsed signal due to a feature (right). The CW Sensor (Sensor 1) is in receiving mode while the CCW (Sensor 2) is in transmitting mode.

On the other hand, the Pitch and Catch technique (Figure 3) which covers a broader range increasing tilt sizing capabilities to $\pm 45^\circ$, and $\pm 10^\circ$ of skew. 'Hook cracks' are an example of tilted cracks where Pitch and Catch technology can help to size when a hook crack lies within the same depth sizing boundaries as tilted and skewed cracks. However, because of the mechanical limitations of the 6" tools, this ILI service was not available.

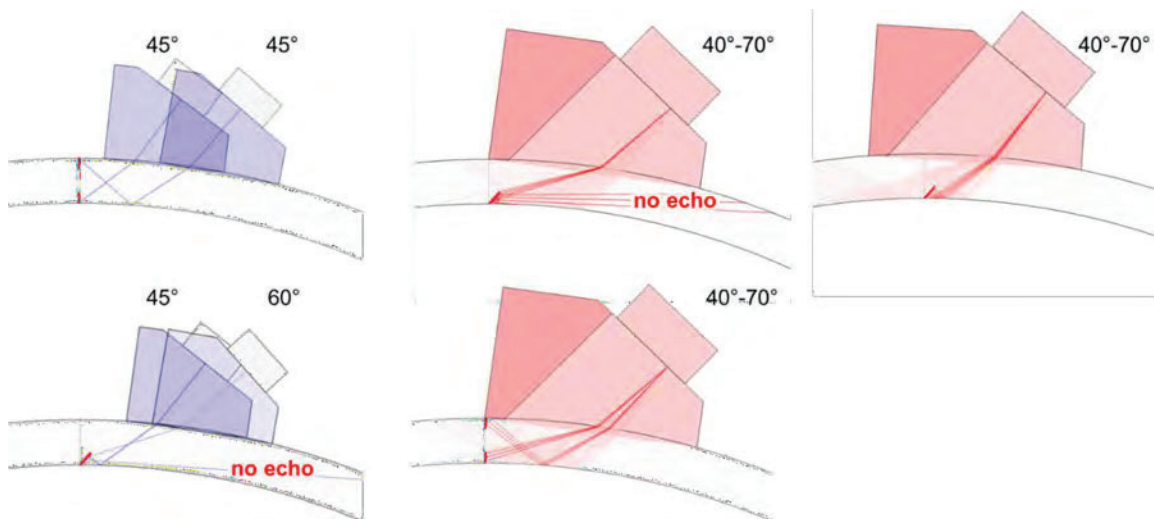
Figure 4. Sound paths for SWUT (blue) and PAUT (red) for tilted cracks (top) and radial, surface-connected cracks (bottom). Note, that the tilted reflector may be missed depending on the probe's angle (for SWUT) and on the probe's position (for PAUT sectorial scans), as the reflections are guided away from the probe.

defects, but there are limitations regarding embedded cracks and planar, but tilted, anomalies with a directional reflectivity. In this case, multiple scans with different probe positions relative to the weld may be required. As a result, detection of tilted or embedded cracks can depend on the probe's angle for shear wave UT and on the probe's position for PAUT sectorial scans (Figure 4).

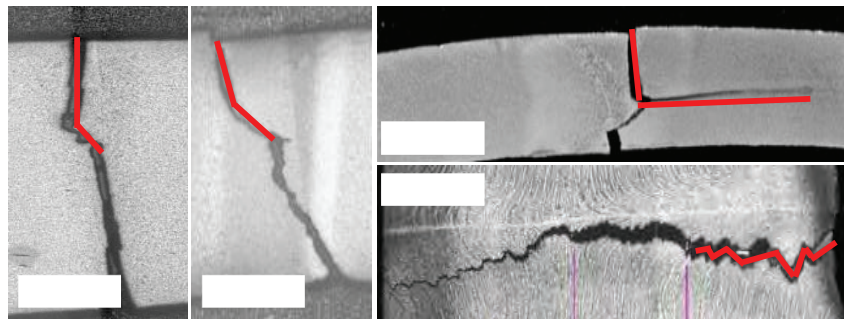
Figure 5. Sample of hook crack morphologies. Red lines indicate the fundamental crack morphology (Hartl, K. et al. 2021).

Figure 5 depicts some example pictures of hook crack flaws. The different flaws are grouped in 4 main categories (LeRoy, M. et al. 2020):

- A – Predominantly radial orientation with small non-radial component at the tip.
- B – Non-radial flaws with additional deviating tip component.
- C – Flaws showing a significant horizontal component, but with a radial surface connected component.
- D – Zig-zag flaws, radial, but with many alternating components in clockwise and counter-clockwise directions.

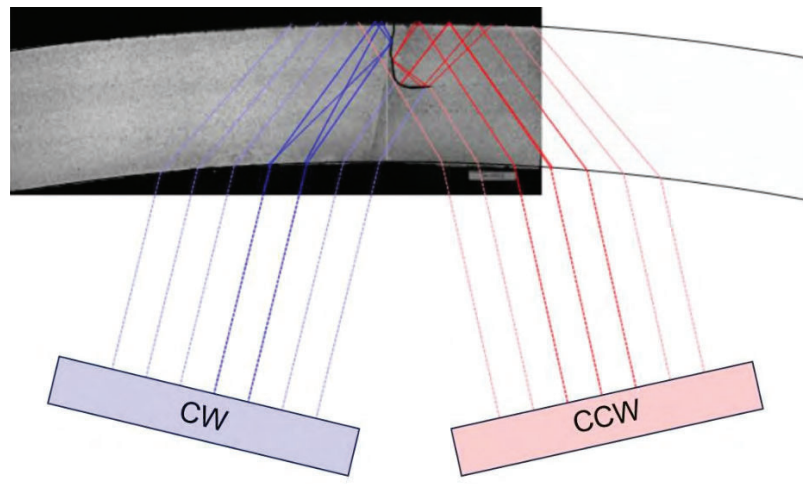
Figure 6. Scheme of a hook crack detected by clockwise and counterclockwise sensors. Colour lines simulate the sound beam, and the stronger ones indicate reflections from the flaw back to the sensors.

The first pattern was the expected one, due to the nature of the hook cracks, which are seam flaws that are not purely radial and generally include some parallel to the surface component. With hook cracks, it is expected that ILI data signals would differ between the clockwise (CW) and counterclockwise (CCW) sensors, either in amplitude, signal pattern behaviour or both. Figure 6 depicts an example of a flaw found in the pipeline system and a simulated ultrasonic 45° UT technology sizing it. From the CW sensor perspective, corner echo would be reflected to the

transducer, this record would depict a linear indication with high amplitude. However, from the CCW sensor perspective, multiple echoes from the hook component of the flaw would be received by the transducer reflecting from the "hook" component of the crack leading to multiple linear indications that make the data look "cloudy".

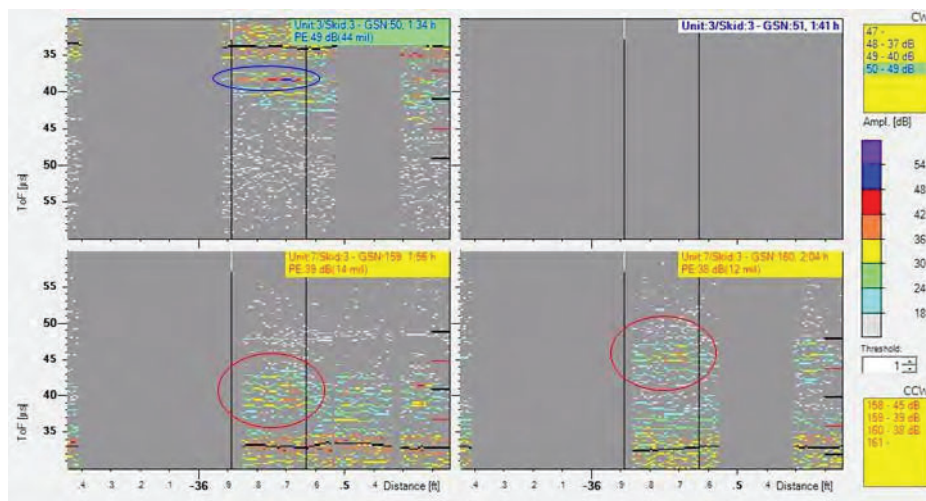
Figure 7. B-Scan data for a verified hook crack. Upper scans correspond to CW sensors and bottom scans to CCW sensors.

Figure 7 shows a sample B-Scan data of one of the recorded anomalies. Each sensor recordings are colour coded by its amplitude, the darker the higher, this recorded amplitude is depicted in front of their Time of Flight (TOF), from the sensor and back, and relative distance to the referenced girth weld. Upper left corner shows circled in dark blue the CW sensor recording of a linear anomaly, bottom scans depict circled in red two CCW sensors with cloudy reflections from multiple echoes.

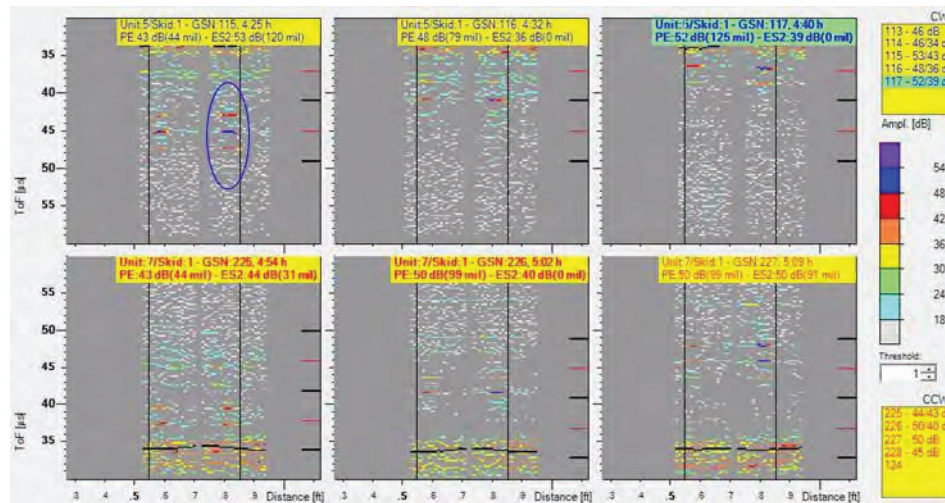
Figure 8. B-Scan data for a verified hook crack.

show same signal and patterns in the data recorded from both sides of the weld, however, these indications followed a pattern of three linear reflections (as seen in Figure 8 circled in dark blue) close to each other but in different TOF. This signal behaviour could indicate some level of complexity in the geometry of the flaws but not necessarily related to a hook crack.

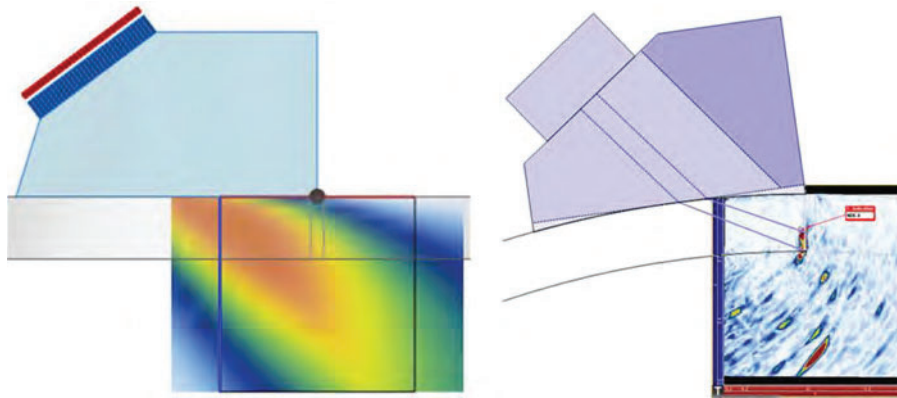
Figure 9. Left: TFM sensitivity map for the setup using a TT-mode (but neglecting the pipe curvature). Right: Sketch of probe in 90° skew position and the corresponding T-scan for an internal reflector on the weld centreline. Additional echoes originate from small impurities within the steel.

In this case, transversal waves without mode conversions were used (TT-mode). The sensitivity varies within the TFM zone, so probe position and dimension of the TFM zone were optimized according to the weld geometry and expected anomalies. (Figure 9, left) The resulting setup made it possible to detect and analyse echoes from both internal and external anomalies. Equivalent to a PAUT sectorial scan, the T-scan shows the amplitudes within the TFM zone as colours, and the horizontal and vertical plot axes refer to the distance from the probe (Figure 9, right).

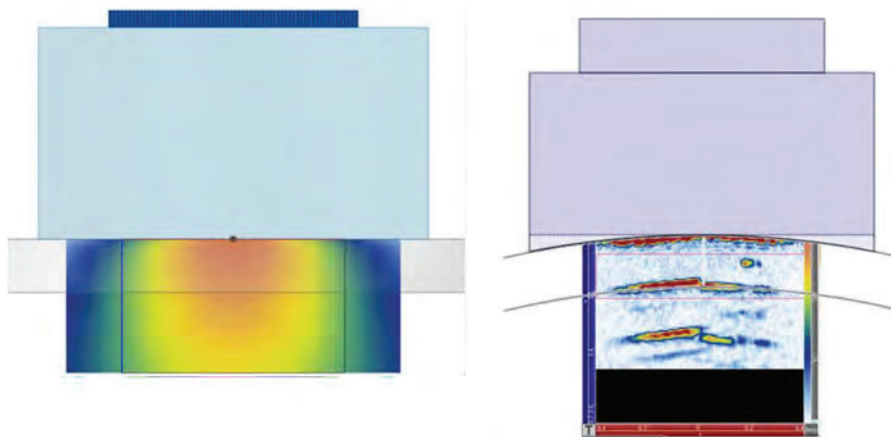
Figure 10. Left: TFM sensitivity map for the setup using a LL-mode (but neglecting the pipe curvature). Right: Sketch of probe above the seam weld and the corresponding T-scan for a laminar reflector clockwise from the centreline.

A separate TFM scan was performed with longitudinal waves (LL-mode), with the probe directly above the seam weld, allowing to detect lateral reflectors and thickness variations. Analysing this first proved beneficial, as it could indicate wall thickness variations or the presence of anomalies such as laminations or weld misalignment which might otherwise mislead the analysis of the transversal wave modes. Both a lateral reflector and weld misalignment are visible in the example in Figure 10.

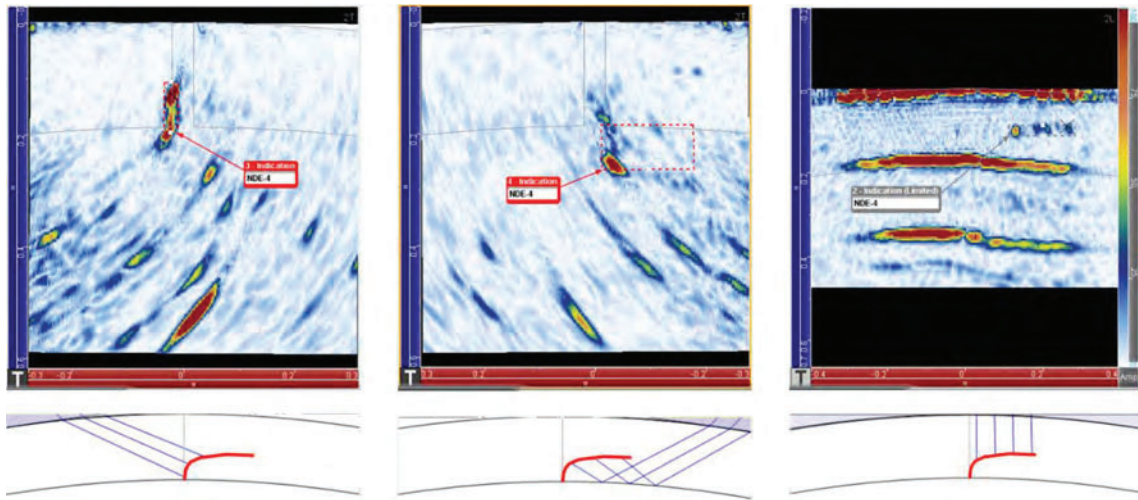
Figure 11. TFM T-scan images of a hook crack. From left to right: probe shooting clockwise (TT-mode, 90° skew), counterclockwise (TT-mode, 270° skew), and vertical (LL-mode). The sketches below indicate the main direction of the ultrasonic signals.

Figure 11 shows TFM T-scans for a very pronounced hook crack. The clockwise shooting probe shows clear echoes above the inner pipe wall i.e., in the first leg. The probe on the opposite side of the weld

shows the main echo below the inner pipe wall i.e., in the second leg, and it even detected hints of its lateral components. The latter became clear indications in the LL-mode. Overall, this crack met characteristics A, B, D, F, G, and H from Table 3.

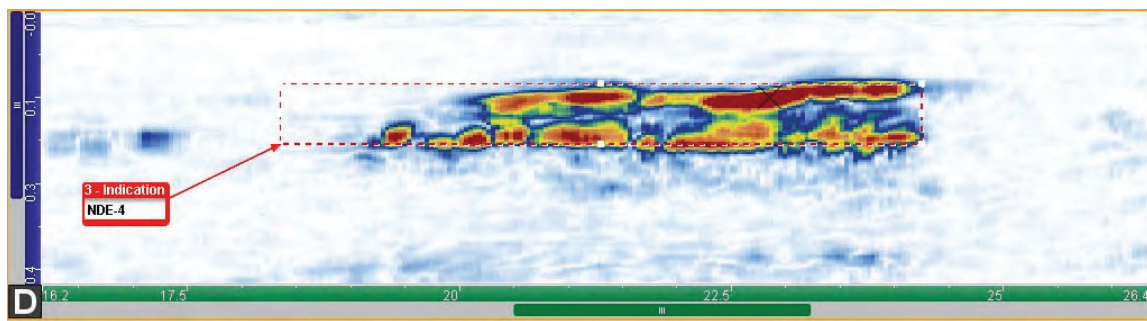
Figure 12. TFM D-scan from the clockwise shooting probe (90° skew) for the hook crack discussed above.

It was also observed that some of the deeper hook cracks showed a plateau in the crack-depth profile. This can be seen in the D-scan in Figure 12, showing echo amplitudes with the vertical and horizontal axes referring to depth below the probe and axial distance along the seam weld, respectively.

If the hooked shape originates from the crack following the steel's grain structure, such a plateau shouldn't be unexpected, and it might be usable as additional characteristic of (deep) hook cracks for future inspections.
